# Dynamic Characteristics and Damage to Structures of the Earthquake at the Western Part of Nagano Prefecture in 1984

Masaru KITaura\*, Masakatsu MIYAJIMA\* and Toshikazu IKEMOTO\*

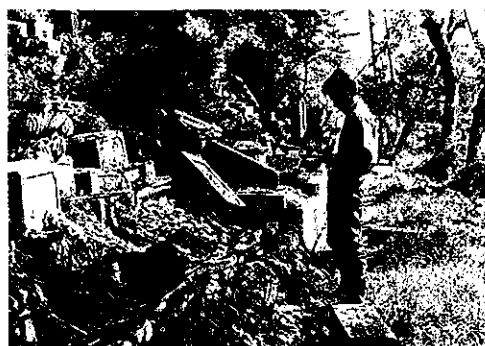
A view of the overturned tombstones near Otaki office is shown in Photo. 1. The results of overturned tombstones are listed in Table 3. Estimated horizontal acceleration using the overturned tombstones ( $\alpha$ (gals)) can be derived from

Photo. 1 A view of overturned tombstones near Otaki village office

In Table 3, the ratios of overturned tombstones at the regions from Noguchi to Hougoshi in Otaki village are very high: 80~100%. The estimated horizontal acceleration is about 400gals. The estimated acceleration is high and it corresponds to the six on JMA intensity scale. Similarly we estimated that earthquake intensities in most areas were the six on JMA intensity scale, and that in some areas they were the seven on the same scale. These estimated values do fit those estimated by Japan Meteorological agency. However, it is considered that the vertical component of the ground motion dominates the horizontal component, because there are many overturned tombstones due to the saltation and rotation. Therefore exact estimation of the horizontal acceleration of earthquake that occurred in the shallow ground and on the land such as this shock is not made perfectly only by investigation of overturned tombstone.

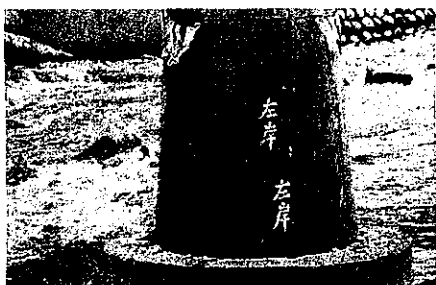
The damage to the bridges due to the ground motion itself, however, was slight as same as the buildings. In Matsubara bridge, the soil behind the bridge abutment settled about 15cm, some parts of the reinforced concrete piers were ripped in the direction perpendicular to the axis of the bridge by the ground motion (See Photo. 2) and the break of the anchor-bolt at the fixed bearing was caused (See Photo. 3). It is conceivable that the ground motion in this direction could be predominant. Other bridges suffered slight damage.

Photo. 2 Damage to reinforced concrete pier of Matsubara bridge

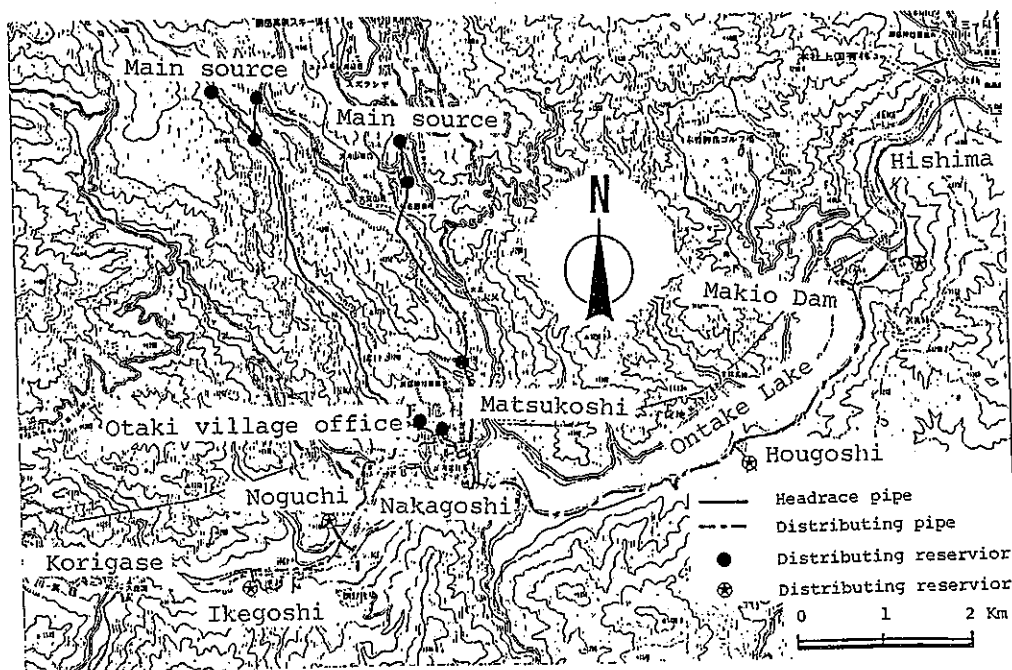
Fig. 9 Network of the water supply system in Otaki village

The overall damage has been estimated at 208 million yen, mainly in Otaki village. The particular modes of the damage to the pipelines were sweeping of the pipelines due to the large slope failure, the breaks and the cracks of the pipe body of the asbestos cement pipes and the pull-out and looseness at the joints of the polyvinyl chloride pipes. This section briefly describes the restorations of the water supply systems in Otaki village, that followed the damage inflicted by this earthquake. The emergency water supply operation employing polyvinyl containers immediately following the earthquake was conducted because of suspension of water supply and muddy water in many houses. Fig. 9 shows the network of the water supply system in Otaki village. This system had two main sources of water supply. One of them, however, did not work due to the slope failure in Matsukoshi area. The headrace pipes, whose length is about 3km from the source to the distributing reservoir, consist of the asbestos cement pipes and polyvinyl chloride pipes with 75mm and 100mm diameter. About twenty damage was found and was repaired. As to the distributing pipes, above ground piping employing vinyl pipes with 50mm diameter was made as emergency restoration since it was discovered that the asbestos cement pipes were completely destroyed.

A total of about 16 days was required for temporary recover of the water supply systems. Even then, the supplied water is not good for drink in spite of chlorination because of the supplied water was muddy. The water supply using the water wagon was continued for several days.
