# Cable externalization at the proximal portion of the superior vena cava coil in Riata implantable cardioverter defibrillator leads

## **Case reports**

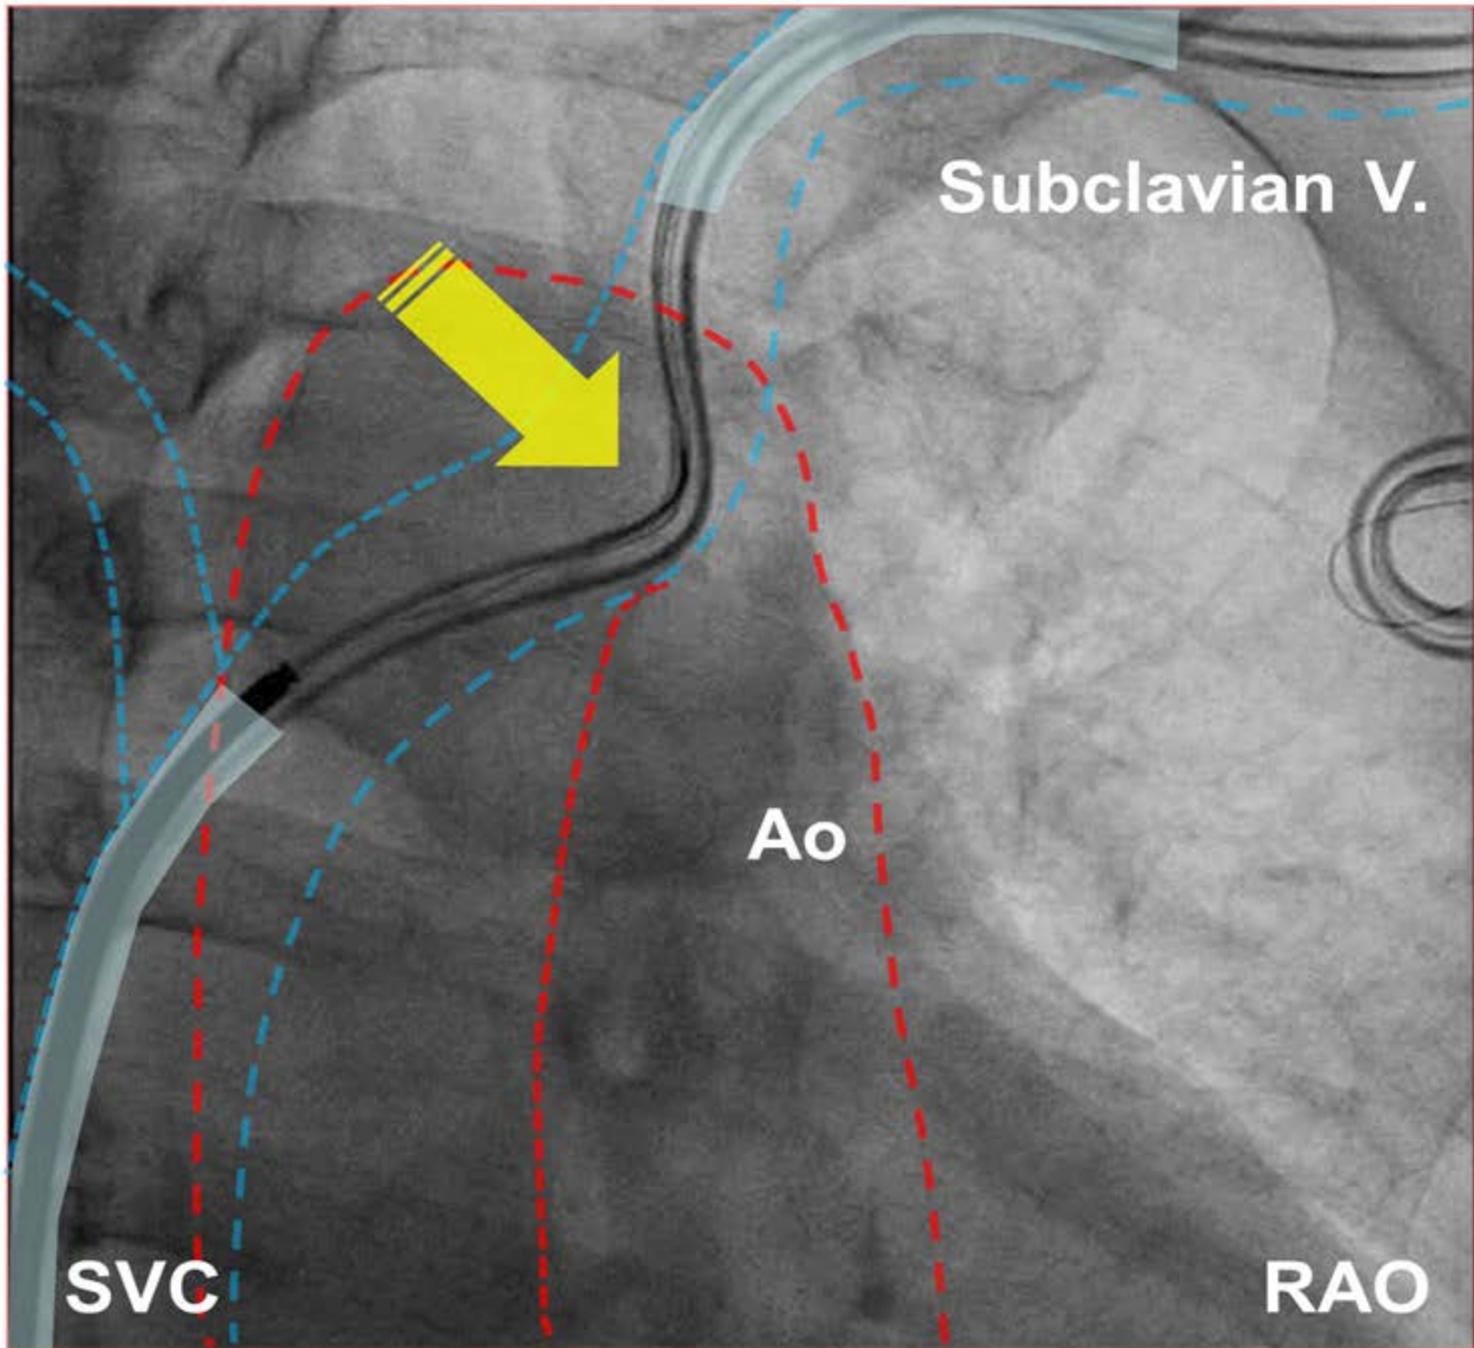
Fig.1 Anatomical relationship between the ICD lead and aortic arch

proximal portion of the SVC coil was confirmed by X-ray fluoroscopy (Fig.1). Because of the lead crash and increase in the pacing threshold, we decided to extract the Riata lead transvenously.

This was a rare case in which the ICD lead was tightly adherent to the subclavian vein and SVC, and the cable was externalized between these adhesions. In preoperative X-ray fluoroscopy, the lead

was tightly fixed to the vein wall at the subclavian vein and SVC, and became bent between these adhesions. The motion of the lead at this site was synchronized with the pulsation of the aortic arch (Fig.1). The ICD lead might develop inside-out abrasion due to mechanical stress induced by pulsation from the aortic arch.

The ICD lead received pulsation from the aortic arch [yellow arrow] between the adhesions at the subclavian vein and the superior vena cava (SVC) coil [light blue lines]. Cable externalization between the adhesions was suspected on X-ray fluoroscopy.

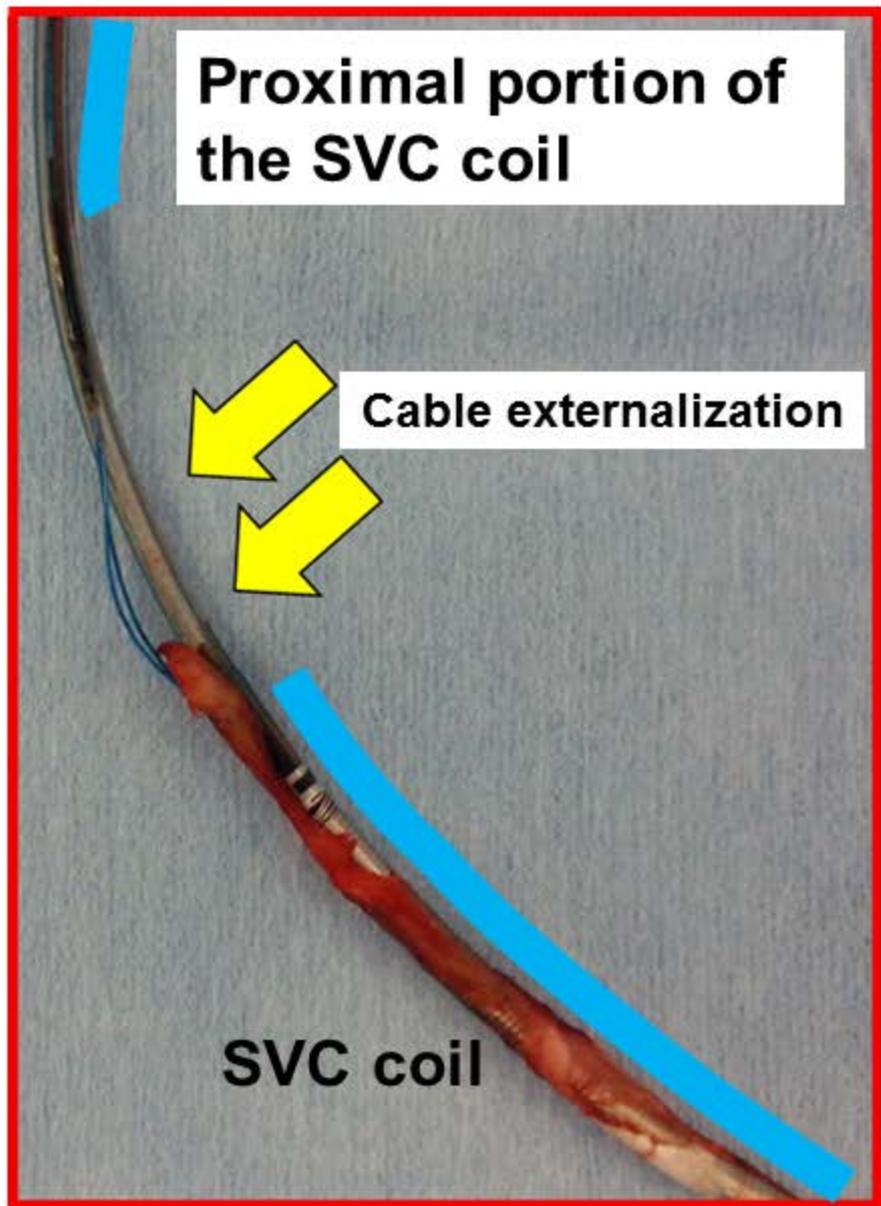
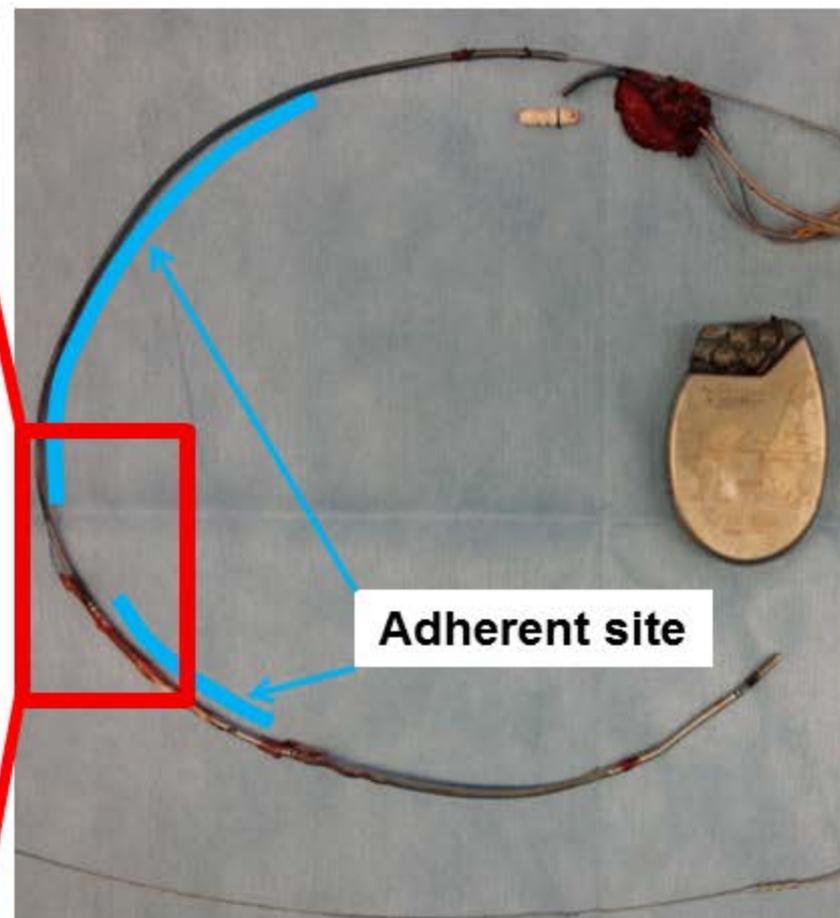
Fig.2 Extracted Riata ICD lead and generator

At the extraction procedure, firstly, a locking stylet was inserted into far end of Riata lead and fixed. Then, we removed tight adhesions by using a laser sheath. Riata lead was successfully extracted without affecting the atrial lead. Tightly adherent fibrous tissue at the subclavian vein and SVC coil, and also cable externalization at the proximal portion of the coil was observed on the extracted lead (Fig.2). The cable had not externalized underneath SVC coil. Though ETFE coating was damaged by extraction procedure, electrical abnormality was not observed in the entire conduction path in extracted lead analysis.

Tightly adherent tissue on the ICD lead was seen at the subclavian vein and SVC coil [blue line]. The cable was externalized between the adhesions [yellow arrow].

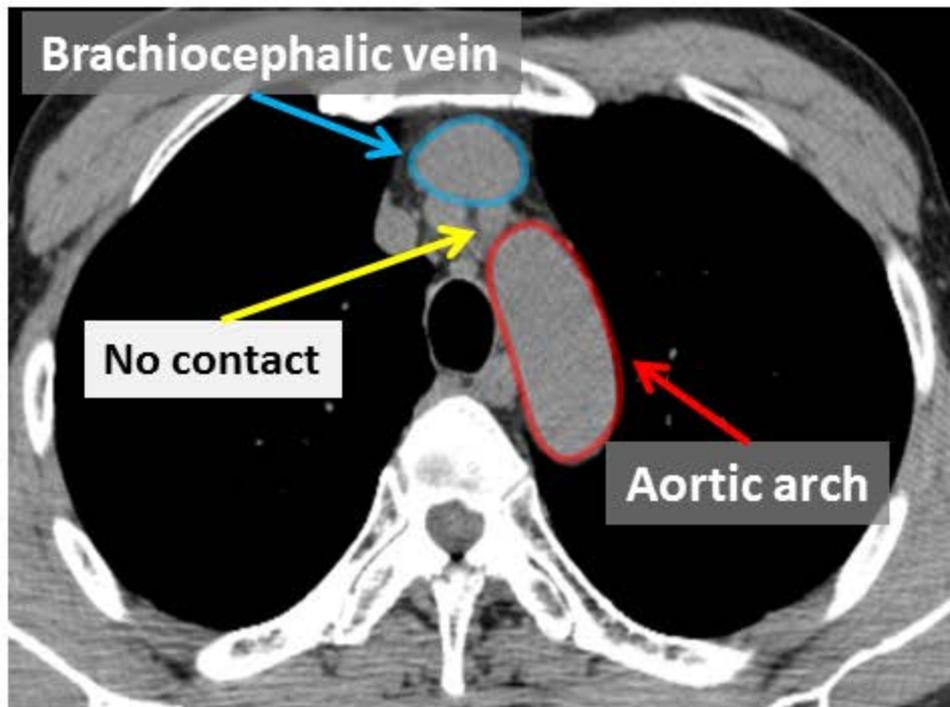
**A**

Figure 3A showed the CT image before device implantation. The left brachiocephalic vein [blue circle] had no contact with aortic arch [red circle]. Figure 3B showed the CT image after device implantation. The left brachiocephalic vein [blue circle] moved downward and made contact with the aortic arch [red circle] after device implantation.

**Before device implantation****B**

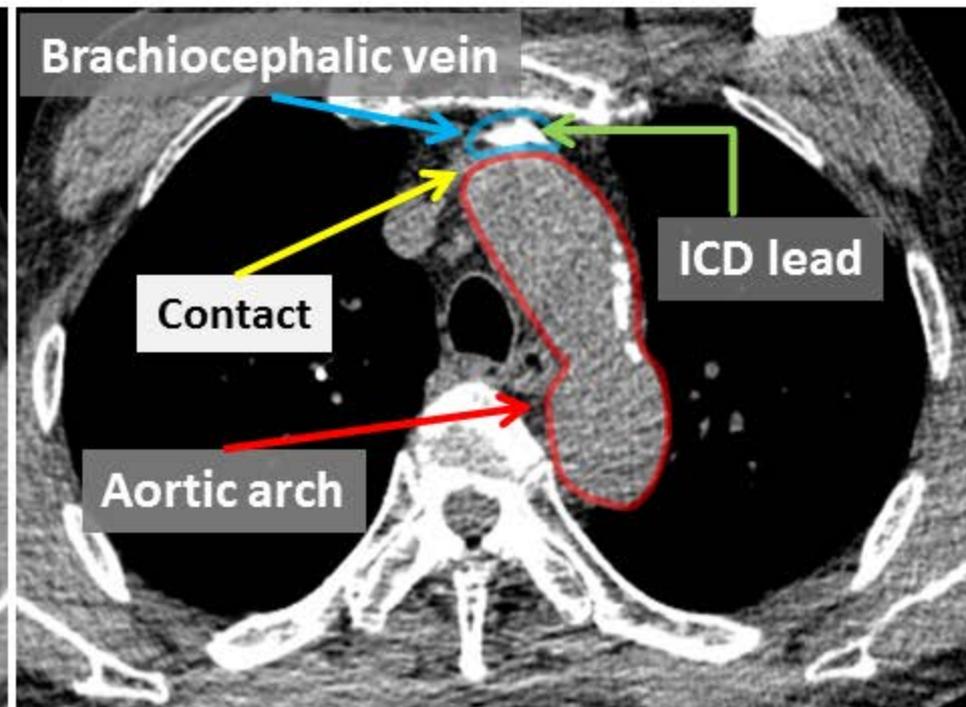
**After device implantation**

Usually, the left brachiocephalic vein does not have direct contact with the aortic arch. However, in this case, CT before and after device implantation showed that the left brachiocephalic vein had moved downward and made contact with the aortic arch (Fig.3). The deformation of the left brachiocephalic vein might have been induced by the weight of the lead, pushing force, or extension of the SVC by lead insertion.
