RECONNAISSANCE REPORT ON THE 2000 KOHZUSHIMA KINKAI EARTHQUAKE

An M_s6.4 earthquake occurred on July 1, 2000 offshore of Kohzushima Island in the Tokyo municipal jurisdiction. Large tremors also were felt on Kohzushima on July 9 and on Niijima on July 15. This is the damage investigation report on the 2000 Kohzushima Kinkai earthquake made by a JSCE reconnaissance team. Earthquake swarms continued near Kohzushima, Niijima, and Shikinejima islands for about three months. A JMA seismic intensity of lower 6 was recorded twice on Kohzushima during July, 2000. An outline of the earthquake and aftershocks and the damage done to civil structures is given. Slope failures, damage to retaining walls and disaster responses, in particular, are focused on.

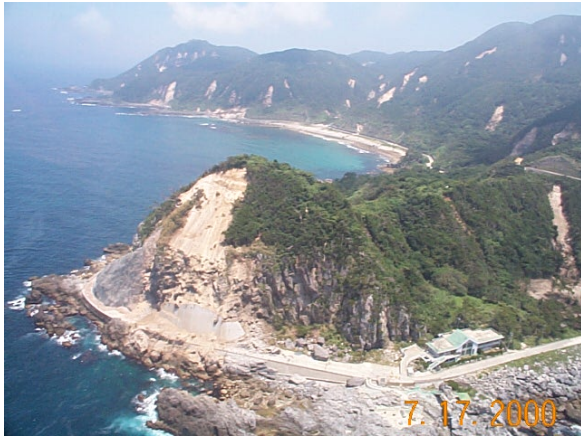
Soils at sites where most of the slope failures occurred, along Maehama Beach, Sawajiri Bay, and Nagahama Beach (**Photo 1(a)**), mainly are composed of pyroclastic flow sediments and rhyolitic rocks with many cracks. Traces of many previous slope failures can be seen along the pyroclastic cone of Mt. Tenjo, and a huge slope failure was caused by the July 2000 earthquake (**Photo 1(b)**).

(a) Slope failure along the road from Sawajiri Bay to Nagahama Beach

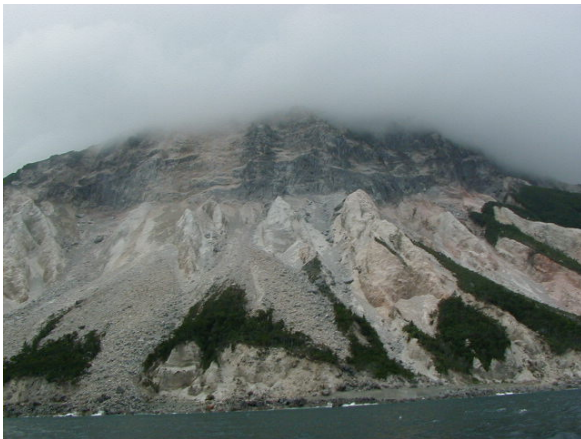
(b) Slope failure of the pyroclastic cone of Mt. Tenjo facing Takou Bay

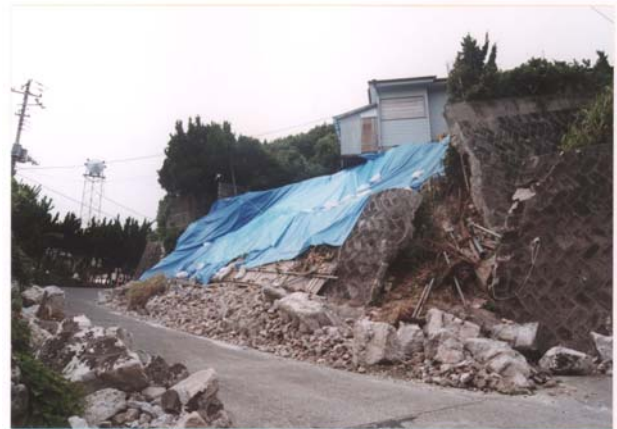
Photo 3 Collapse of a stone masonry retaining wall

old, previously degraded ones were re-damaged by the earthquake's force. Longitudinal, transversal, and diagonal cracks, as well as bulging and collapse were all generated. A corner of the retaining wall in **Photo 3** shows severe damage.

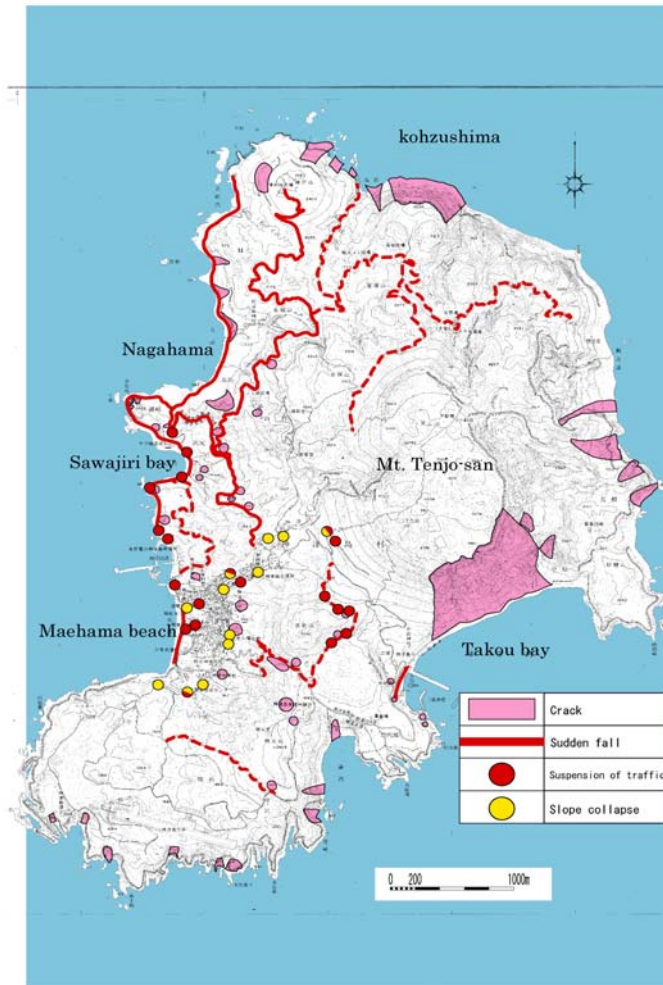
Fig.4 Sites where slope failures occurred

sustained severe damage, but a small offset of several centimeters was generated between bridge beams and abutments. Most of the damage done to roads was caused by slope failures and the collapse of retaining walls (**Fig. 4**). Large cracks were present at many places on the road along the dale of the Kohzu Marsh and on the circuit road.
