Dynamic Characteristics and Damage to Structures of the Earthquake at the Western Part of Nagano Prefecture in 1984

Masaru KITAURA*, Masakatsu MIYAJIMA* and Toshikazu IKEMOTO*

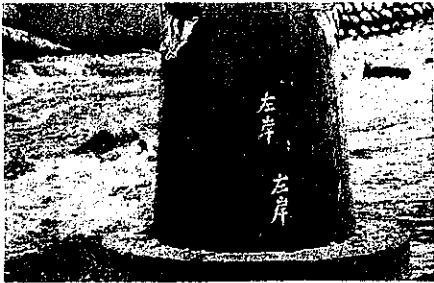
The damage to the bridges due to the ground motion itself, however, was slight as same as the buildings. In Matsubara bridge, the soil behind the bridge abutment settled about 15cm, some parts of the reinforced concrete piers were ripped in the direction perpendicular to the axis of the bridge by the ground motion (See Photo. 2) and the break of the anchor-bolt at the fixed bearing was caused (See Photo. 3). It is conceivable that the ground motion in this direction could be predominant. Other bridges suffered slight damage.

Photo. 2 Damage to reinforced concrete pier of Matsubara bridge

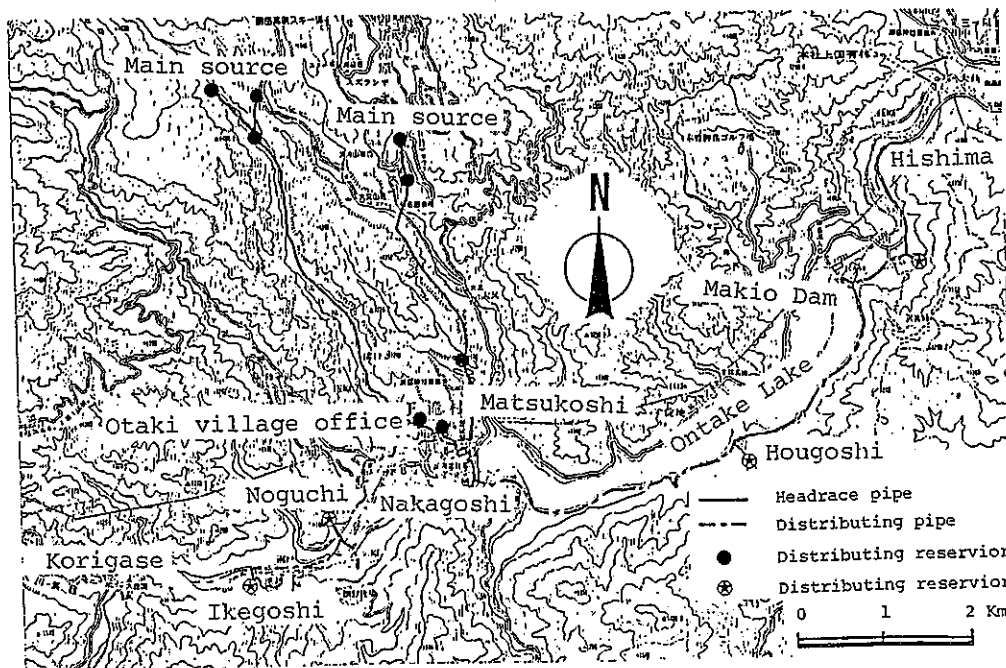
The overall damage has been estimated at 208 million yen, mainly in Otaki village. The particular modes of the damage to the pipelines were sweeping of the pipelines due to the large slope failure, the breaks and the cracks of the pipe body of the asbestos cement pipes and the pull-out and looseness at the joints of the polyvinyl chloride pipes. This section briefly describes the restorations of the water supply systems in Otaki village, that followed the damage inflicted by this earthquake. The emergency water supply operation employing polyvinyl containers immediately following the earthquake was conducted because of suspension of water supply and muddy water in many houses. Fig. 9 shows the network of the water supply system in Otaki village. This system had two main sources of water supply. One of them, however, did not work due to the slope failure in Matsukoshi area. The headrace pipes, whose length is about 3km from the source to the distributing reservoir, consist of the asbestos cement pipes and polyvinyl chloride pipes with 75mm and 100mm diameter. About twenty damage was found and was repaired. As to the distributing pipes, above ground piping employing vinyl pipes with 50mm diameter was made as emergency restoration since it was discovered that the asbestos cement pipes were completely destroyed.

Fig. 9 Network of the water supply system in Otaki village

A total of about 16 days was required for temporary recover of the water supply systems. Even then, the supplied water is not good for drink in spite of chlorination because of the supplied water was muddy. The water supply using the water wagon was continued for several days.
