Case reports

Cable externalization at the proximal portion of the superior vena cava coil in Riata implantable cardioverter defibrillator leads

Tomonori Katsuki (MD), Hiroshi Furusho (MD, PhD), Takashi Kusayama (MD, PhD), Shinichiro Takashima (MD, PhD), Takeshi Kato (MD, PhD), Hisayoshi Murai (MD, PhD), Soichiro Usui (MD, PhD), Shuichi Kaneko (MD, PhD), Masayuki Takamura (MD, PhD)

Department of Cardiology, Kanazawa University Hospital, Kanazawa, Ishikawa, Japan

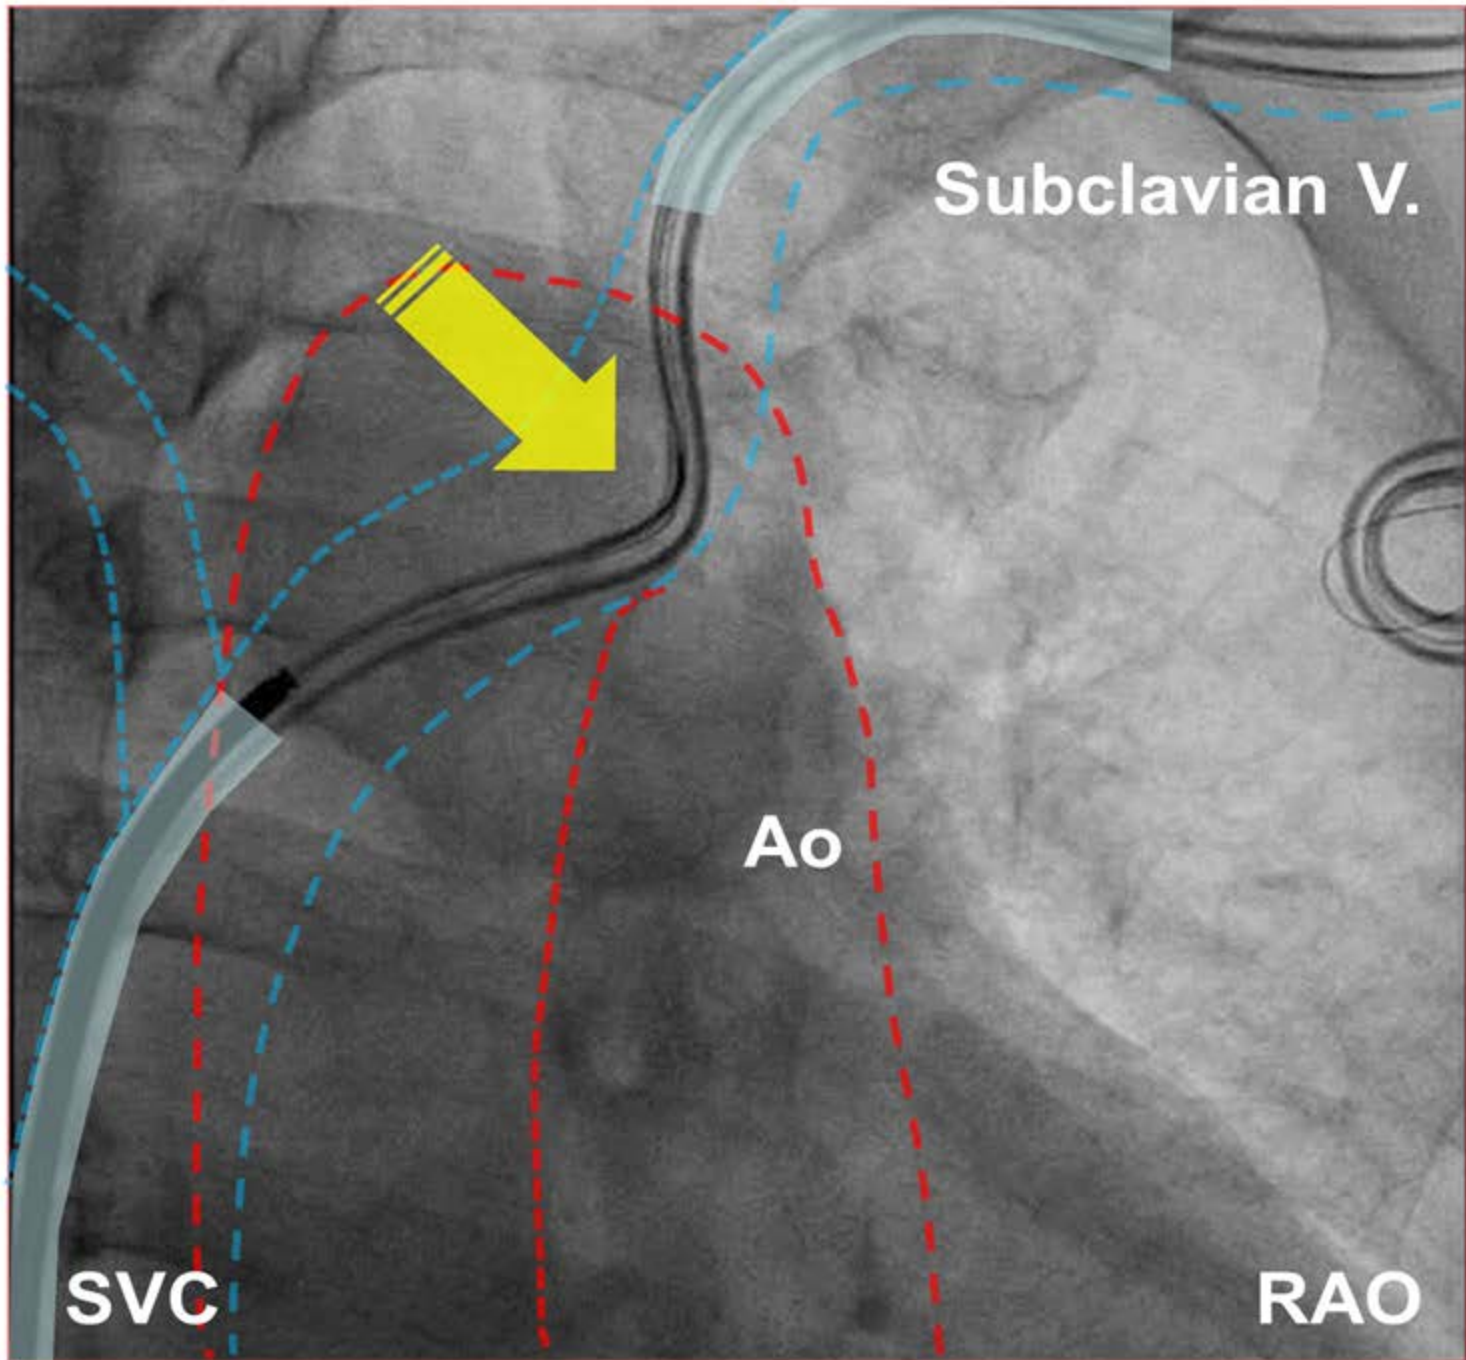
Fig.1 Anatomical relationship between the ICD lead and aortic arch

proximal portion of the SVC coil was confirmed by X-ray fluoroscopy (Fig.1). Because of the lead crash and increase in the pacing threshold, we decided to extract the Riata lead transvenously.

This was a rare case in which the ICD lead was tightly adherent to the subclavian vein and SVC, and the cable was externalized between these adhesions. In preoperative X-ray fluoroscopy, the lead

was tightly fixed to the vein wall at the subclavian vein and SVC, and became bent between these adhesions. The motion of the lead at this site was synchronized with the pulsation of the aortic arch (Fig.1). The ICD lead might develop inside-out abrasion due to mechanical stress induced by pulsation from the aortic arch.

The ICD lead received pulsation from the aortic arch [yellow arrow] between the adhesions at the subclavian vein and the superior vena cava (SVC) coil [light blue lines]. Cable externalization between the adhesions was suspected on X-ray fluoroscopy.

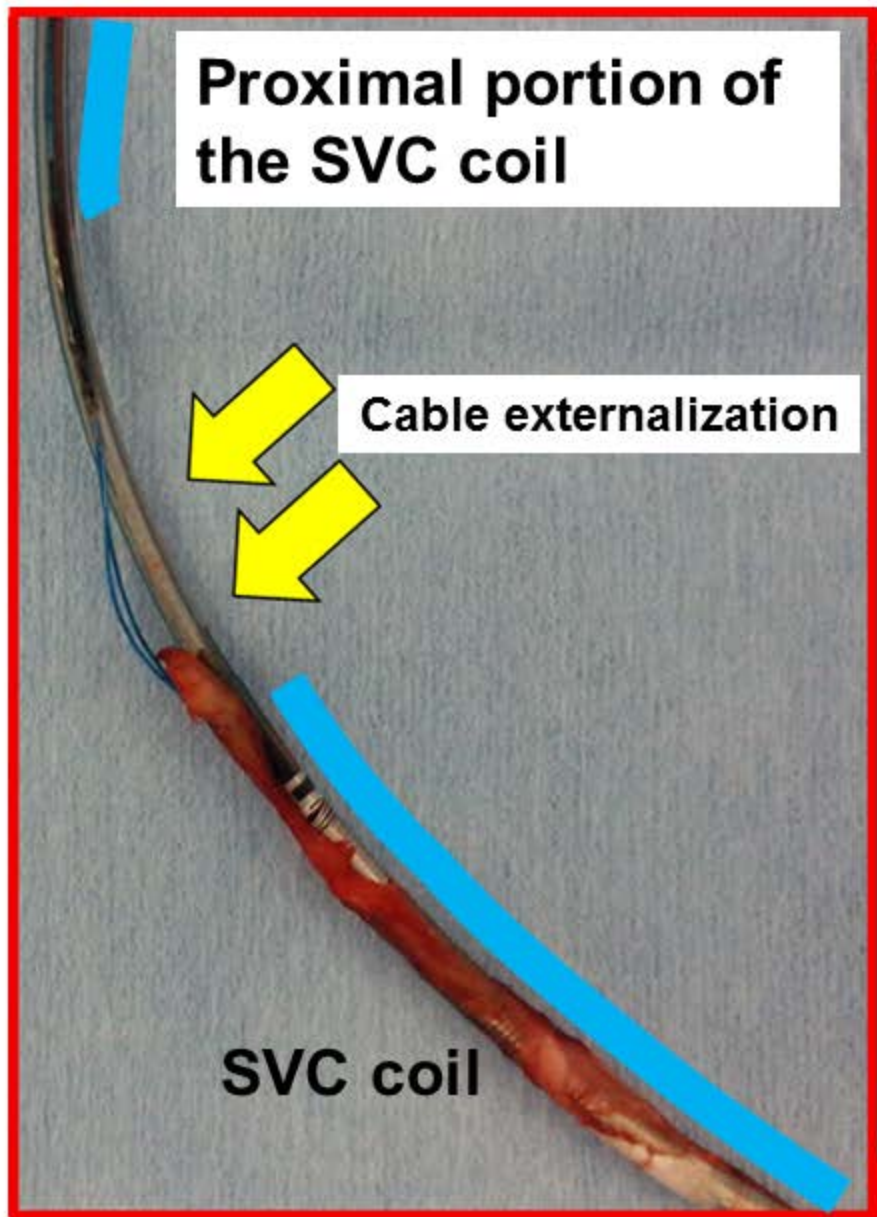
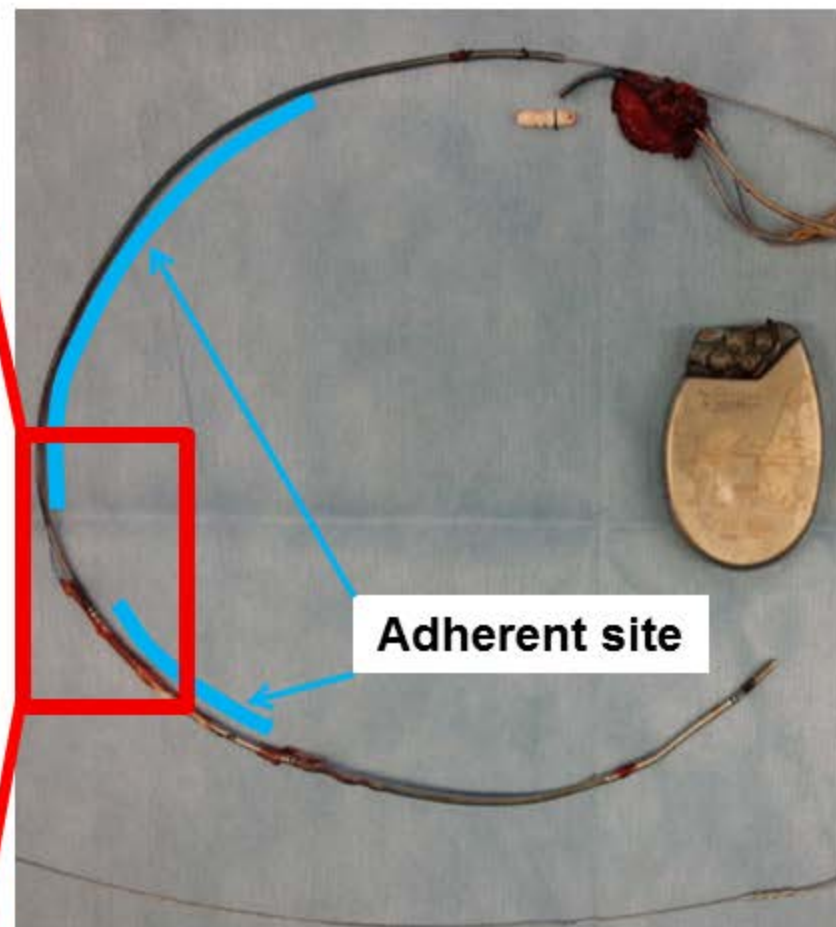
Fig.2 Extracted Riata ICD lead and generator

At the extraction procedure, firstly, a locking stylet was inserted into far end of Riata lead and fixed. Then, we removed tight adhesions by using a laser sheath. Riata lead was successfully extracted without affecting the atrial lead. Tightly adherent fibrous tissue at the subclavian vein and SVC coil, and also cable externalization at the proximal portion of the coil was observed on the extracted lead (Fig.2). The cable had not externalized underneath SVC coil. Though ETFE coating was damaged by extraction procedure, electrical abnormality was not observed in the entire conduction path in extracted lead analysis.

Tightly adherent tissue on the ICD lead was seen at the subclavian vein and SVC coil [blue line]. The cable was externalized between the adhesions [yellow arrow].

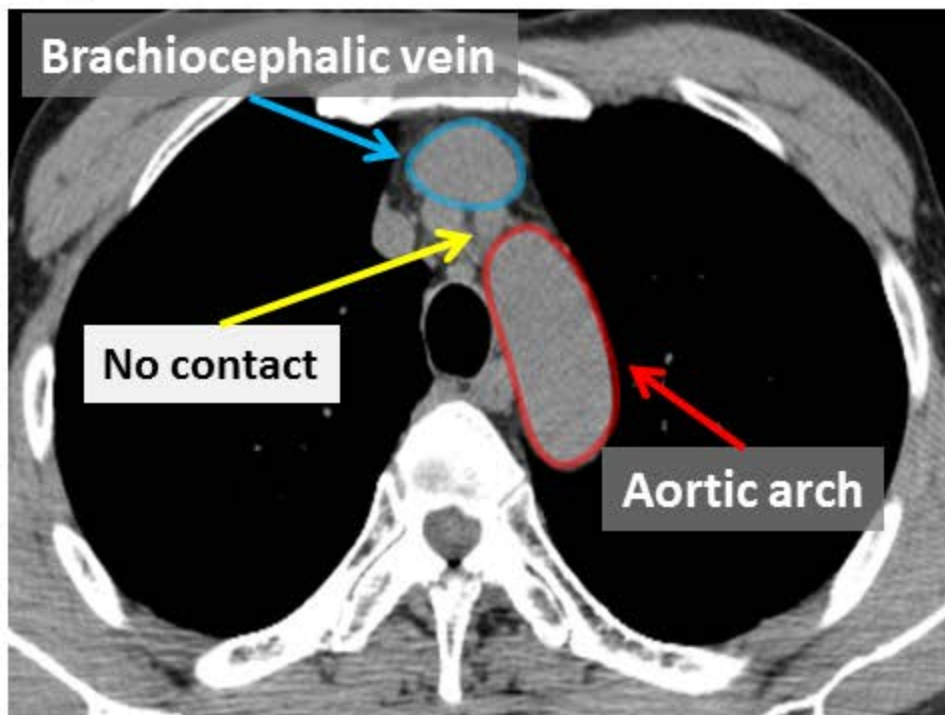
A

Figure 3A showed the CT image before device implantation. The left brachiocephalic vein [blue circle] had no contact with aortic arch [red circle]. Figure 3B showed the CT image after device implantation. The left brachiocephalic vein [blue circle] moved downward and made contact with the aortic arch [red circle] after device implantation.

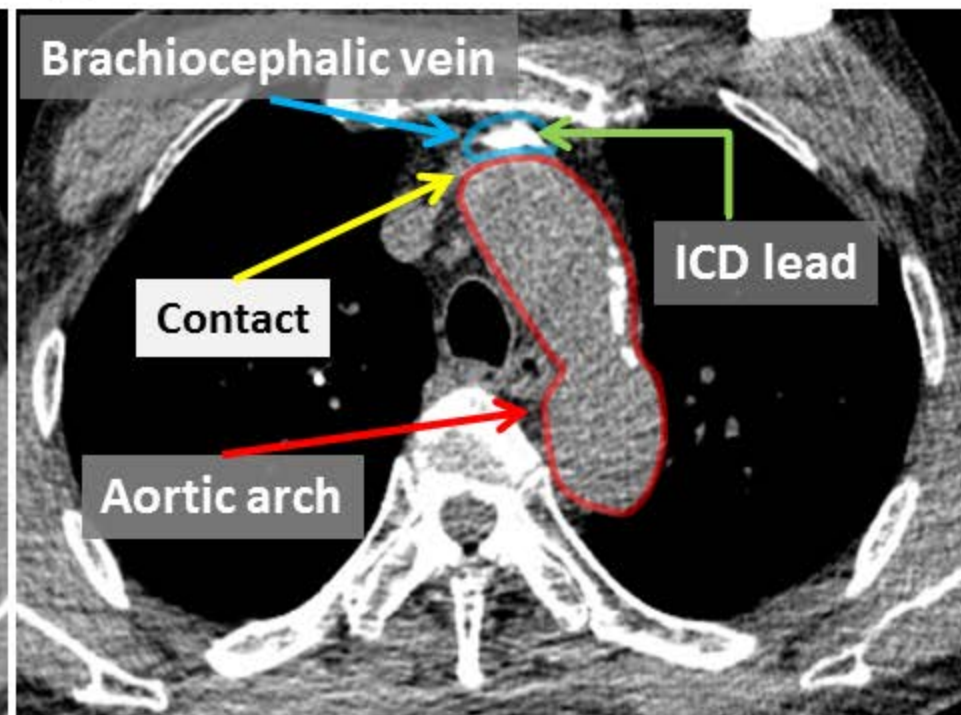
**Before device implantation****B**

Usually, the left brachiocephalic vein does not have direct contact with the aortic arch. However, in this case, CT before and after device implantation showed that the left brachiocephalic vein had moved downward and made contact with the aortic arch (Fig.3). The deformation of the left brachiocephalic vein might have been induced by the weight of the lead, pushing force, or extension of the SVC by lead insertion.
