DOCTORAL THESIS

**ESTIMATION OF MALFUNCTION
OF A HEALTHCARE FACILITY IN
CASE OF EARTHQUAKE**

KANAZAWA UNIVERSITY

Nebil Achour

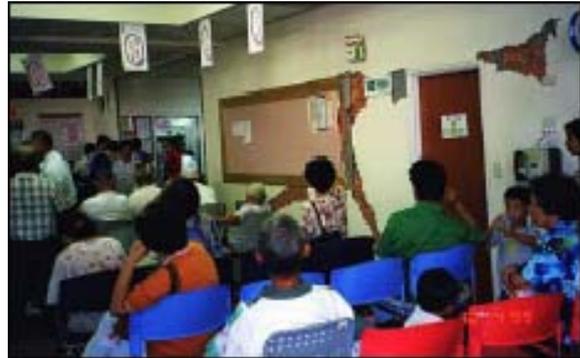
Photo 3.2- Interior damage (1st floor, remained open) Christian Hospital (Source: Lee et al, 2000)

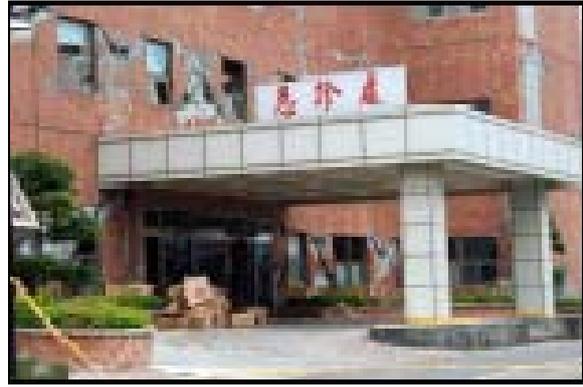
Photo 3.5- Exterior damage, Veteran Hospital

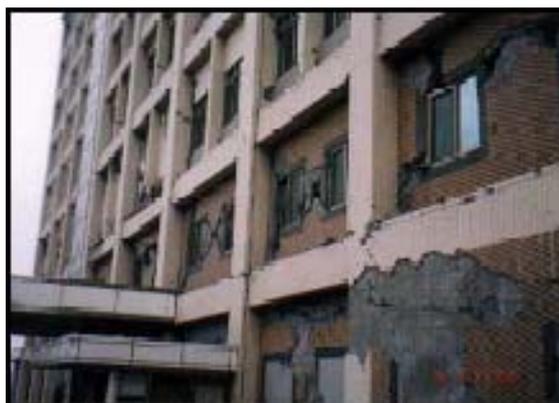
Photo 3.8- Exterior damage, Shiu-Tuan Hospital
(Source: Lee et al, 2000)

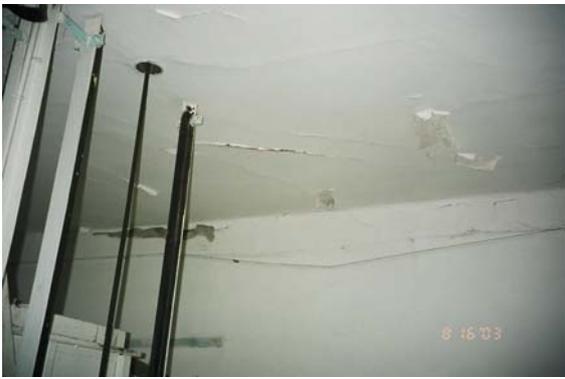
Photo 3.13- Cracks in the structure
CHU Hospital

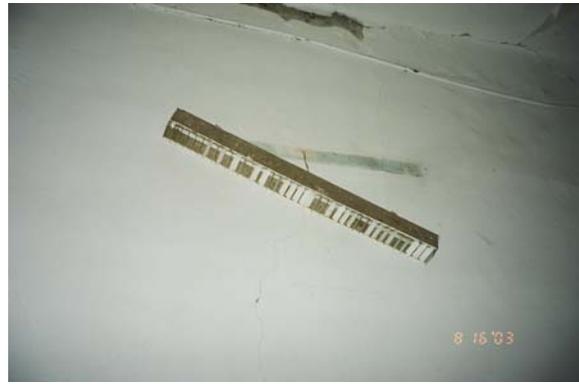
Photo 3.14- Damage to electric equipment
CHU Hospital

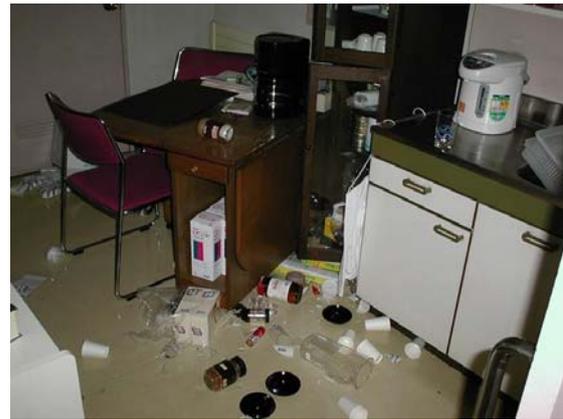
Photo 3.20- Toppling and damage to small equipment, Kushiro Urinary Clinics

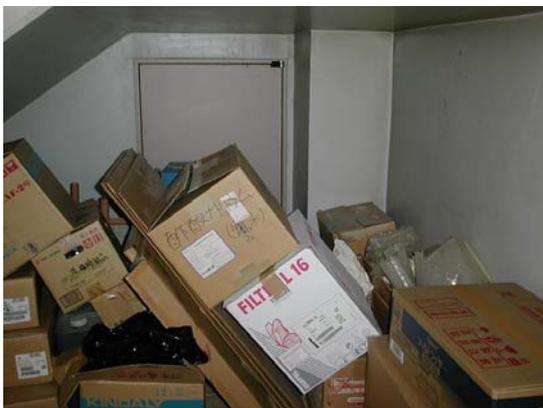
Photo 3.21- Inaccessible door, Kushiro Urinary Clinics

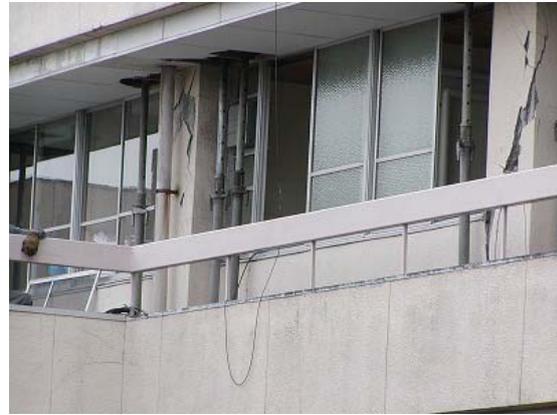
Photo 3.24- Damage to Fukaya Hospital

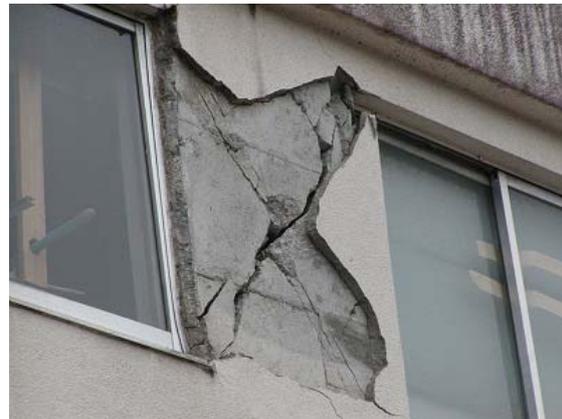
Photo 3.26- Damage to Kashimadai hospital

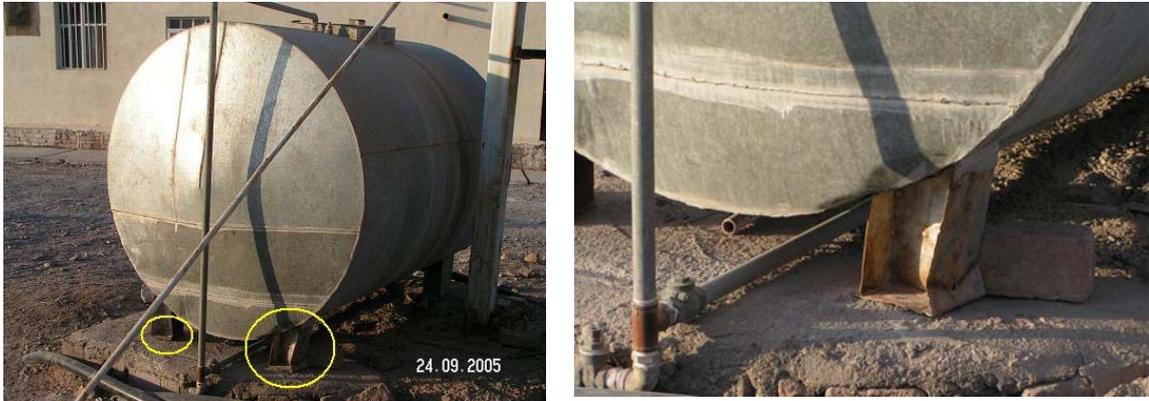
Photo 3.45 and Photo 3.46 show. The buckling was found on all 4 feet with various degrees of severity. However, two of them had serious impact and they affected the tank itself as it is shown in Photo 3.46. The feet should be replaced and the damaged area of the tank should be repaired to avoid any failure in case of another earthquake.

Photos 3.45, 3.46- Buckling of feet of the water tank, Aflatoonian Hospital

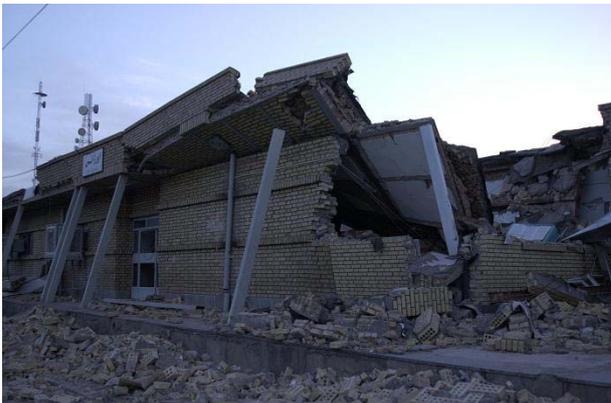
Photo 3.47- Total collapse of Imam Khomeini Hospital February 2004

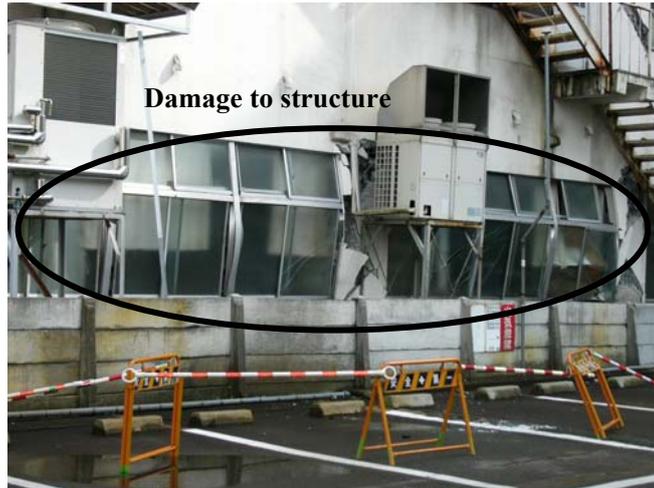
The facility is composed of one building, built in 1978. The shaking caused some cracks in its structure. The facility lost its electric power and water supply for five days; while the gas supply was lost for 18 days from the occurrence of earthquake. The telecommunication system was also inoperable. The loss of electric power caused malfunction to several pieces of medical equipment such as CT scanner, MRI etc.

Photo 3.51- Structural damage to 1968 building, Ojiya Hospital

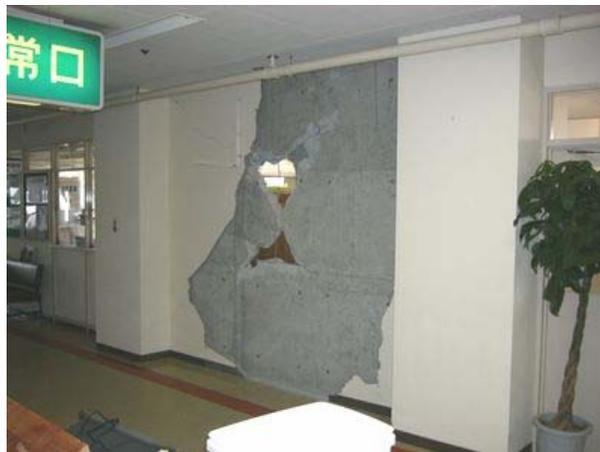
Photo 3.52- Structural damage to 1968 building, Ojiya Hospital

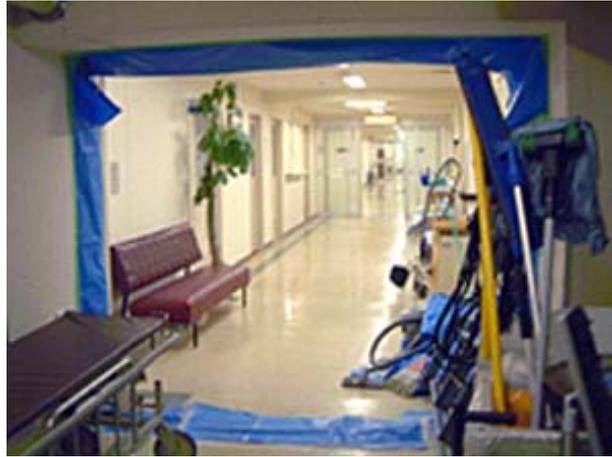
Photo 3.53- Damage to separation joint

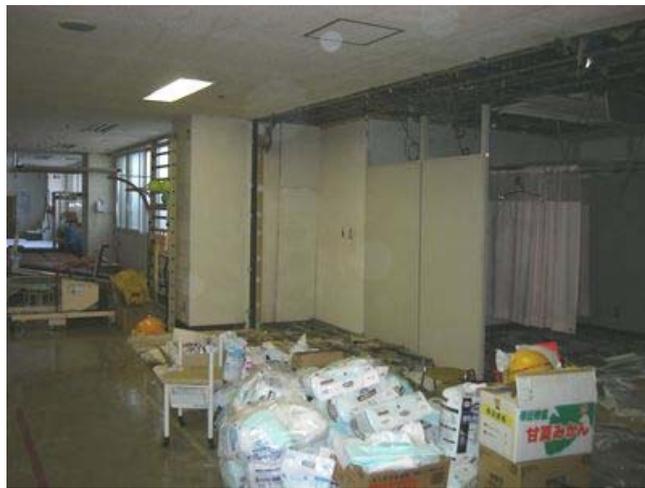
Photo 3.54- Damage to ceilings, Ojiya Hospital

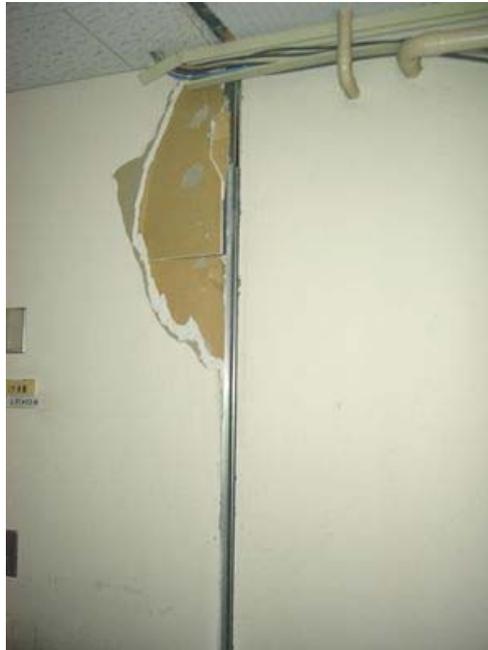
Photo 3.55- Damage to building's joint

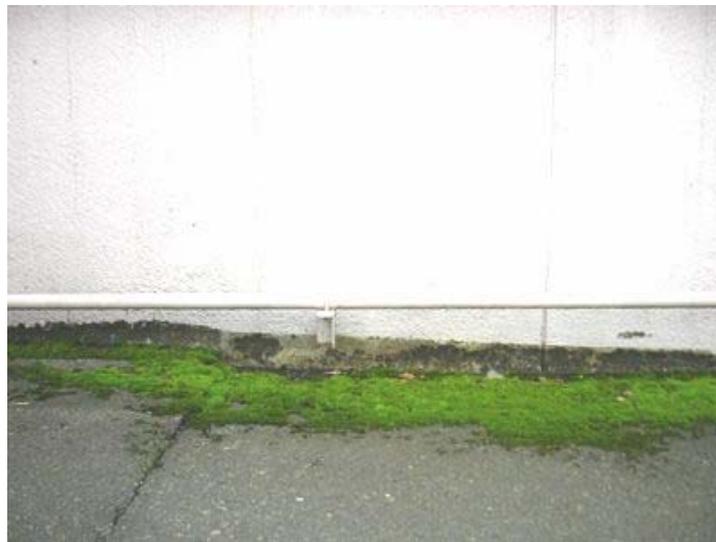
Photo 3.56- Damage caused by liquefied soil

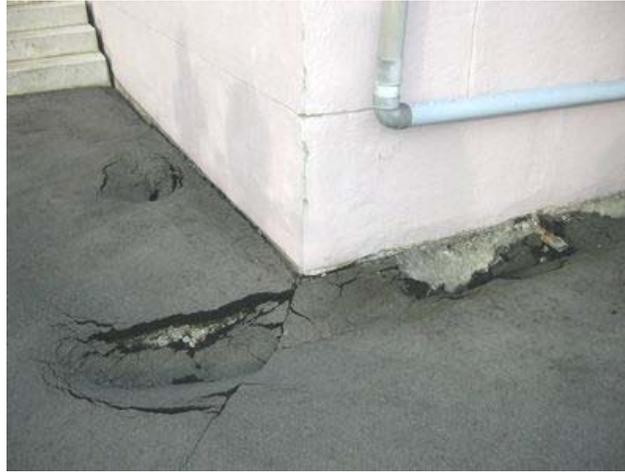
Photo 3.57- Liquefied soil

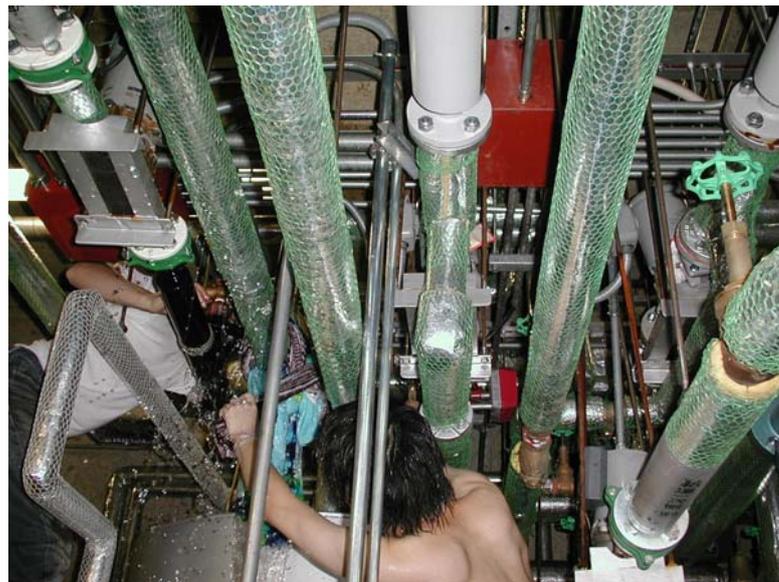
Photo 5.1- Pipe damage, Kushiro Urinary Clinic
