Effects of topographic and geological features on building damage caused by 2015.4.25 Mw7.8 Gorkha earthquake in Nepal: a preliminary investigation report

Abstract

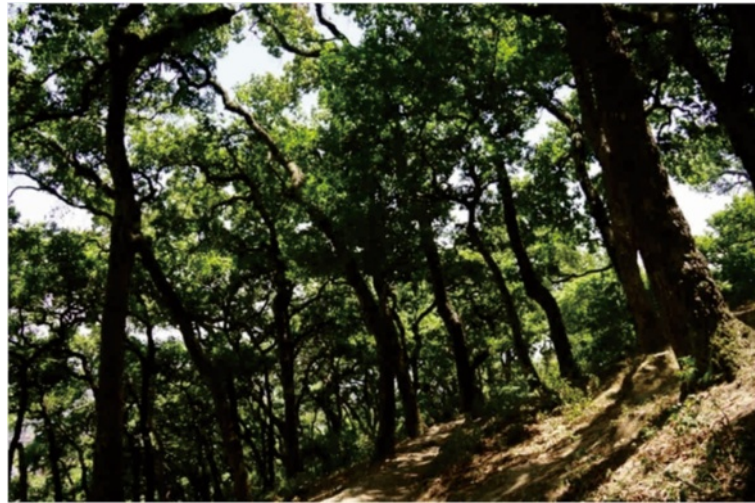
Fig. 3 “Drunken” trees on the north slope of the Swyambhunath World Heritage site, indicating slow slope movement

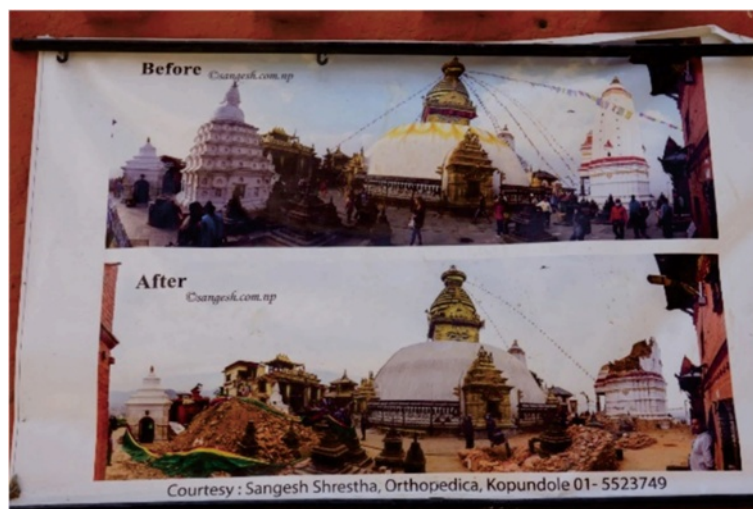
The Swyambhunath World Heritage site is located on the top of the hill. Figure 4 compares the world heritage site before and after the earthquake. It shows that the main temple in the middle was in a relatively

good condition, while the temples surrounding it and located near the hill slope suffered collapse.

During the investigation, it is found that the damages are more severe where the buildings and temples are closer to the slope. It may mean that the shaking is much stronger at the slope shoulder than at the mountain top. After the investigation in the same site, Hashash et al. (2015) pointed out that the topography effects refer to the modification (frequently amplification) of incident ground motion due to energy focusing effects at convex topographic features (hills, ridges, canyons, cliffs, and slopes), complicated subsurface topography (sedimentary basins, alluvial

Fig. 4 Photos showing the Swyambhunath World Heritage site before and after the earthquake (Courtesy: Sangesh Shrestha, Orthopedica, Kopundole)

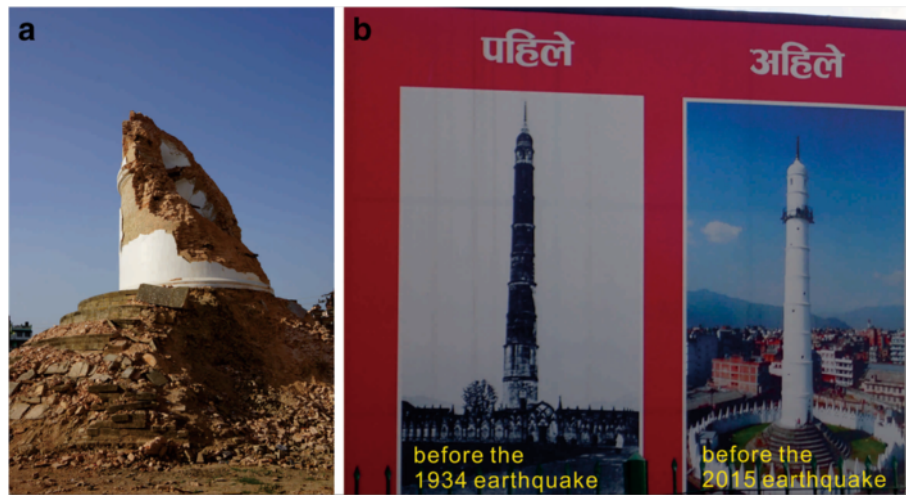
Fig. 5 The collapse of Dharahara tower. **a** damaged Dharahara tower; and **(b)** a poster showing two photos of the tower before the 1934 and 2015 earthquakes

During the earthquake, the Dharahara tower collapsed and more than 180 people lost their lives. The main body of the tower collapsed under the attack of this earthquake, only the base remained (Fig. 5a). According to Wikipedia (2015), the Dharahara tower, was a nine-story, 61.88 m tall. The former Dharahara tower was built in 1832. The tower had a spiral staircase with 213 steps. It can be seen from Fig. 5(a) that the main trunk of the tower is made by bricks with lime mortar cemented, which is weak for seismic action.

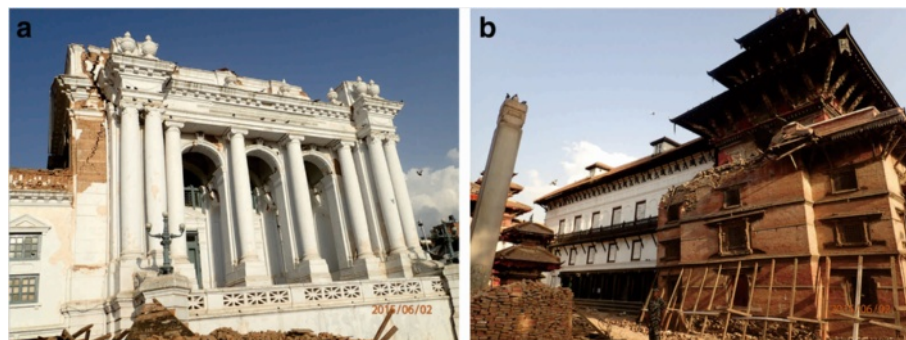
In Durbar Square, it is full of temples and cultural architectures. During the earthquake, lots of ancient temples were damaged severely (Fig. 6). Some of them were completely destroyed (Fig. 7). In Fig. 7, the

Fig. 6 Damages on temples and buildings near the Durbar Square. **a** Gaddi Baithak in Basantapur Durbar Square; **b** one building in Hanuman Dhoka

From a viewpoint of long-term safety of the buildings, reconstruction of these building is recommended. However, the number of damaged buildings is so large that the budget required to rebuild them may have to be evaluated by the government.

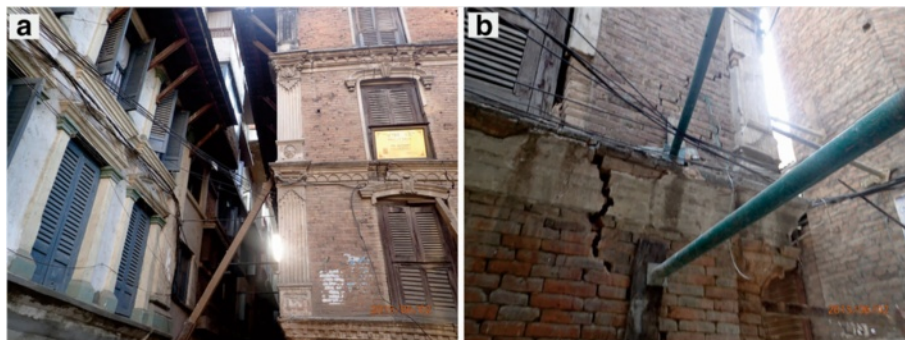
According to the fact sheet of the earthquake by USAID (2015), 510,762 houses were destroyed, and 291,707 houses were damaged by the Earthquake. Durbar Square area is one of the most severe areas suffered the damages (Fig. 8). Cracks appeared on the walls of those buildings, and the residents still lived in the damaged buildings and used wooden and metal sticks to support them.

Fig. 8 Heavy damage occurred to the residential buildings in the Durbar Square area. **a** collapsed buildings supported by wooden sticks; **b** Cracks in the building and metal supporting sticks

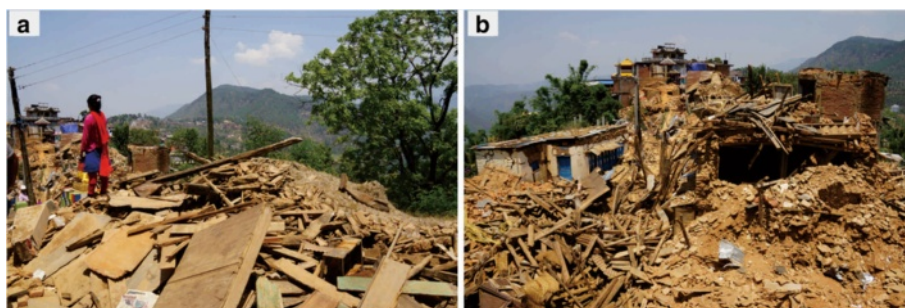
The Chautara town consists of two parts: old town and new town. In the old town area, the buildings had a simple structure with bricks and wooden slabs. In the new town area, concrete buildings were built three stories or higher. Figure 12 shows the damage in the old town area. More than 80 % buildings were destroyed by the earthquake.

Fig. 12 Almost completely destroyed old town in Chautara. **a** Completely flattened buildings; **b** Destroyed buildings with standing walls

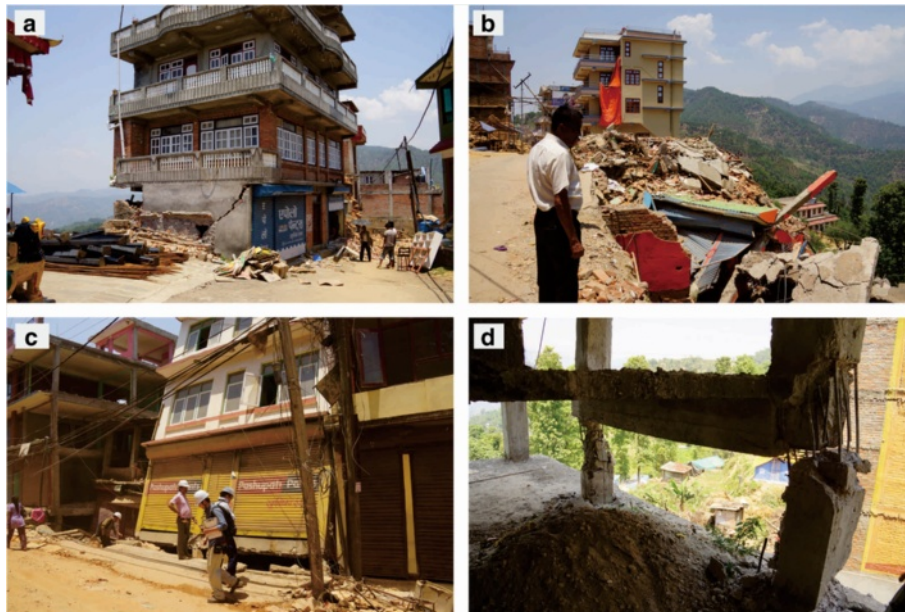
Figure 13 shows the damage in the new town area. The buildings were made by reinforced concrete, with

three or more stories. Some of the concrete building had cracks at the first floor (Fig. 13a). Some of them completely collapsed (Fig. 13b), and some of them tilted to the slope side (Fig. 13c). Breakage had occurred even at the pillars of some buildings under construction (Fig. 13d). In the case shown in Fig. 13d, the so-called short column effect may have occurred. According to Murty (2016), poor behavior of short columns is due to the fact that in an earthquake, a tall column and a short column of same cross-section move horizontally by same amount. Because the short column is stiffer as compared to the tall column, it attracts larger earthquake force. Stiffness of a column means resistance to deformation. The larger the stiffness is, the larger the force required to deform it. If a short column is not adequately designed for such a

Fig. 13 Partially destroyed or damaged new town area in Chautara. **a** Cracks in the concrete building; **b** completely destroyed building; **c** building tilted to the downslope side; **d** breakage in pillars of new uncompleted building

large force, it can suffer significant damage during an earthquake.

The damage to the Chautara town was very severe though it is far from the epicenter and earthquake fault. The reason may be the amplification of the narrow mountain ridge, combined with the special

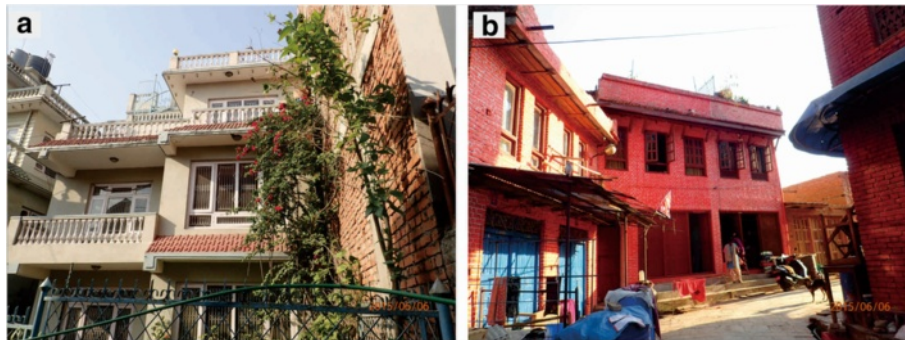
Fig. 15 Solid buildings in Changu Village. No obvious damage can be observed to these buildings **a** & **b**

Figures 15, 16 and 17 show the different buildings and their degree of damage in Changu village. The newly-constructed RC structure building has not suffered obvious damage during the earthquake (Fig. 15), while the old-style brick structure building collapsed or separated by cracks (Figs. 16 and 17). From the collapse sections or faces, it can be found that the mortar was sparse and inadequate.

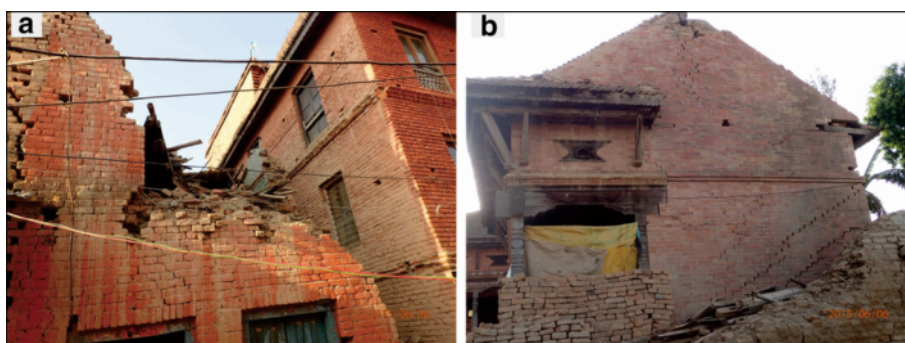
Fig. 16 Damaged buildings with brick structure in Changu village. **a** Heavily damaged brick building; **b** cracks in the brick building

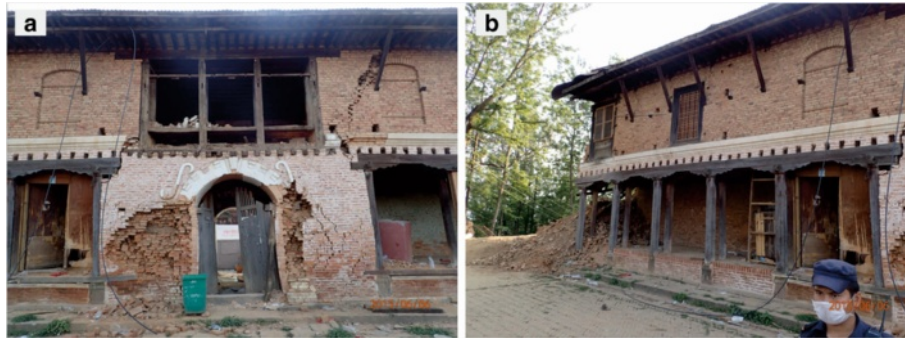
Fig. 17 Damages occurred on the main gate building at the entrance to Changu Narayan. **a** Collapse around the main gate; **b** Collapse at the two sides of the gate building

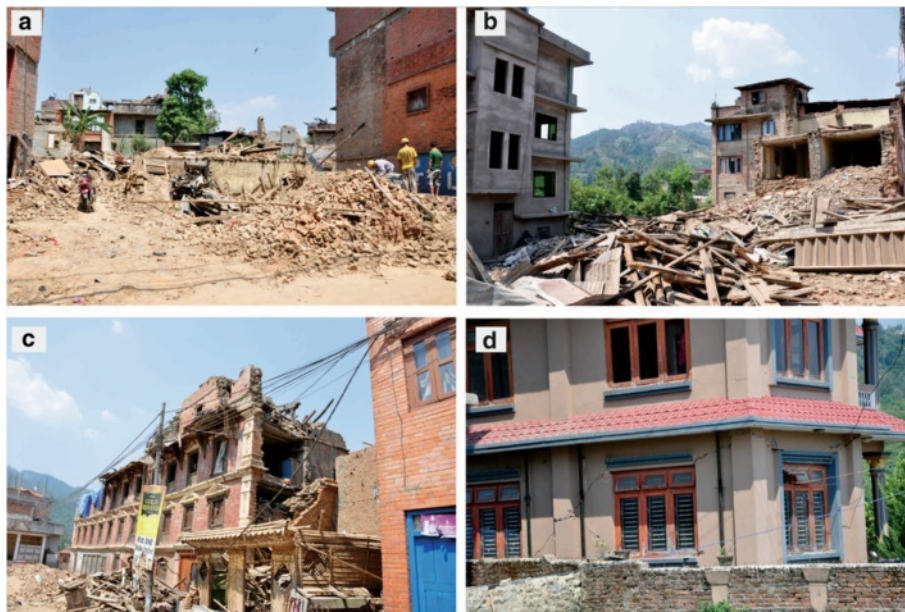
Sankhu area suffered from an extreme damage to the residential buildings. Figure 18 shows some typical collapses occurred in different buildings in this area. The old buildings with brick structure completely collapsed or were severely damaged. While on the new

buildings with concrete slabs in the brick structure or reinforcement by concrete on the walls, inclining occurred or X-shaped cracks were observed, indicating a strong vertical compression stress.

Fig. 18 Building damage situation in Sankhu area. **a** and **b** Completely destroyed wooden and brick buildings; **c** Partial collapses of a three-story building; **d** X-shapes cracks in a new concrete building

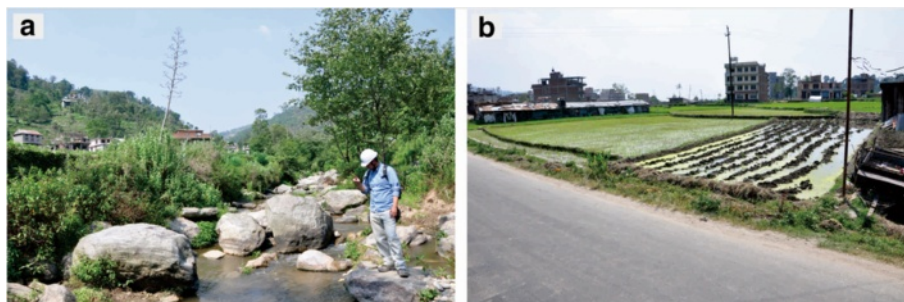
To find the reason why the building were more heavily damaged than the surrounding villages, we observed areas around the residential section and then traveled in a northerly direction. Figure 19 shows the trace of the investigation route. It is found that this area is an alluvial fan. At Position A, we found large boulders in the shallow valley, and flowing water (Fig. 20a). On the terrace, two-floors or higher building were in good condition. At position B, there were rice paddies, surrounded by concrete buildings of two to four stories. The damage at point B was not so severe. It was observed that the most severe damage occurred at the middle-lower part of the alluvial fan. It is estimated that at that part, ground deformation has been amplified by the specified soil layer structure, and caused the concentrated collapses in the old buildings.

Fig. 20 Evidences of the alluvial fan near Sankhu. **a** Large boulders and flowing water in the valley; **b** Rice paddies at the upslope side of high buildings

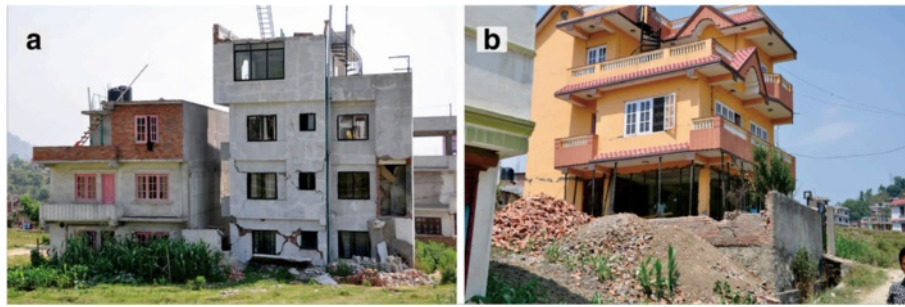
Figure 23 shows some typical damages to residential buildings in this area. A common tendency can be found in the nature of these damages, i.e., collapse or cracks mainly occurred at the downslope side of the buildings. Even there were no permanent deformation left on the ground after the earthquake, the severe damaged building were located in a limited area. We estimated that under the limited area, a landslide may exist. When the buildings were built on a probable landslide, the ground shaking might be much stronger

than the surrounding area, and caused more severe damage on the buildings.

Fig. 23 Damages occurred on the residential buildings in Purano Naikap area. **a** X-shaped cracks in the first and second floors, some part collapsed; **b** Collapse occurred to one side of the first floor

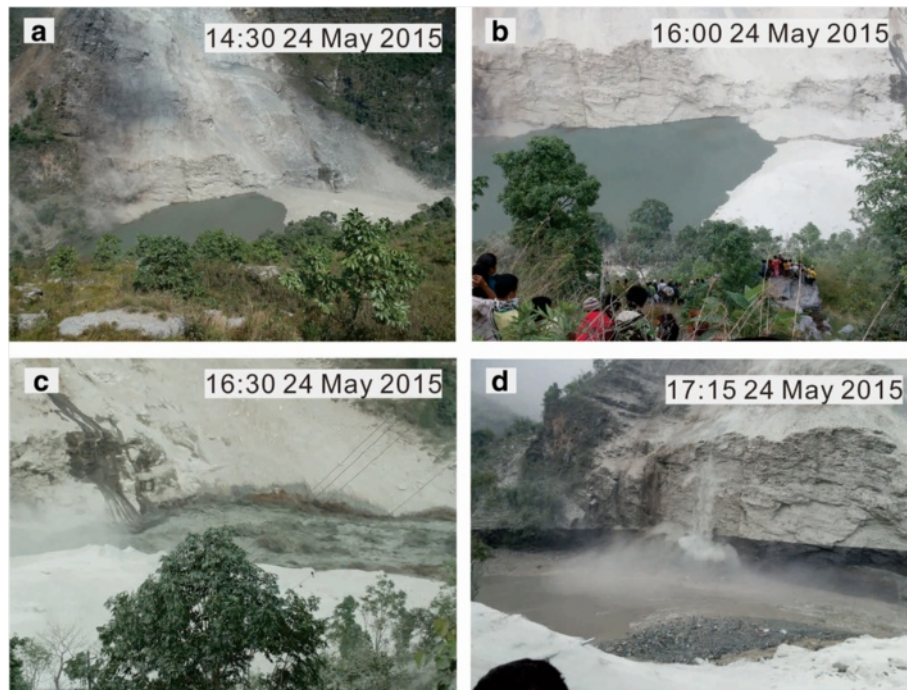
- 11:10 of 22 May 2015: small scale rock fall occurred;
- 1:30 am of 24 May 2015: major rockfall occurred and the landslide dam was formed;
- Around 16:00 of 24 May 2015: overflow started (Fig. 25b);
- Around 16:30 of 24 May 2015: landslide dam collapsed and the valley completely opened (Fig. 25c).

So roughly, it can be estimated that it took about 38 hours from the time of the small-scale rockfall to change into a major failure. It took 14.5 hours for the landslide dam lake to become fully filled, and 30 minutes for the landslide dam to complete collapse by overflow.

Fig. 25 Time series photos showing the process of landslide dam from its formation to complete failure (Photos supplied by Nepal Army). **a** the landslide dam before overflowing; **b** overflow occurred on the landslide dam around 16:00 of 24 May 2015; **c** collapse of the landslide dam around 16:30 of 24 May 2015; **d** the opened channel of the valley

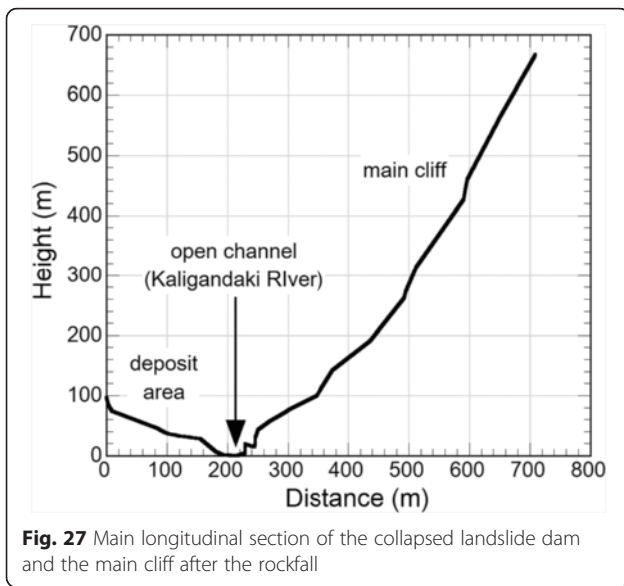
finder. Figure 27 shows the results of the measurements. It can be seen from the figure that the height of the main cliff was higher than 660 m, and the average slope angle was about 54 degree. The travel distance of the collapsed debris in the deposit area was about 200 m, with an average slope angle of 21 degree. The maximum thickness of the landslide dam was estimated as 30 m.

Fig. 27 Main longitudinal section of the collapsed landslide dam and the main cliff after the rockfall

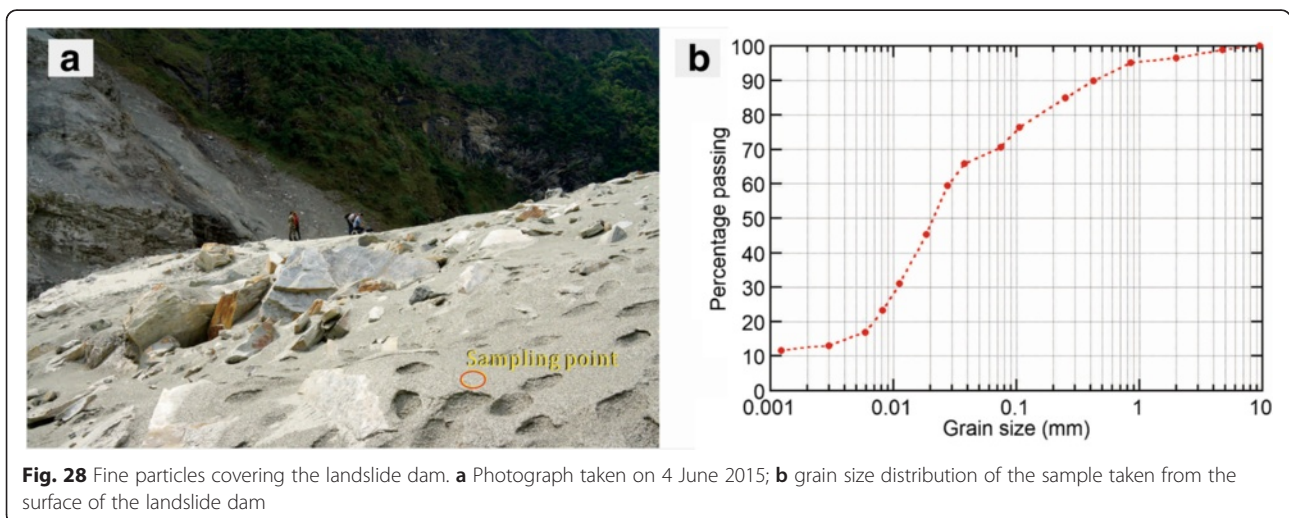
When we conducted the investigation at the Kaligandaki landslide dam, it was found that the landslide dam surface was covered by fine particles. The thickness of the fine particle layer was about 0.4 m. It was so loose that footprints can be easily seen (Fig. 28a). Some soil samples were taken from the surface, and the grain size distribution analysis was conducted (Fig. 28b). It shows the soil sample is well graded silt, and the mean grain size is 0.02 mm.

For the purpose of time prediction for landslide dam failure, we learned from that the collapse of the landslide dam by overflow only took 30 minutes. One of the possible reasons might be the crushing of the thin rock mass when the rockfall fell to the ground. The bedrock of the cliff is thin bedding phyllite which

is relative soft and composed of fine scale-like minerals. Because of the strong collision from about a 700 m high position, the structure of the rock mass was pulverized. We concluded that the landslide dam consisting of loose deposits of the rockfall might be vulnerable for overflow, and the longevity of the dam will be short.

Fig. 28 Fine particles covering the landslide dam. **a** Photograph taken on 4 June 2015; **b** grain size distribution of the sample taken from the surface of the landslide dam
