Structural damage to houses and buildings induced by liquefaction in the 2016 Kumamoto Earthquake, Japan

Results: Field reconnaissance was conducted in the target area on May 27th–30th, 2016. The post-earthquake inclination angle and the tilt direction of 68 affected houses and buildings in the liquefied sites in Kumamoto City were measured by using a laser rangefinder (Leica DISTO D 510). Ground structure and condition were also determined from topographic maps, bore data and the calculated liquefaction resistance factor, F_L .

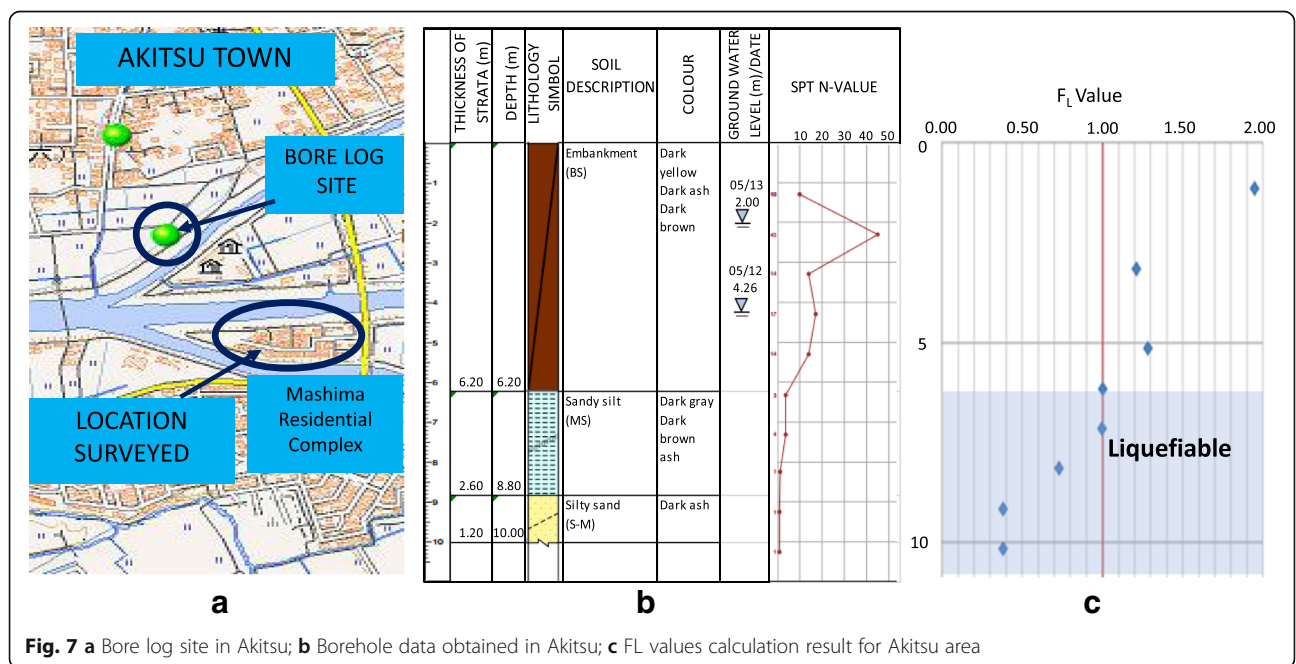
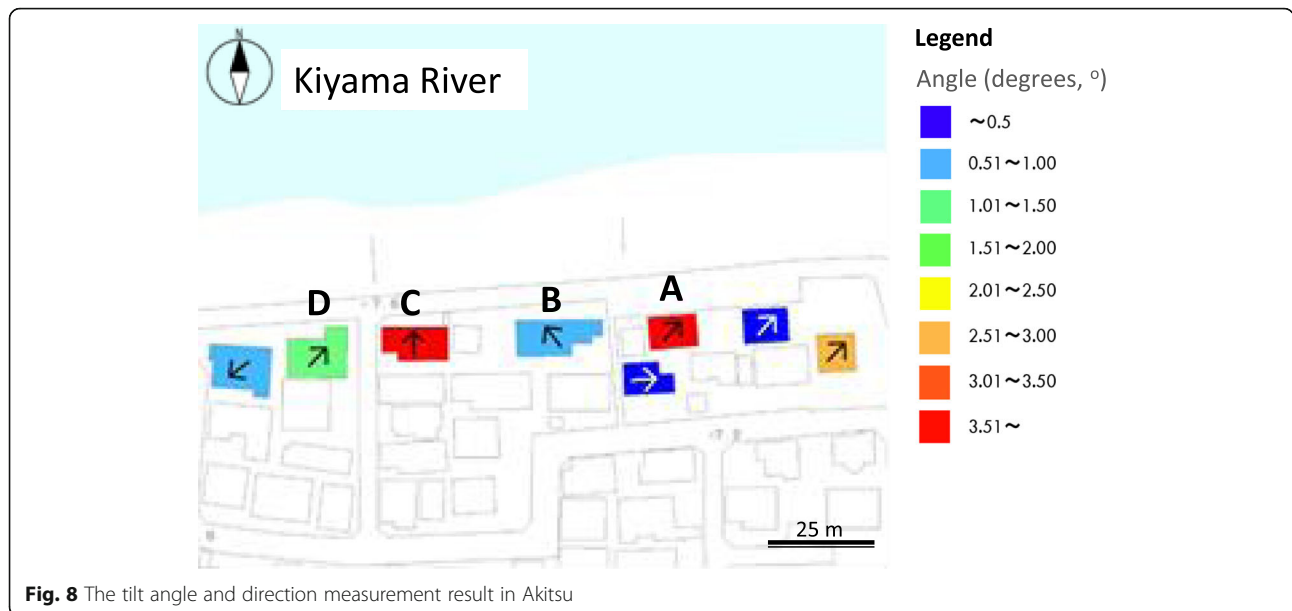
Eight houses were measured in this area. Figure 8 shows the measurement results of their tilt angle and tilt direction. In this figure, the tilt angle is indicated by a color difference for every 0.5° and the direction of inclination is marked by an arrow. The tilt angle used is the largest angle of all points measured in each house. Interestingly, a few houses assessed in this area were inclined in the same direction, which was the location of the river. This implies that the damage was caused not only

by the subsided soils under the structure but also by the liquefaction occurrence at the riverside area located in front of the houses.

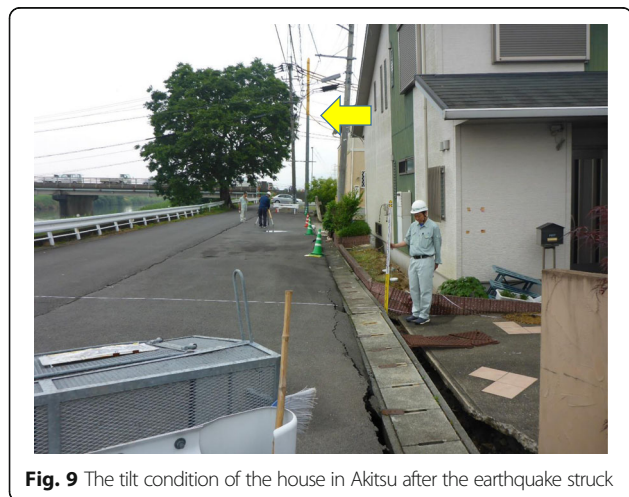
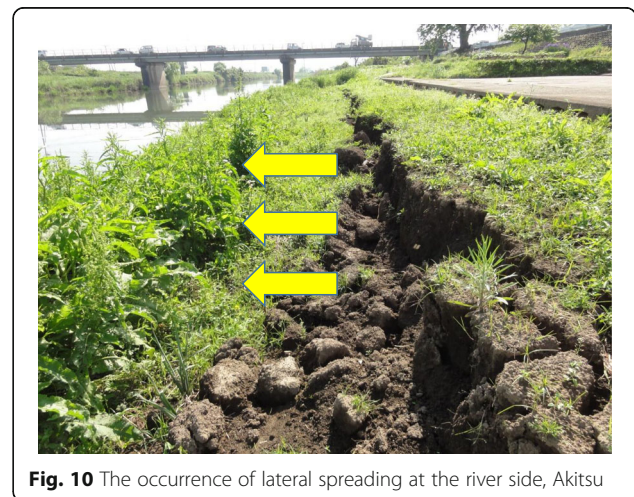
Fig. 11 The summary of the structure type and damage level (Buildings A, B, C and D in Fig. 8) in Akitsu

Figure 9 shows the state of the house after the earthquake struck and shows that the house became tilted toward the river. Furthermore, as can be seen in Fig. 10, the lateral movement also occurred toward the river side at this site. As a result, adjacent houses tend to be tilted in the same direction with a lateral spreading direction. Figure 11 presents the summary of the structure types and the damage in this area. As for building A, it was inclined 3.6° to the north and 3.7° to the east as there was substantial ground subsidence on the north side and different settlement of the foundation occurred. Ground subsidence at the north side also occurred in buildings C and D and similarly to building A, these buildings tilted to the north. Although

ground subsidence occurred, building B only experienced minor inclination and minor vertical gap development due to the insignificant differential settlement of its foundation. This is because this building was supported by a foundation of piles. Figure 12 shows the pile foundations that support building B. Based on this result, it is thought that the foundation type also influenced the degree of inclination of building structures.

Structure Type	Wooden frame, 2 storey	Steel frame, 2 storey	Wooden frame, 2 storey	Wooden frame, 2 storey
Inclination damage	3.6° to the North, 3.7° to the East	Minor inclination (less than 1°)	3.6° to the North	1.5° to the North

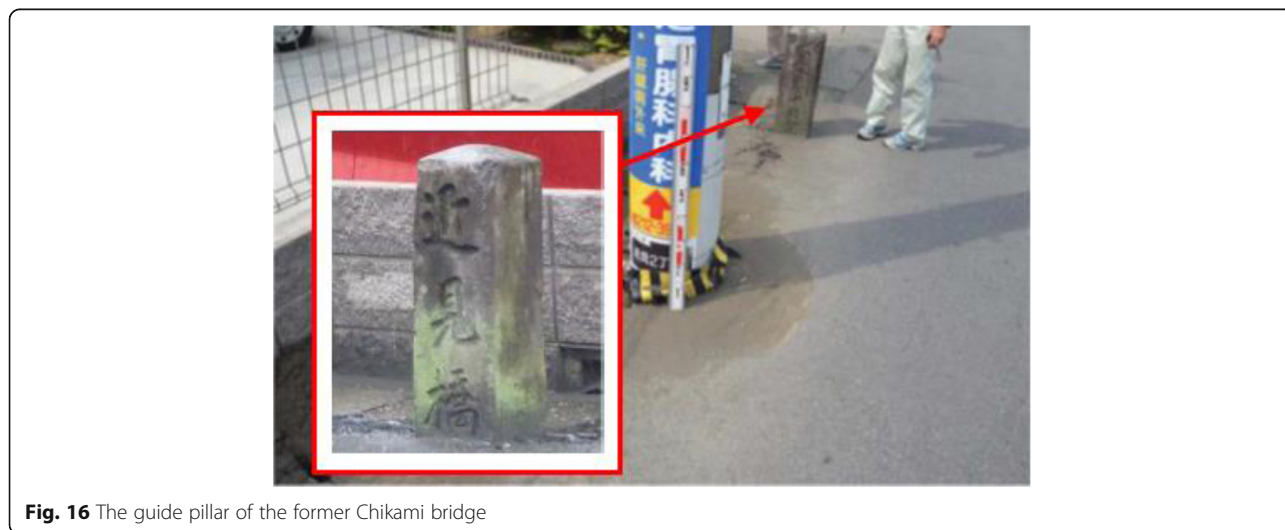
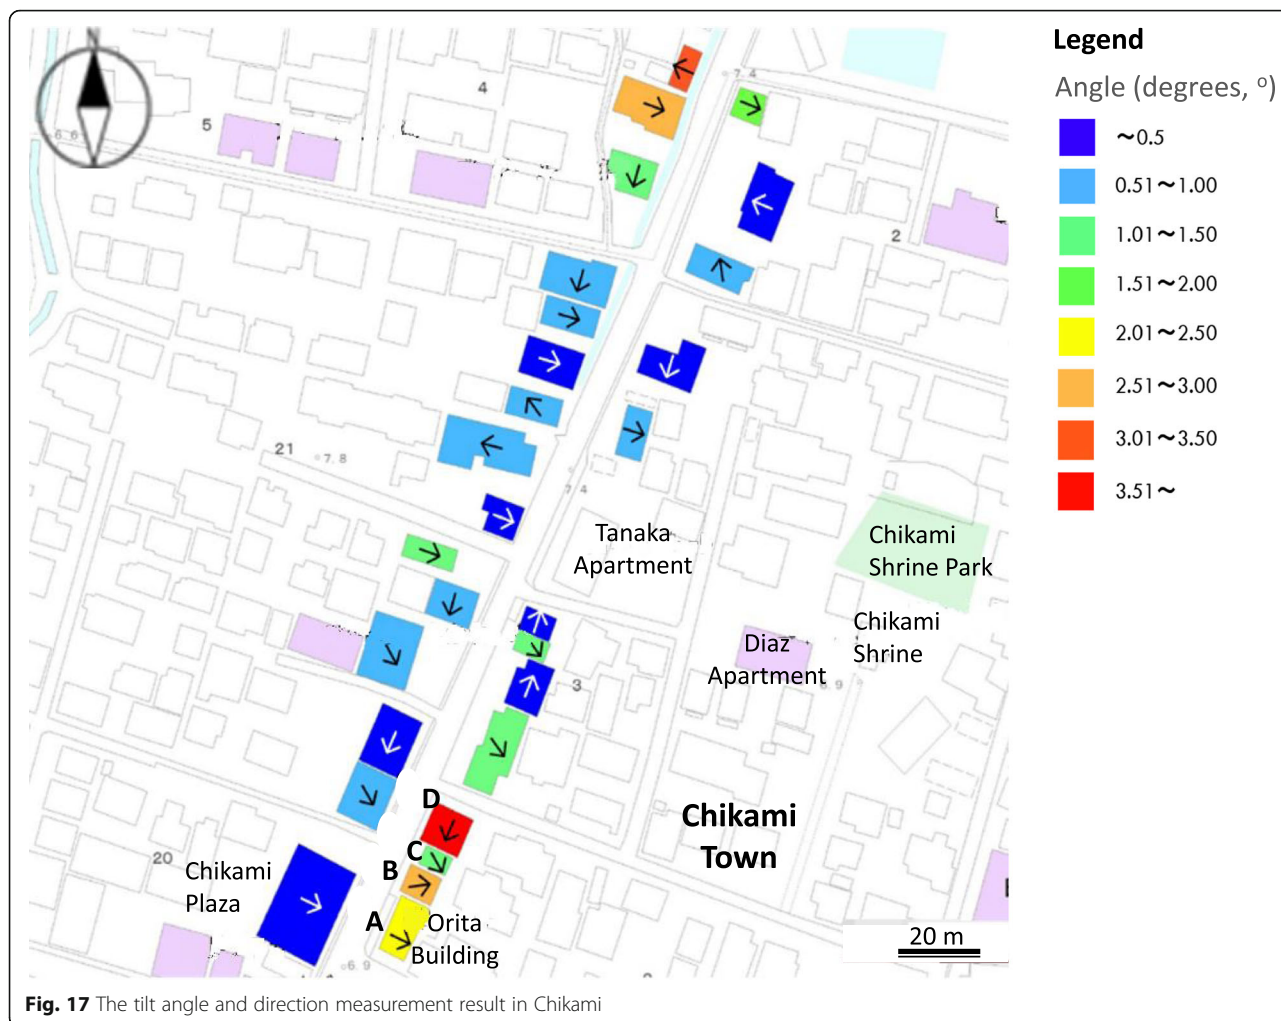
Fig. 18 The summary of the structure type and damage level (Buildings A, B, C and D in Fig. 17) in Chikami

Figure 17 shows the measurement results of the inclination angle and tilt direction of the buildings in Chikami area. There is a tendency for houses experiencing large tilt angles were located on the adjacent site. It can also be seen from this figure that the direction of inclination is to the southeast where the river used to be. Structure types and building damage are summarized in Fig. 18. Differential settlement occurred in both steel framed and wooden framed buildings. The four buildings, A, B, C, and D are taller than other building in their vicinity, as a result, the tilt angle and the damage inflicted were substantial. Buildings B and C were tilted so as to appear to be attracted to each other like magnets. This was probably caused by the combined weight of the two adjacent buildings resulting in a greater settlement on the neighboring side. It also seems that the non-uniform settlements were influenced by the weight of the structure and the position of its center of mass. For building D, the north side wall was severely damaged resulting in a large inclination.

Building	a	b	c	d
Photo				
Structure Type	Steel frame, 3 storey	Wooden frame, 2 storey	Wooden frame, 3 storey	Wooden frame, 2 storey
Inclination damage	1.5° to the East	2.7° to the East, front wall is damaged	1.3° to the East, first floor is damaged	5.7° to the East, North side wall is damaged

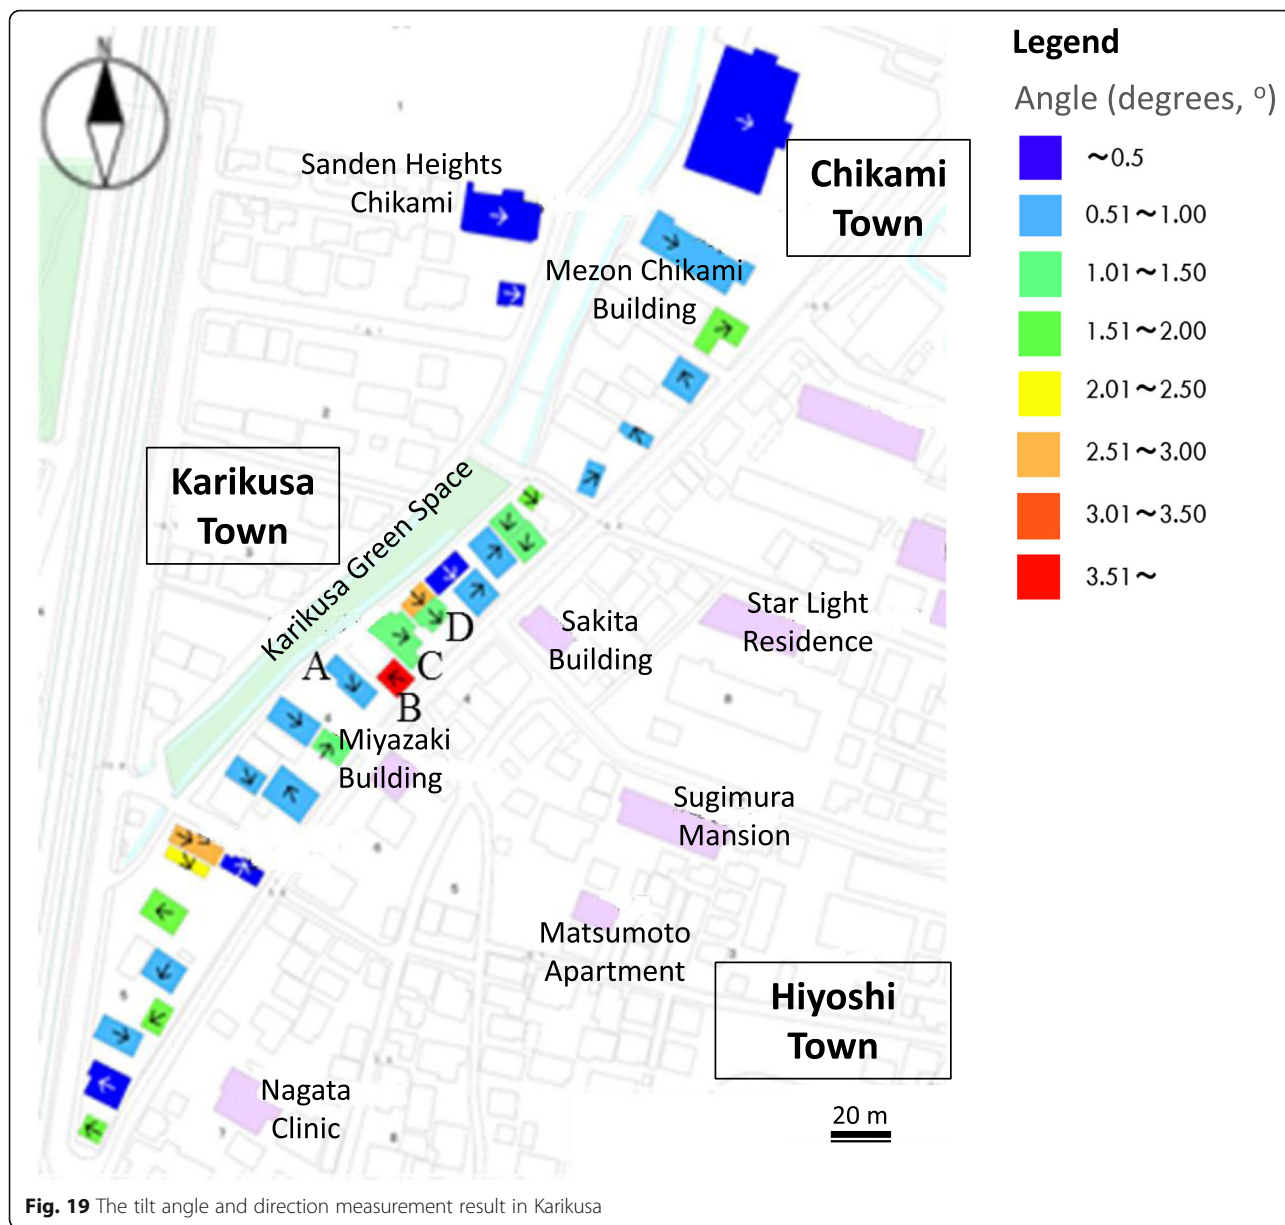
Fig. 20 The summary of the structure type and damage level (Buildings A, B, C and D in Fig. 19) in Karikusa

Figure 19 gives the tilt angles and tilt directions of the houses in the Karikusa area. Similarly, in this area, many buildings experienced an inclination toward the east. Figure 20 shows the summary of the structural forms and building damage in this area. The building with the largest inclination angle is building B, which was a one storey building. There was no significant wall or structural damage to this building, but a lot of boiled sand traces remained around the building, indicating a large amount of sand boiling had occurred. Buildings A, C, and D were inclined to the east.

Structure Type	Steel frame, 2 storey	Wooden frame, 1 storey	Steel frame, 2 storey	Wooden frame, 2 storey
Inclination damage	Minor inclination (less than 1°)	3.6° to the West	1.3° to the East	1.3° to the East
