RECONNAISSANCE REPORT ON THE 2000 KOHZUSHIMA KINKAI EARTHQUAKE

An $M_J6.4$ earthquake occurred on July 1, 2000 offshore of Kohzushima Island in the Tokyo municipal jurisdiction. Large tremors also were felt on Kohzushima on July 9 and on Niijima on July 15. This is the damage investigation report on the 2000 Kohzushima Kinkai earthquake made by a JSCE reconnaissance team. Earthquake swarms continued near Kohzushima, Niijima, and Shikinejima islands for about three months. A JMA seismic intensity of lower 6 was recorded twice on Kohzushima during July, 2000. An outline of the earthquake and its aftershocks and the damage done to civil structures is given. Slope failures, damage to retaining walls and disaster responses, in particular, are focused on.

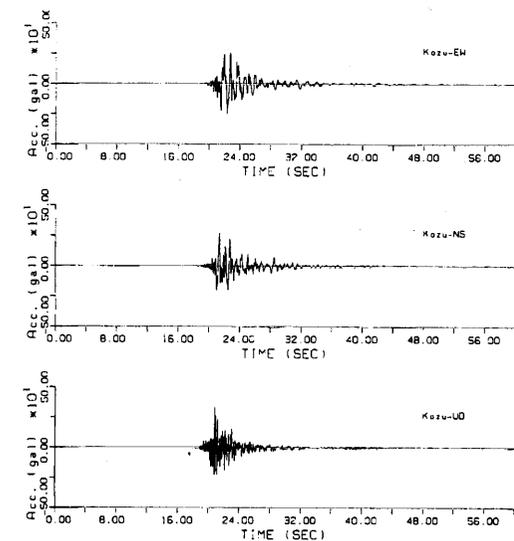
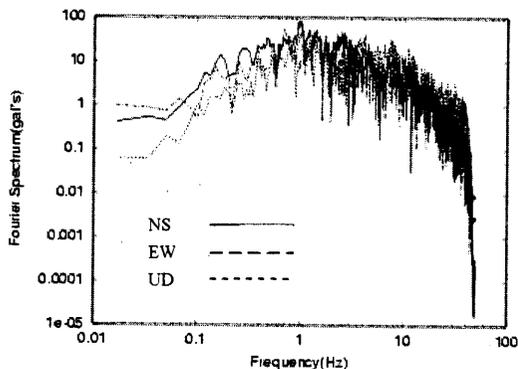
Earthquake records obtained by the TMG at the village office are shown in Fig.3 with their Fourier spectra. Only base-line corrections were made to these records. Peak accelerations for the EW, NS, and UD components respectively are 256, 273, and 334gal.

The instrumental seismic intensity calculated from these three components is 5.2. Predominant frequencies based on the Fourier spectra are 1-2 (Hz) for the horizontal components and 6-7 (Hz) for the vertical component. For reference, the peak accelerations for the July 15 earthquake, recorded on Niijima, were 422gal (NS), 500gal (EW), and 509gal (UD).

Fig.3 Observed records and their Fourier spectra at the Kohzushima village office July 9, 2000.

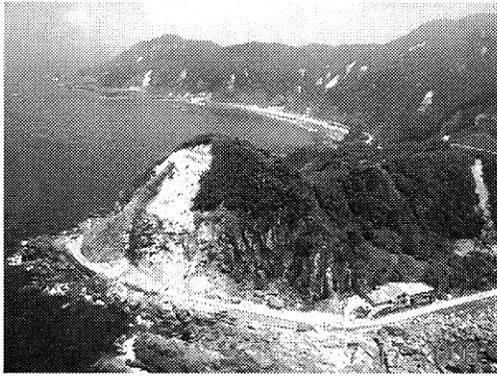
Soils at sites where most of the slope failures occurred, along Maehama Beach, Sawajiri Bay, and Nagahama Beach (**Photo 1(a)**), mainly are composed of pyroclastic flow sediments and rhyolitic rocks with many cracks. Traces of many previous slope failures can be seen along the pyroclastic cone of Mt. Tenjo, and a huge slope failure was caused by the July 2000 earthquake (**Photo 1(b)**).

(a) Slope failure along the road from Sawajiri Bay to Nagahama Beach

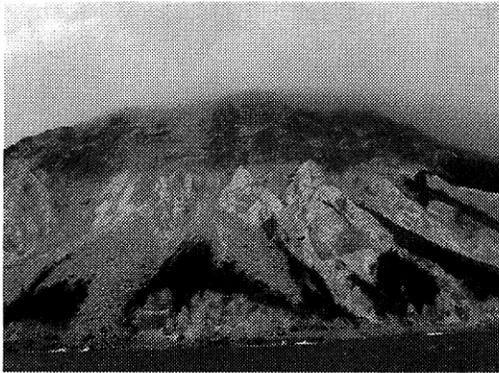
(b) Slope failure of the pyroclastic cone of Mt. Tenjo facing Takou Bay

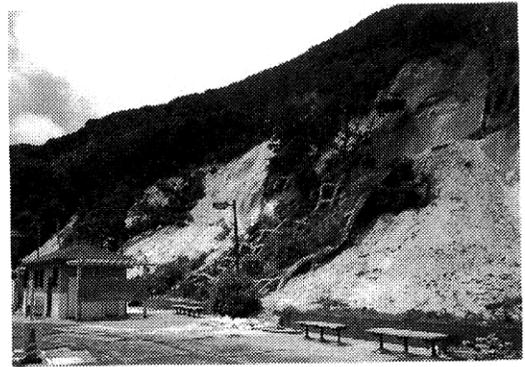
Photo 2 Failure of molded blocks used for slope protection (Miura Harbor)

- (3) Concrete lattice frame: Concrete lattice frames were constructed by spray blasting with concrete or borrow material. This protection method worked better than methods (1) and (2). Overhanging areas along the coast, however, sustained severe damage due to the surface slope failures (**Photo 2**).
- (4) Concrete lattice frame with ground anchor: This method is used on slopes close to such important structures as a school or hospital and on river banks as well. No failures occurred, and slope safety was preserved.
- (5) Rock fall protection net: Protection nets were installed along the island's circuit road. Some were broken by huge rock falls. Their posts and anchors could not resist such strong forces.

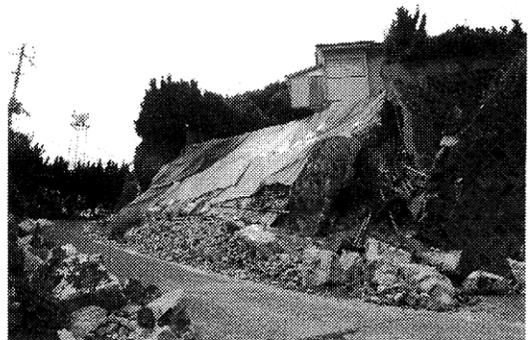
Photo 3 Collapse of a stone masonry retaining wall

- (1) Stone masonry retaining walls: Stone blocks for these masonry walls are quarried on the island. As these stone masonry retaining walls are very old, previously degraded ones were re-damaged by the earthquake's force. Longitudinal, transversal, and diagonal cracks, as well as bulging and collapse were all generated. A corner of the retaining wall in **Photo 3** shows severe damage.
- (2) Gravity retaining walls: This type of retaining wall in combination with a rock fall protection fence was installed at places where countermeasures against steep slope failure had been undertaken. No damage occurred to this type of the retaining wall.
- (3) Terre Armee retaining walls: Terre Armee is an earth reinforcement method. This type of retaining wall was present at several sites in the southern part of the village. There was almost no damage

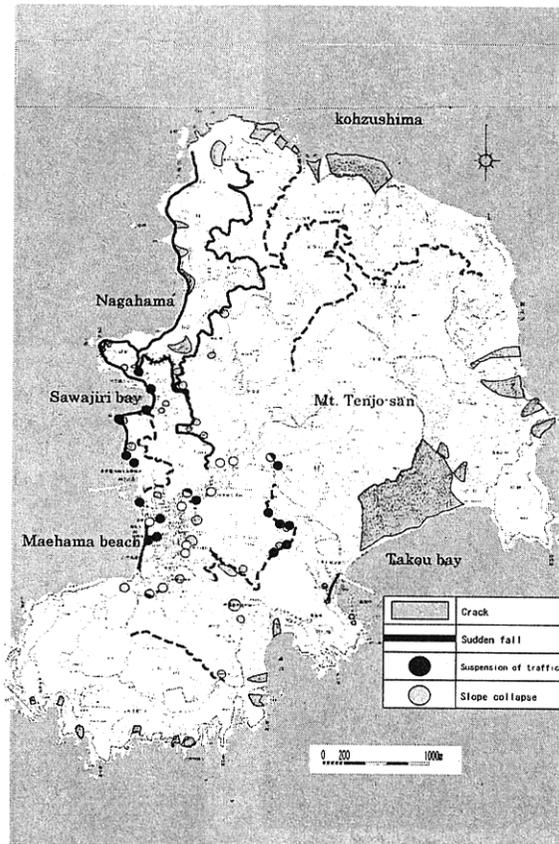
There are five road bridges on the island. None sustained severe damage, but a small offset of several centimeters was generated between bridge beams and abutments. Most of the damage done to roads was caused by slope failures and the collapse of retaining walls (**Fig. 4**). Large cracks were present at many places on the road along the dale of the Kohzu Marsh and on the circuit road.

Fig.4 Sites where slope failures occurred
