Dynamic Characteristics and Damage to Structures of the Earthquake at the Western Part of Nagano Prefecture in 1984

Masaru KITaura*, Masakatsu MIYAJIMA* and Toshikazu IKEMOTO*

Abstract

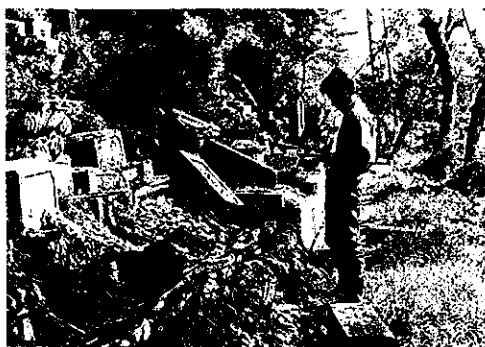
A view of the overturned tombstones near Otaki office is shown in Photo. 1. The results of overturned tombstones are listed in Table 3. Estimated horizontal acceleration using the overturned tombstones (α (gals)) can be derived from

Photo. 1 A view of overturned tombstones near Otaki village office

In Table 3, the ratios of overturned tombstones at the regions from Noguchi to Hougoshi in Otaki village are very high: 80~100%. The estimated horizontal acceleration is about 400gals. The estimated acceleration is high and it corresponds to the six on JMA intensity scale. Similarly we estimated that earthquake intensities in most areas were the six on JMA intensity scale, and that in some areas they were the seven on the same scale. These estimated values do fit those estimated by Japan Meteorological agency. However, it is considered that the vertical component of the ground motion dominates the horizontal component, because there are many overturned tombstones due to the saltation and rotation. Therefore exact estimation of the horizontal acceleration of earthquake that occurred in the shallow ground and on the land such as this shock is not made perfectly only by investigation of overturned tombstone.

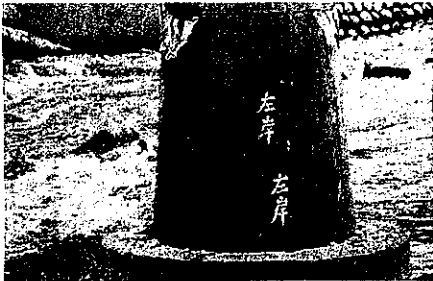
The damage to the bridges due to the ground motion itself, however, was slight as same as the buildings. In Matsubara bridge, the soil behind the bridge abutment settled about 15cm, some parts of the reinforced concrete piers were ripped in the direction perpendicular to the axis of the bridge by the ground motion (See Photo. 2) and the break of the anchor-bolt at the fixed bearing was caused (See Photo. 3). It is conceivable that the ground motion in this direction could be predominant. Other bridges suffered slight damage.

Photo. 2 Damage to reinforced concrete pier of Matsubara bridge

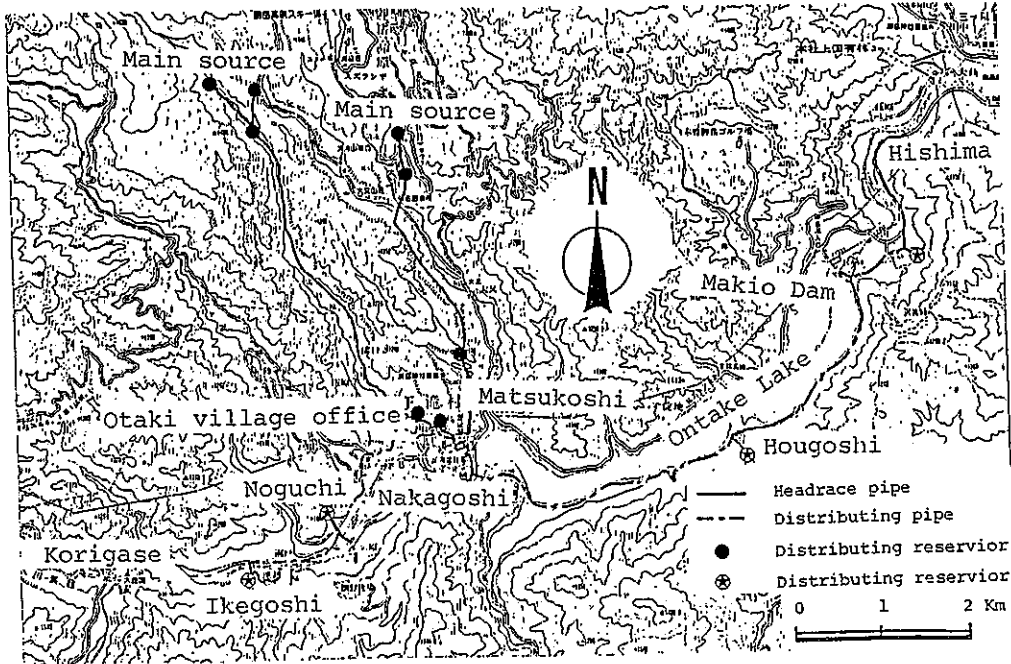
Fig. 9 Network of the water supply system in Otaki village

The overall damage has been estimated at 208 million yen, mainly in Otaki village. The particular modes of the damage to the pipelines were sweeping of the pipelines due to the large slope failure, the breaks and the cracks of the pipe body of the asbestos cement pipes and the pull-out and looseness at the joints of the polyvinyl chloride pipes. This section briefly describes the restorations of the water supply systems in Otaki village, that followed the damage inflicted by this earthquake. The emergency water supply operation employing polyvinyl containers immediately following the earthquake was conducted because of suspension of water supply and muddy water in many houses. Fig. 9 shows the network of the water supply system in Otaki village. This system had two main sources of water supply. One of them, however, did not work due to the slope failure in Matsukoshi area. The headrace pipes, whose length is about 3km from the source to the distributing reservoir, consist of the asbestos cement pipes and polyvinyl chloride pipes with 75mm and 100mm diameter. About twenty damage was found and was repaired. As to the distributing pipes, above ground piping employing vinyl pipes with 50mm diameter was made as emergency restoration since it was discovered that the asbestos cement pipes were completely destroyed.

A total of about 16 days was required for temporary recover of the water supply systems. Even then, the supplied water is not good for drink in spite of chlorination because of the supplied water was muddy. The water supply using the water wagon was continued for several days.
