# RECONNAISSANCE REPORT ON THE 2000 TOTTORI-KEN SEIBU EARTHQUAKE

Damage done to civil structures by the 2000 Tottori-ken Seibu Earthquake was investigated. Field surveys were made from October 8-10 by eight members dispatched by the JSCE in cooperation with other researchers. Descriptions are given of the earthquake, seismic ground motion; the damage done to such civil structures as roads, road bridges, lifelines, dams, port facilities; slope failures; and public risk management. Although peak ground accelerations were extremely intensive, structural damage was not as severe as compared with the average damage caused by past earthquakes in Japan. Such disaster responses as search and rescue activities, emergency responses, disaster information communication, and victim supports are discussed.

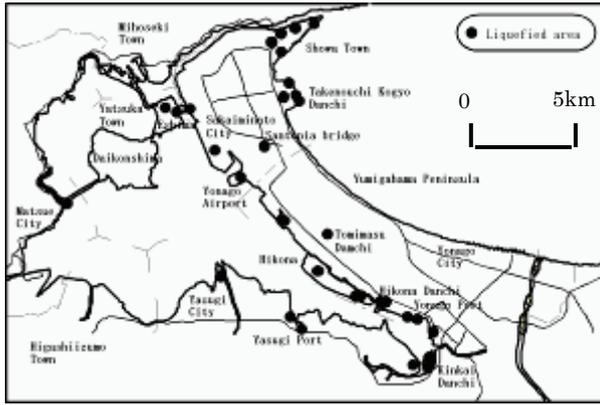
Fig. 5 Confirmed liquefaction sites.

Fig.5 shows locations where boiled-out sand and cracks in the ground were found during our reconnaissance. The Yumigahama Peninsula, running from Sakaiminato to Yonago, is an 18km-long, 4km-wide sandbar<sup>12)</sup> composed of soil deposited by the Hino River. It has been reclaimed for farm and industrial land (Fig.6<sup>13)</sup>). The figure shows that the area on the Miho Harbor side is mostly natural coast line, whereas on the Nakaumi side most is reclaimed ground.

**Figs.5** and **6** show that liquefaction was concentrated in the Takenouchi industrial park (**Photo 1**), Showa Town, and reclaimed ground near Yonago Harbor. In the industrial park and Showa Town, liquefaction was extensive (**Photo 2**). Damage included land subsidence around structures, heaving of piers, subsidence of and cracks in aprons, unequal subsidence and deformation of lightweight structures due to lateral flowage, and destruction of water supply pipelines. In Hatagasaki (Yonago Harbor), the Hikona and Nishikiumi housing estates, and Minatoyama Park, there was damage both to the ground and structures.

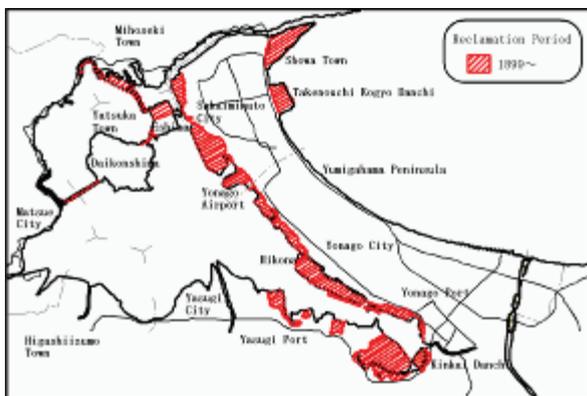
Fig. 6 Reclaimed ground on the Nakaumi littoral.

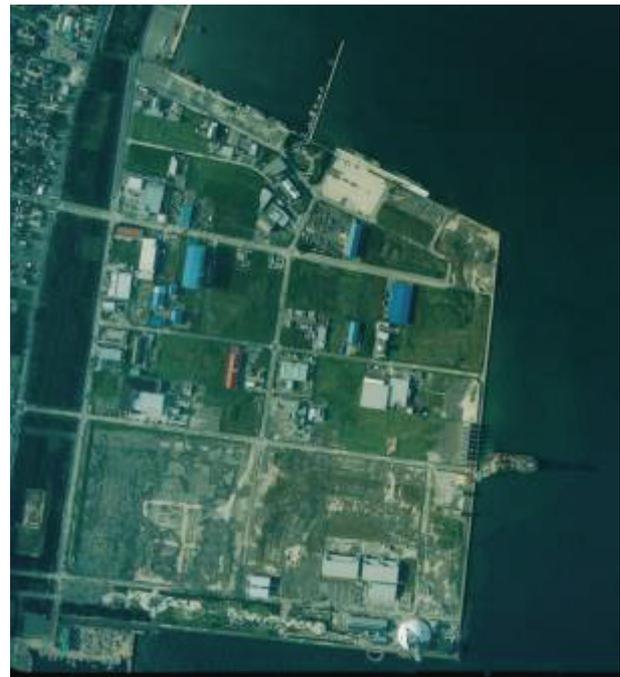
Photo 1 Aerial photograph of the Takenouchi Industrial Park In Sakaiminato taken after the earthquake (October 7, 2000).

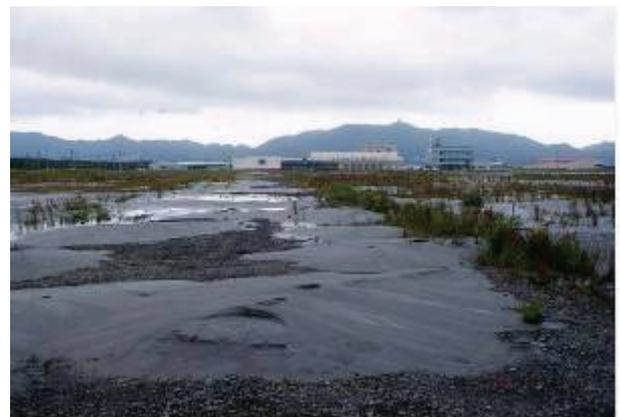
This investigation indicated that the sand boiled out by liquefaction at the Takenouchi Industrial Park in Sakaiminato consisted of a large amount of black, fine-grain sand. Fig.4 shows grain-size accumulation curves for boiled-out sand at the Industrial Park and the Sakaiminato fishery wharf where quay walls were damaged. The boiled-out sand at the Takenouchi Industrial Park contains more fine grains than that at the fishery wharf.

Photo 2 Boiled-out sand produced by liquefaction (Takenouchi Industrial Park).

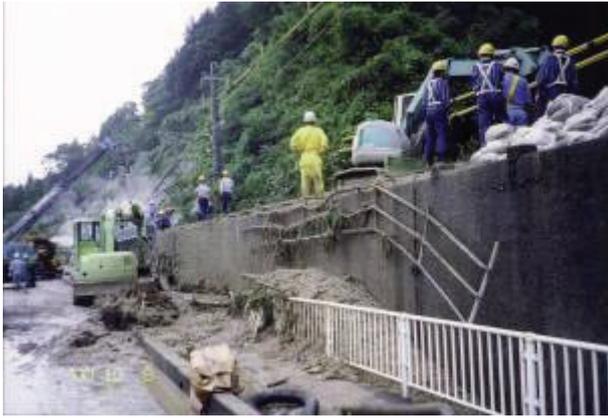
**Photo 3** Slope failure along the JR Hakubi line and Route 181 in Kaibara, Hino.

In Hino, roads were closed in 17 places, including Route 180 in Shimokurosaka, due to slope failures. As for West Japan Railway (JR West), the tracks of its Hakubi line parallel to Route 180 were cut due to slope failure (**Photo 3**), and the JR San'in Line and most local lines in the Kinki and Chugoku Districts had to cancel operations. In a 500m range that included the Nezuma Tunnel (175m), four landslides occurred. On Route 180, a stretch between Kurosaka and Neu was closed to traffic because of rock falls and landslides, and a farm road (the Nigotani-Takiyama one) and the Kamiishimi-Kurosaka road had to be used as detours.

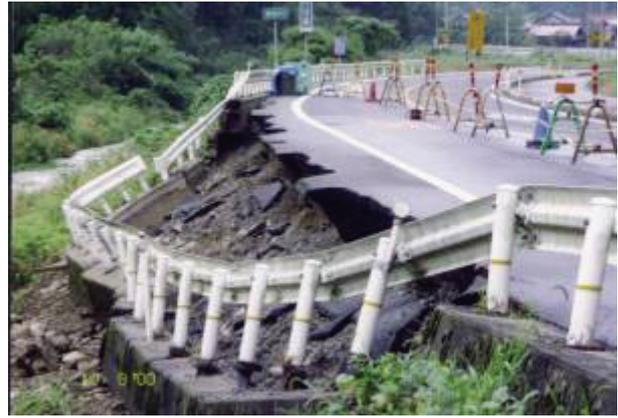
**Photo 4** Damaged guard rail caused by slope failure in Nigotani, Hino.

Temporary guard fences had been set up by 17:00 on October 14, and Route 180 re-opened on one side. There was one-side traffic along the Mashumi River in Nigotani District (**Photo 4**) because of an 80m long, 2m wide slope failure on the river side.

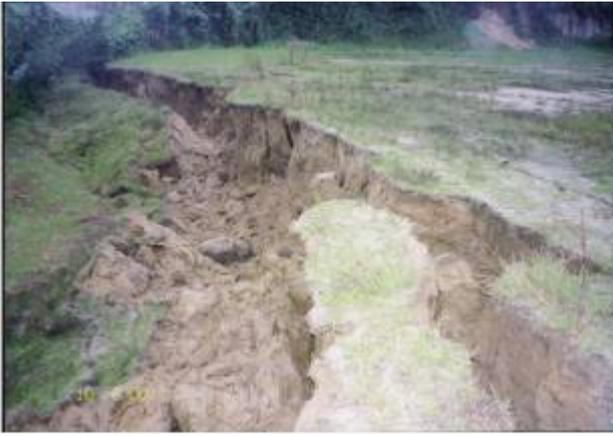
The baseball field of the Hosshoji Junior High School, located on a hill, suffered a 2-3m crack due to a landslide of its earthfill (**Photo 5**).

**Photo 5** Tension crack in the baseball field at Hosshoji Junior High School, Saihaku.

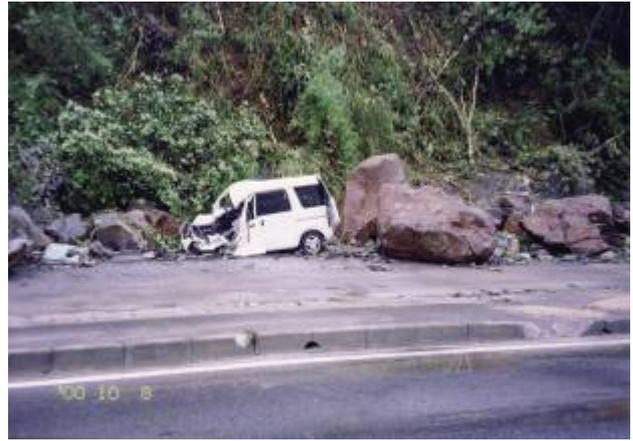
**Photo 6** Car damaged by fallen rocks near the prefectural road in Udai, Mizoguchi.

A landslide occurred in the vicinity of the prefectural road near an amusement park called Onikko Land in the Udai District of Mizoguchi. A parked car was destroyed by falling rocks and soil, and the driver slightly injured (**Photo 6**).

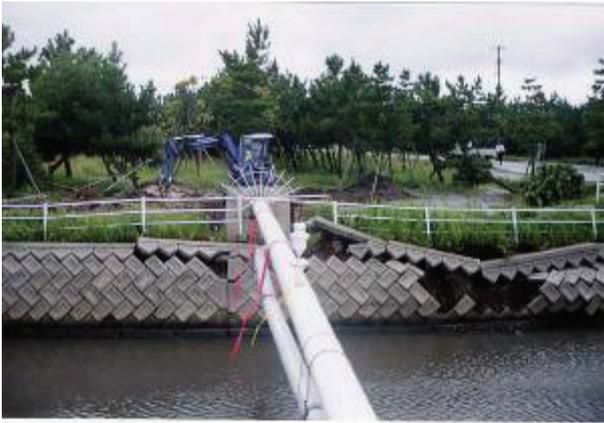
**Photo 7** Damage to an aqueduct over a catch drain in the western part of the Takenouchi Industrial Park.

at the Takenouchi industrial park in Sakaiminato, in particular, sustained severe damage due to liquefaction. **Photo 7** shows a damaged aqueduct bridge at the southwest entrance to the park. Deformation occurred because the bank protection, a catch drain, moved due to liquefaction and the width of the drain was reduced. The ground subsided as well. As for damage to pipelines, small caliber pipes of less than 50mm showed the most damage. Also, a few large caliber ones of more than 300mm were damaged. The most severely damaged pipes were those of cast iron, most failure modes being due to repeated separation and penetration behavior. Damage to steel pipes was second, most caused by the cutting of screw parts. Few asbestos cement pipes were damaged despite their low strength. This is because they had not been buried under recently developed ground that was considered liquefiable. They became damaged due to buckling and separation at joints.

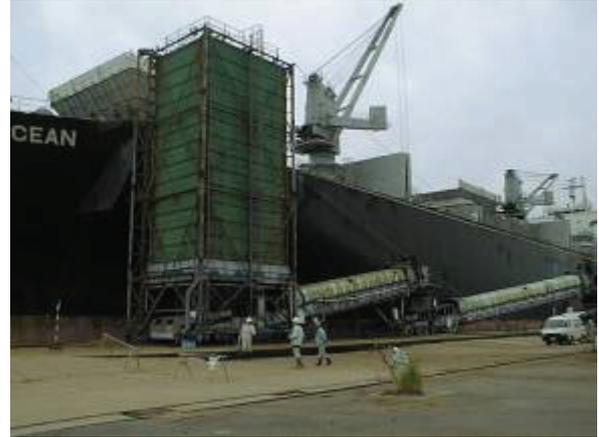
**Photo 9** Damaged -13m quaywall at Showaminami.

Most of the backfill behind the caisson subsided, and vertical offset was generated between the backfill and caisson. The largest offset took place at the easternmost -13m quaywall, a 50cm dislocation occurring between the apron and yards (**Photo 9**). Behind the quaywalls, traces of boiled-up sand produced by liquefaction were present around the columns. The relative displacements from the normal direction of all 3 quaywalls were small, therefore the bulging of the quaywall faces did not affect the moorings. Investigation confirmed that cargoes could still be handled because liquefaction under the paved backfill was not pronounced, the chip unloader worked well, and the front depth of the quaywall was sufficient. The outer harbor No.1 and 2 piers of the open type had little displacement in the normal direction, but there was an opening crack of about 7cm behind the sheet piles. The Ejima steel sheet pile quaywall (-9.0m) showed no outstanding damage, only a few cracks.

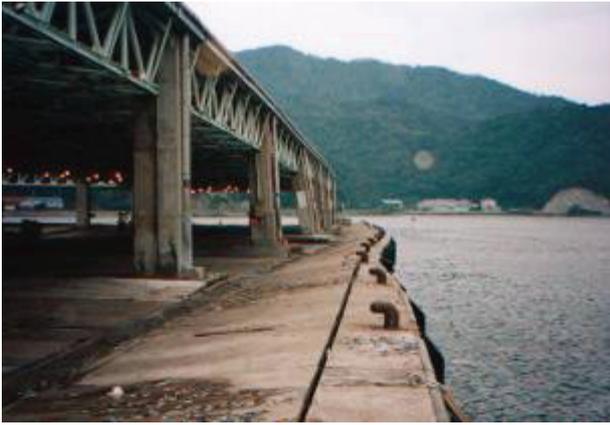
**Photo 10** Damaged fishery wharf at Showakita.

Unlike the major harbor facilities, the -6.0m quaywall of the Showakita fishery wharf, the so-called 'Kani Pier', was severely damaged (**Photo 10**). Liquefaction occurred, and the quay shed subsided a maximum of 0.6m around its columns. Moreover, the face of the quaywall curved a maximum of 1.3m. The Takenouchi area, land reclaimed by dredge pumps, suffered wide liquefaction. Channel width in the reclaimed ground decreased by 2m, and the riverbed heaved a maximum of 1m. At the marina in the south of the area, three piers for yacht moorings embedded in the seabed collapsed. In general, where liquefaction occurred facilities were damaged.
