Geotechnical damage in the 2018 Sulawesi earthquake, Indonesia

SHORT REPORT

Masakatsu Miyajima^{1*}, Hendra Setiawan², Masaho Yoshida³, Yusuke Ono⁴, Kenji Kosa⁵, Ida Sri Oktaviana², Martini² and Irdhiani²

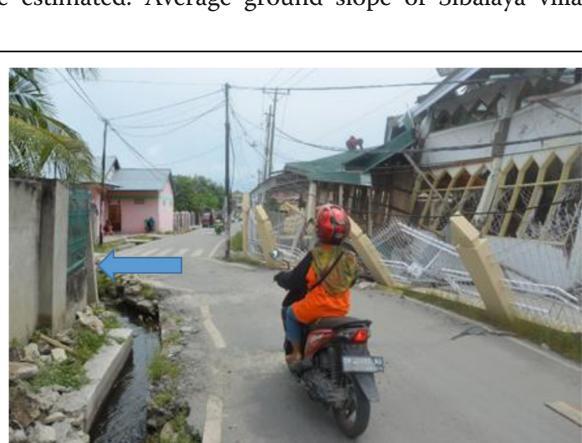
straight. After the earthquake, fault movement triggered the occurrence of lateral ground displacement and bent the four roads mentioned above. The horizontal displacements of the four roads are 2.7 m of Pangeran Diponegoro street, 3.8 m of Cemara street, 4.5 m of Kedondong street and 5.0 m of Pipa Air street, respectively.

Fig. 7 Large ground displacement of 5.0m at Pipa Air street in Palu city

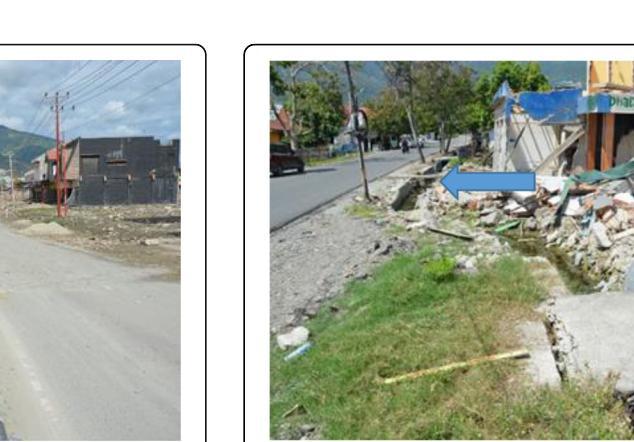
Fig. 5 Large ground displacement of 3.8m at Cemara street in Palu city

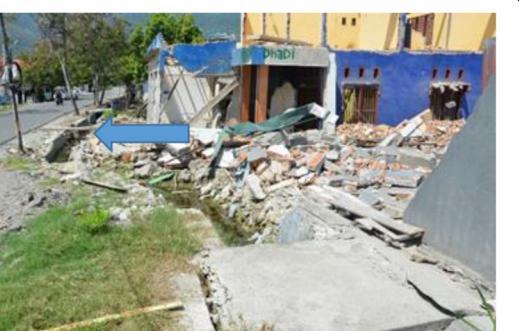
Fig. 6 Large ground displacement of 4.5m at Kedondong street in

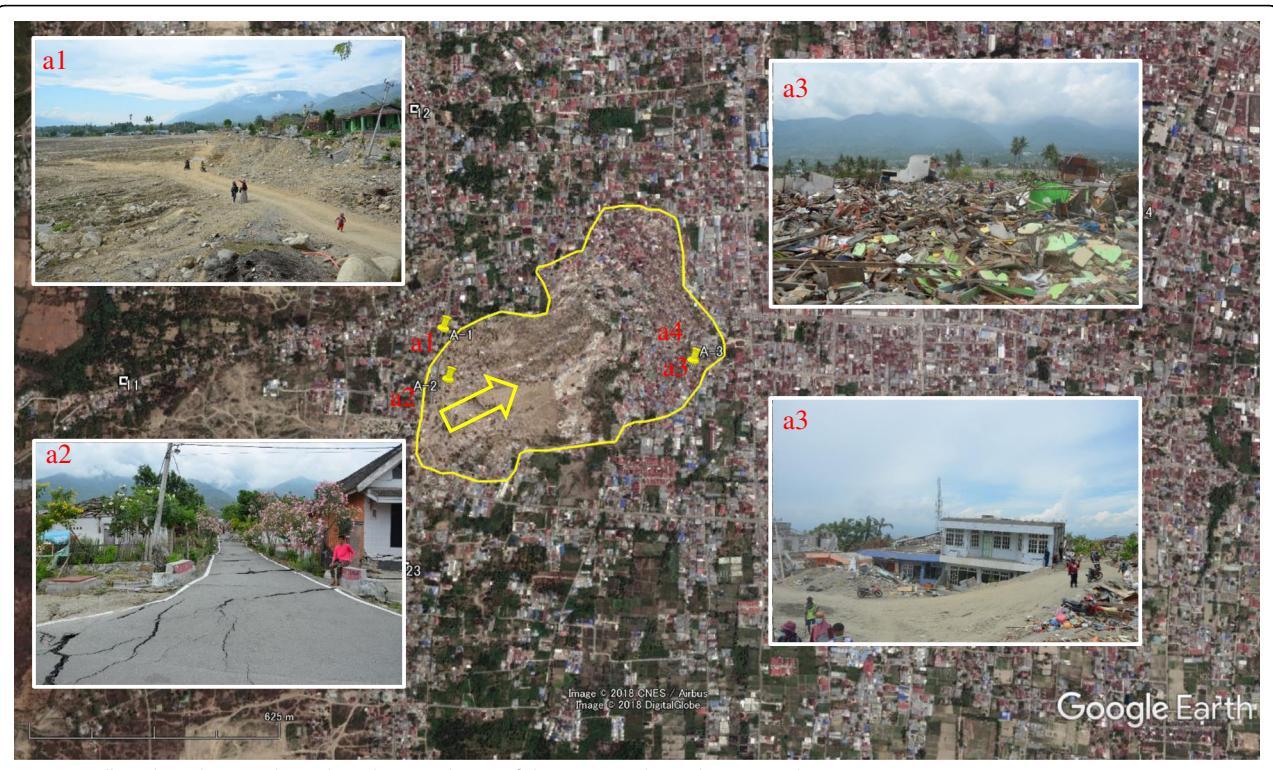
Figure 9 shows a satellite photograph by Google Earth and some photographs of damage in Balaroa district in Palu city. The direction of the large ground flow is shown by a yellow arrow in this figure. The ground flow occurred from south-west ot north-east. Large ground settlemnts and large tension cracks appeared at the upper side of the flow and collasped houses were piled up and many houses were buried in the flowed soil at the lower side. Balaroa district is a densely populated area. This district was reclaimed from a swamp in 1978

to 1979, then the district was used for residential houses from 1980. Therefore, the underground water level is high. Six hundred people were died of the more than 2000 inhabitants, while more are still missing. The area affected in Balaroa district was around 380,000m². Balaroa housing complex almost disappeared due to the ground flow. It is reported that around 1700 houses were buried due to lateral ground movement.

Fig. 9 Satellite photo by Google Earth and some photos of damage in Balaroa district in Palu city

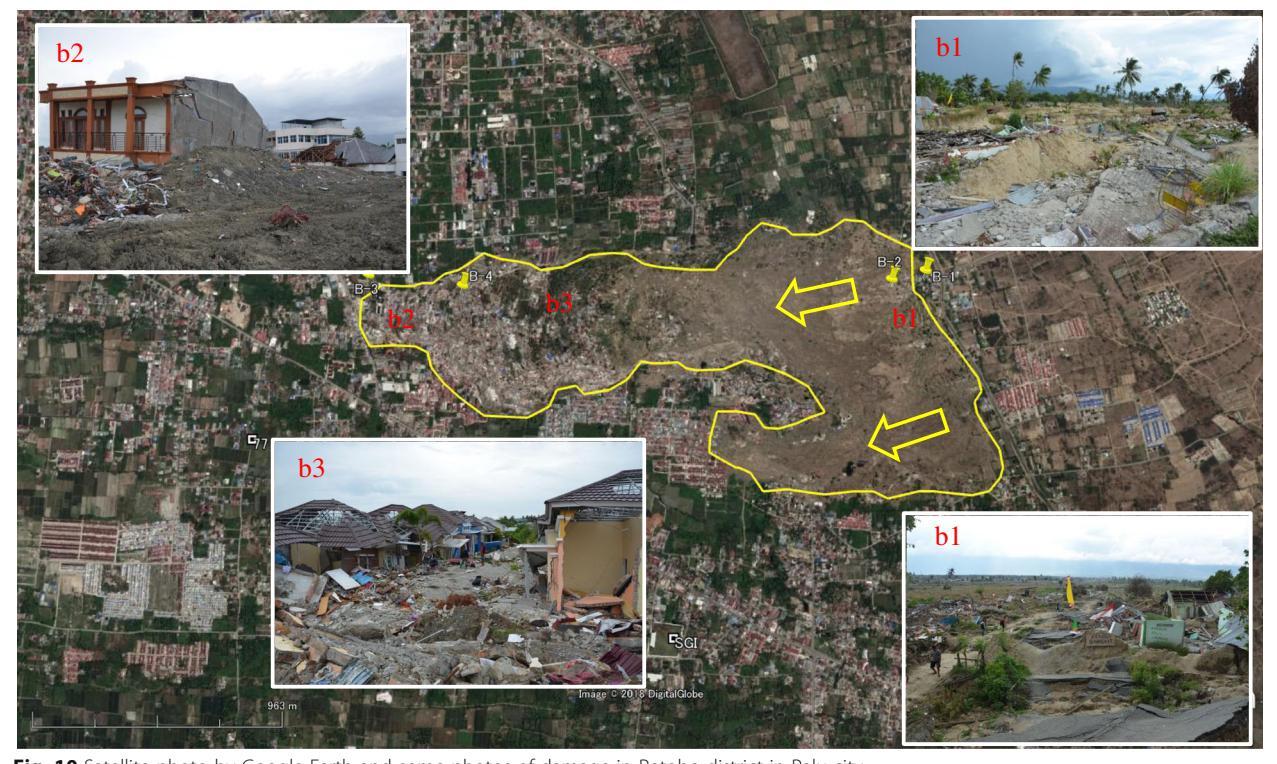
Figure 10 shows a satellite photograph by Google Earth and some photographs of damage in Petobo district in Palu city. The direction of the large scale ground flow is also shown by a yellow arrow in this figure. The ground flow occurred from east to west here. The affected area was used for residential houses before the event. Similar to Balaroa district, more than 700 houses were severely destroyed by the ground flow and hundreds of people died here. The area affected in Petobo district was much larger than Balaroa, which is around 150,000m².

Fig. 10 Satellite photo by Google Earth and some photos of damage in Petobo district in Palu city

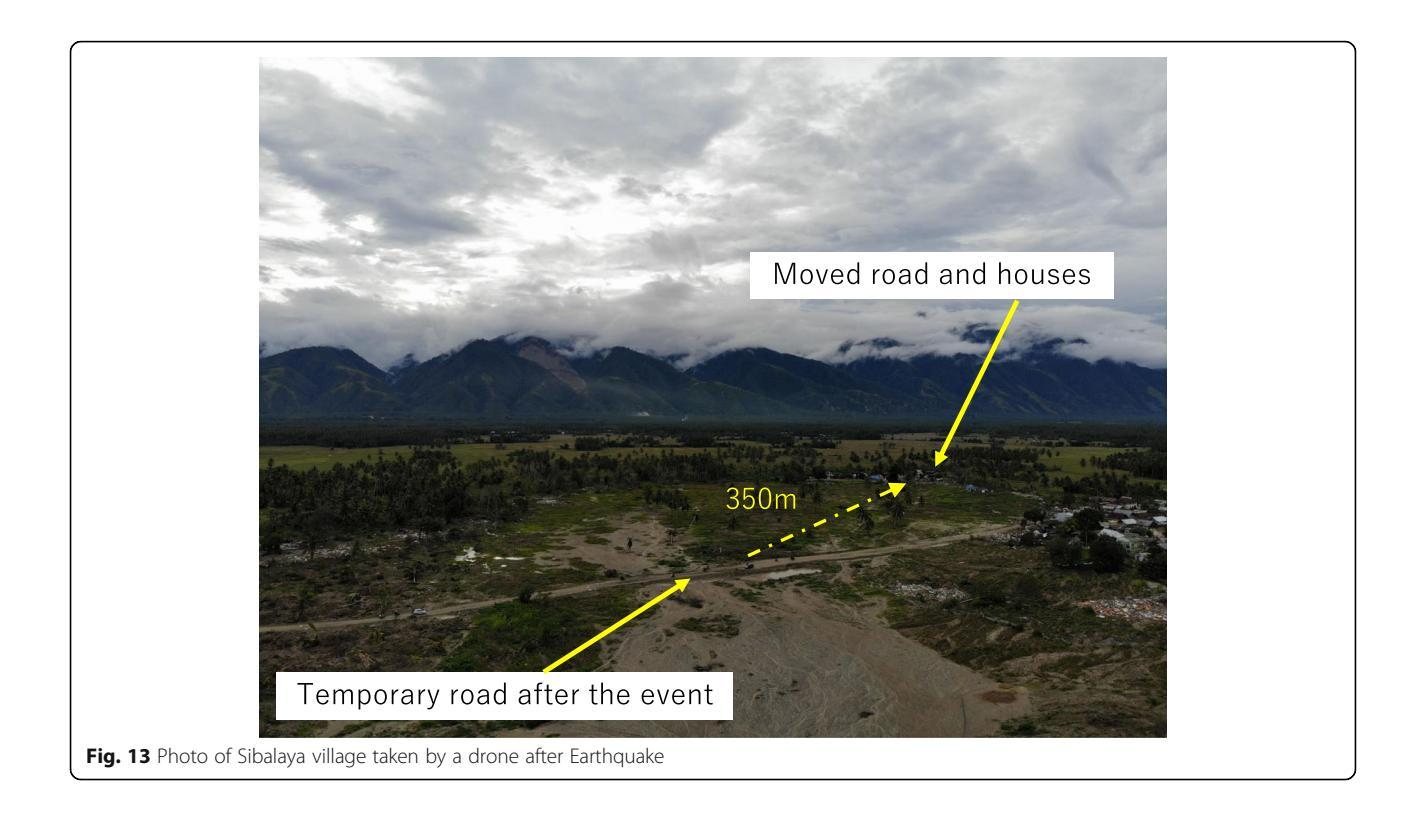
Figure 12 shows a satellite photograph by Google Earth before the earthquake and some photographs of damage in Sibalaya village. The direction of the large scale ground flow is also shown by a yellow arrow in this figure. Sibalaya village is located about 40 km south of Palu city. A satellite photograph of Sibalaya village after the earthquake could not be obtained yet. Most of this area was also used for rice field before the event. In this area, only three people were dead due to building collapse. Figure 13 shows the photograph of Sibalaya village taken by a drone after the event. The road and houses moved laterally up to about 350 m. Figure 14 shows the same house before and after the event. What made this phenomenon extraordinary is that the moving road and some houses only experienced minor damage. The mechanism of the large ground flow should be clarified in near future.
