Recycling concrete rubbles with reactive aggregates from ASR-affected bridge pier

A. Sugiyama, K. Torii, K. Sakai, K. Shimizu & Y. Sato

*Department of Civil and Environmental Engineering, Div. of Natural Science & Technology,
Kanazawa University, Kanazawa, Ishikawa, Japan*

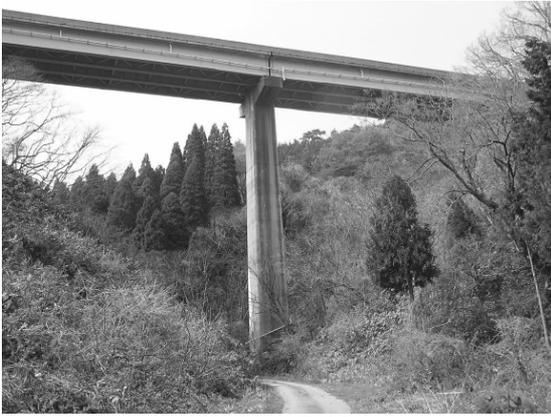
Figure 1. Overview of Kashima Bridge.

Kashima Bridge with a 2-span steel girder structure was constructed in 1978, as shown in Figure 1. Its T-shaped RC pier is 42 m high. The location of Kashima Bridge on the Noto highway is presented in Figure 2. A recent research has clarified that 230 bridges out of a total of 620 bridges in the north district of Noto peninsula in Ishikawa Prefecture, which is about 40 percent, are judged as ASR-affected ones in the inspection carried out in 2004. The Kashima Bridge is located in the center of the Noto highway which is running in the mountain area from Kanazawa to Anamizu (Torii et al. 2006).

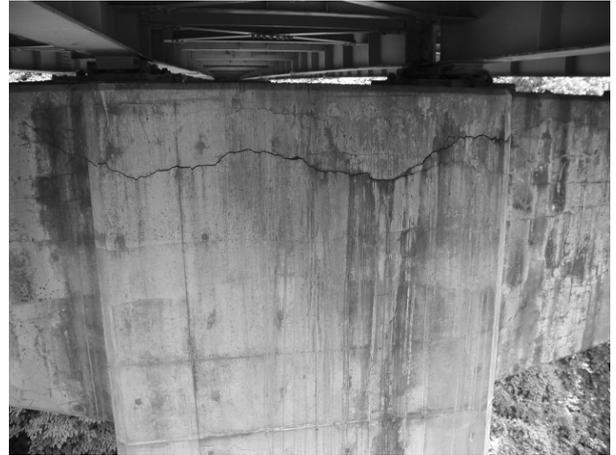
Figure 3. Large horizontal cracks in center of pillow beam.

Figures 3 and 4 show the cracking of pillow beam of the Kashima Bridge. It is observed that there are large horizontal cracks with width of 5 to 8 mm on the side of pillow beam beneath the shoes, and that the cover concrete at the end of cantilever partially peels off due to the rainfall water with deicing salts. On the other hand, the cracking of column and footing is not so significant, although there are some vertical cracks with width of 1 to 2 mm on the column and the partial map cracking on the footing. In order to evaluate the deterioration of the inner part of pillow beam due to ASR, the ultrasonic wave method was applied to the side surface of pillow beam of 2.5 m wide, where the feature of wave pattern with the passing time of elastic wave from one side to opposite was measured. Figure 5 shows the results of ultrasonic wave method of pillow beam. Ultrasonic wave velocity ranged from 3000 m/sec to 4000 m/sec, which corresponds to the degree of deterioration of concrete due to ASR. Importantly, at the end of cantilever where the cover concrete peeled off, the ultrasonic wave could not propagate at all. Also, the frequency at average peak, which is calculated from the analysis of total wave energy, also shifted toward the lower value as the deterioration due to ASR proceeded.

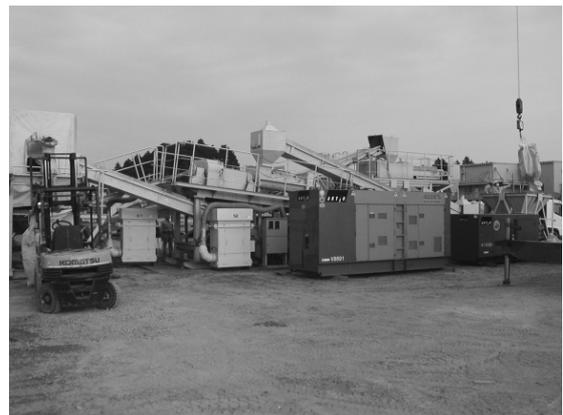
Figure 8. Recycled aggregate production apparatus.

In the process of producing recycled aggregate, concrete rubbles from the Kashima Bridge were firstly crushed using a jaw crusher and sieved at the grain size of 40 mm or less. Furthermore, in order to satisfy the quality requirement of recycled aggregate class H according to JIS A5021, adhesive mortars of recycled aggregate were removed through the process of screw abrasion, and sieved again at the grain size of 25 mm or less, as shown in Figure 8. Recycled aggregates produced by crushing process and followed by screw abrasion process are classified to class L and class H recycled aggregate, respectively. Physical properties of two types of class L and class H recycled aggregates and original andesite aggregate are presented in Table 1. Mixture proportion of concrete using recycled aggregate is presented in Table 2. Ordinary Portland cement was used for making concrete. Coarse and fine aggregates used were class H recycled aggregate and non-reactive river sand, respectively. The water-cement ratio and sand-aggregate ratio of concrete were 50% and 46% for each mixture. An alkali ($\text{Na}_2\text{O}_{\text{eq}}$) of 5.06 kg/m^3 was added to the concrete
