# Review on the Relationship between the Spatial Developments and the Change of Wooden Houses in Original Settlements in the Suburban Expansion of Bangkok

Walanrak Poomchalit<sup>1\*</sup>, Katsuhiko Suzuki<sup>1</sup> and Arno Suzuki<sup>2</sup>

**Keywords:** Spatial Development, Original Settlements, Wooden Houses, Conservation

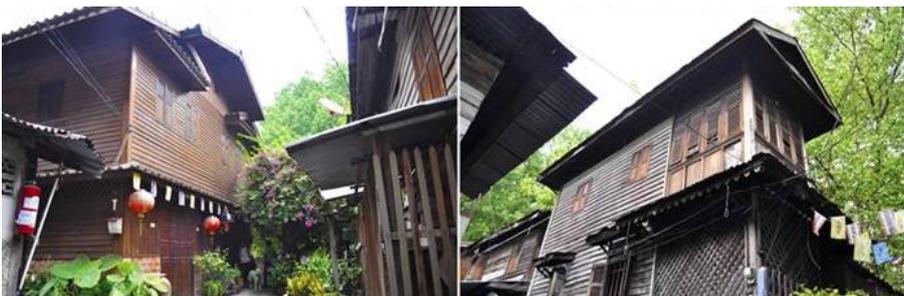
However, this community was originally settled in the era of King Rama III (Phaithayawat, 2011). It contains wooden Thai houses in various styles, and is home to Thai musical folk drama and traditional lifestyles (Manager Online, 2016).

Figure 4. Wooden houses in the Pom-Mahakarn community (Manager Online, 2016)

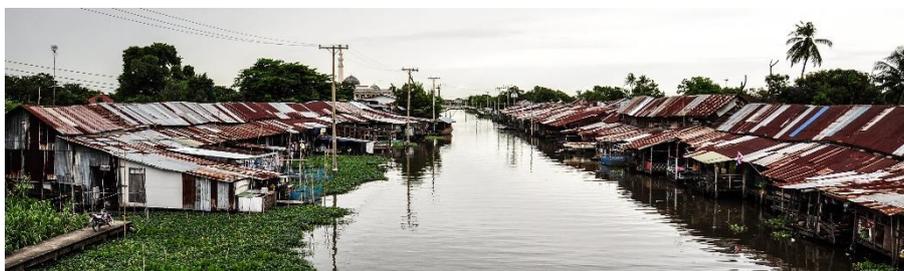
Figure 5. The settlement of the Khlong Preng community on both sides of Prawet Buri Rom Canal.

Original settlements with wooden houses exist on both sides of the junction of the main and sub-canal. They appear decayed because the original dwellers moved out and left their homes with renters or to abandonment. The decay was likely gradual because the people moved away gradually. There is a possibility that some buildings became abandoned before renting. By observation, most renters seemed to be outlanders and also had low income.

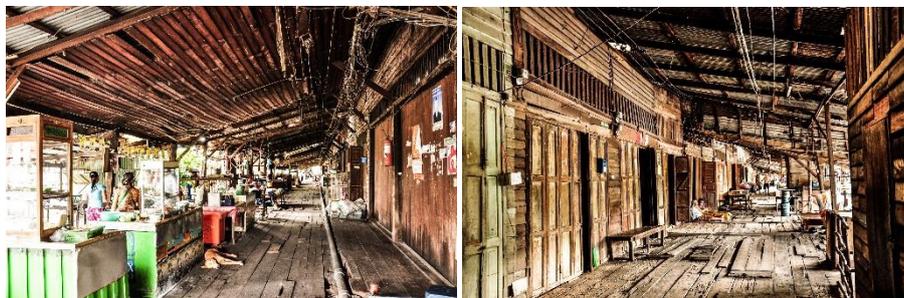
Figure 6. Decayed houses in the Khlong Preng Community along Prawet-Buri Rom Canal

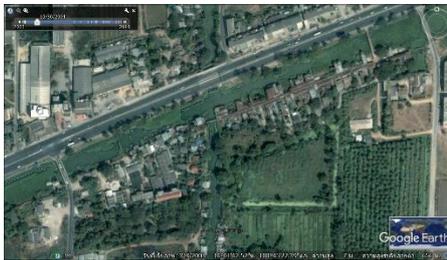
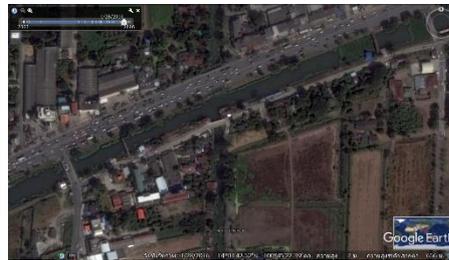
Satellite imagery in 2004

Satellite imagery in 2007

Figure 7. Sub-canal 7 in 2004 and 2007; before and after road  
(Google Earth, 2016).

However, the settlements along Rangsit Prayoosak Canal are not the same. They are shaped by local roads that were planned along the canal-side where the original communities settled, and they are probably disappearing because the width of the local roads is almost equal to the width of the communities themselves.

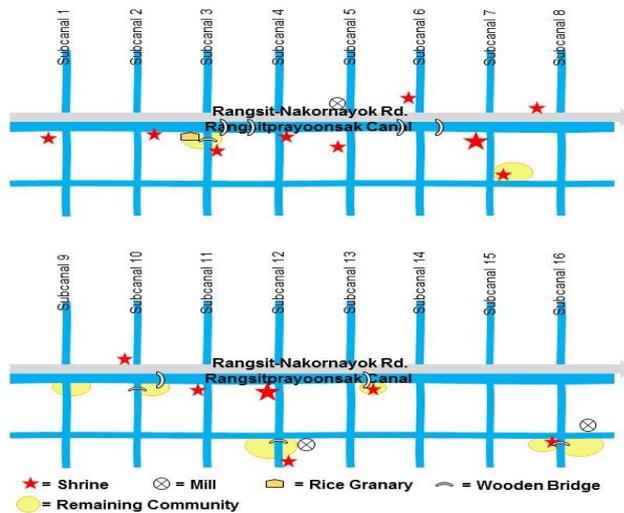
Figure 8. Characteristic of settlements along Rangsit Prayoosak Canal.

The character of Chinese settlement in this area included shrines located near junctions, wooden bridges with large structures and wooden houses. Some communities grew to fill the distances that rice travelled on its trade routes. Approximately every 8-10 kilometers, communities of rice traders settled, so that every four or five sub-canales there was another trader community. They appeared in canals 3, 7, 12 and 16 (Figure 8). For rice trading communities, there are quays or rice piers, granaries and also mills.

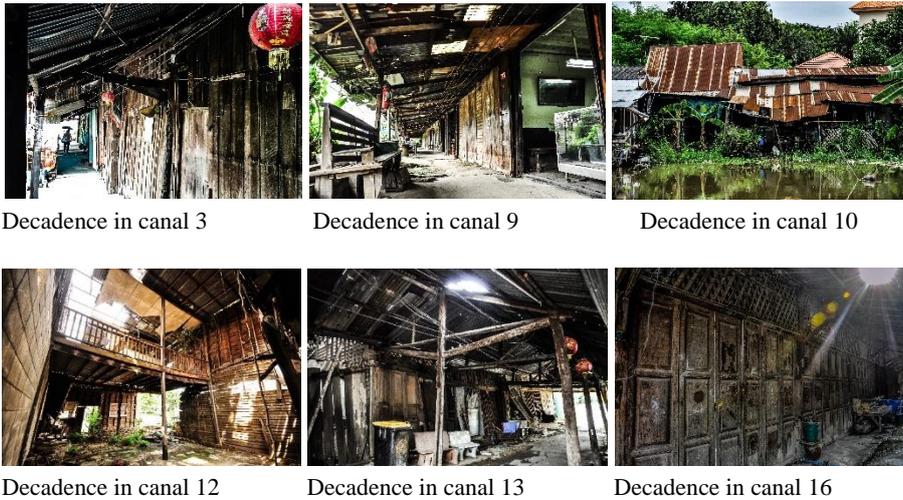
Deterioration happens to the whole house: the walls, doors, windows, roof, and main load-bearing structures such as posts and beams. Some

houses have collapsed, while some have been rebuilt or repaired with temporary structures, but are not in a liveable condition.

Figure 10. Decadent appearance of houses at sub-canals 3, 9, 10, 12, 13 and 16

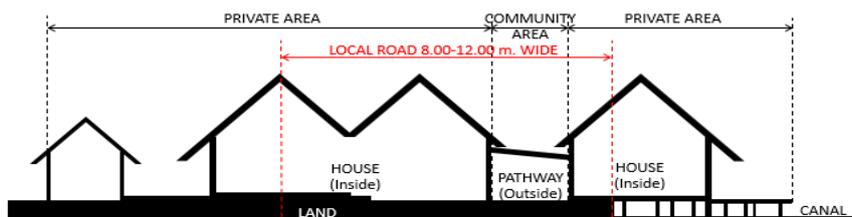
Since 2008, with an increasing number of residences and vehicles, traffic congestion along Rangsit-Nakornnayok Road has needed to be alleviated. The government reclaimed land alongside Rangsit Canal which put the Royal Irrigation Department in charge of local road construction (Intrawitchayanan, 2016). The road passed through the middle of communities where pedestrian pathways were located and the community was divided.

Figure 11. Community settlement and the placement of local road.

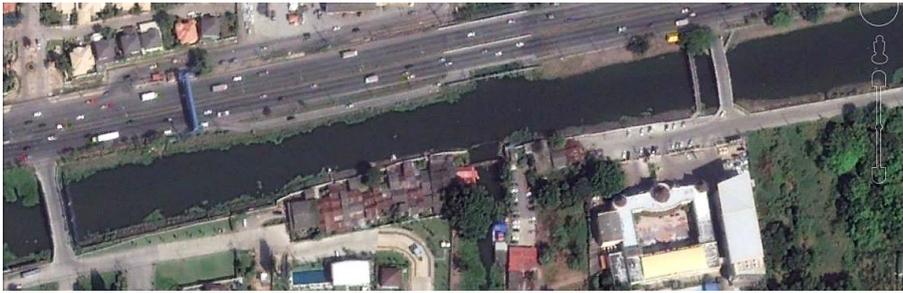
Figure 12. Road without connection at Sub-canal 3  
(Google Earth, 2016).

This development increased migration because of the instability of living in development areas. Houses were abandoned and most of the remaining people were not able to improve or maintain their houses because they had a low income.

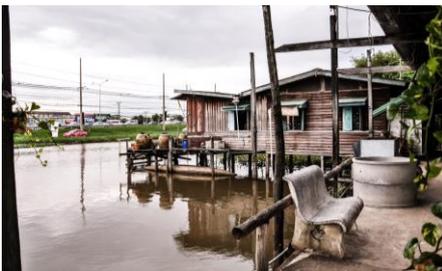
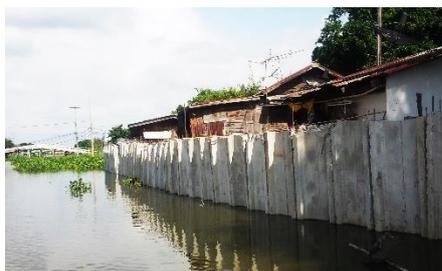
However, after a flood crisis in 2011, the Royal Irrigation Department planned to construct a flood barrier of 165-170 metres ([Poomchalit, Sanguandsap, & Mukasirisuk, 2013](#)). The operation was completed by the end of 2014. The barrier separated the community from the canal. The Royal Irrigation Department was able to reduce the impact to communities through another solution, but the characteristic quality of the waterfront communities was lost. Many bridges, quays, and entire settlements in some cases disappeared during the construction.

Waterside image before flood barrier.

Waterside image after flood barrier.

Figure 13. The community before and after the flood barrier was constructed.

In 2016, the Royal Irrigation Department expropriated the land along the flood barrier to connect the local roads. The 8 metre-wide road was intended to pass through the community ([Maneewong, 2016](#)), however, the unclarified direction of the road is creating instability and uncertainty, and the dwellers have since abandoned the village to ruin.

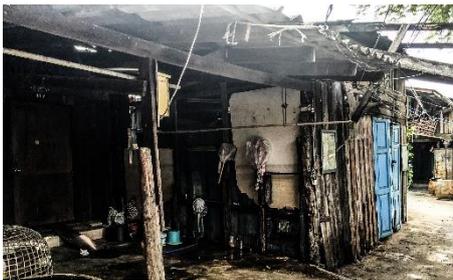
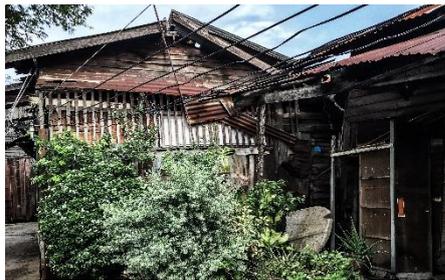
Concerning appearance, the decadence is obvious from the walls, roof, door, entrance, and the disposition of structures. The owners do not have the capacity for maintenance. Some houses were abandoned, while others were left to renters because the owners had moved out.

Decadence due to living activities

Decadence due to lack of maintenance

Figure 14. The decadence of houses in the community

Decadence occurred because the residents could not adapt themselves to advancements in modern technology and the changing condition of society. Old communities often have specific habits and cannot adjust easily. Consequently, when the rice trade moved to transport by road, the people who were experts at sailing became unemployed. This sudden loss of income was the prime reason they were unable to maintain their houses.

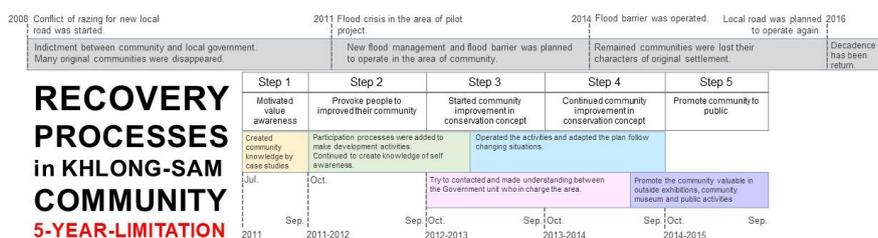
Figure 15. 5-year program of community improvement, analysis by author.

During the community improvement activities shown in Figure 15, people adapted unused space in front of the middle granary to make a small park. They added more green areas and wooden decks for relaxing.
