The Strengthening of an ASR-Affected Water Intake Tower in a Hydro-Electric Dam by Using Post-tensioned Tendons and the Long-term Monitoring of the Tower

Journal of Advanced Concrete Technology, volume 14 (2016), pp. 384-396

Scientific paper

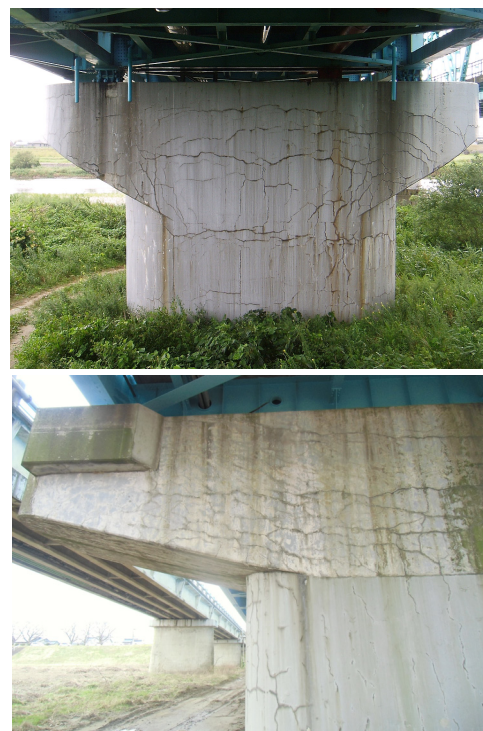
Fig. 1 Typical features of seriously ASR-deteriorated bridge piers.

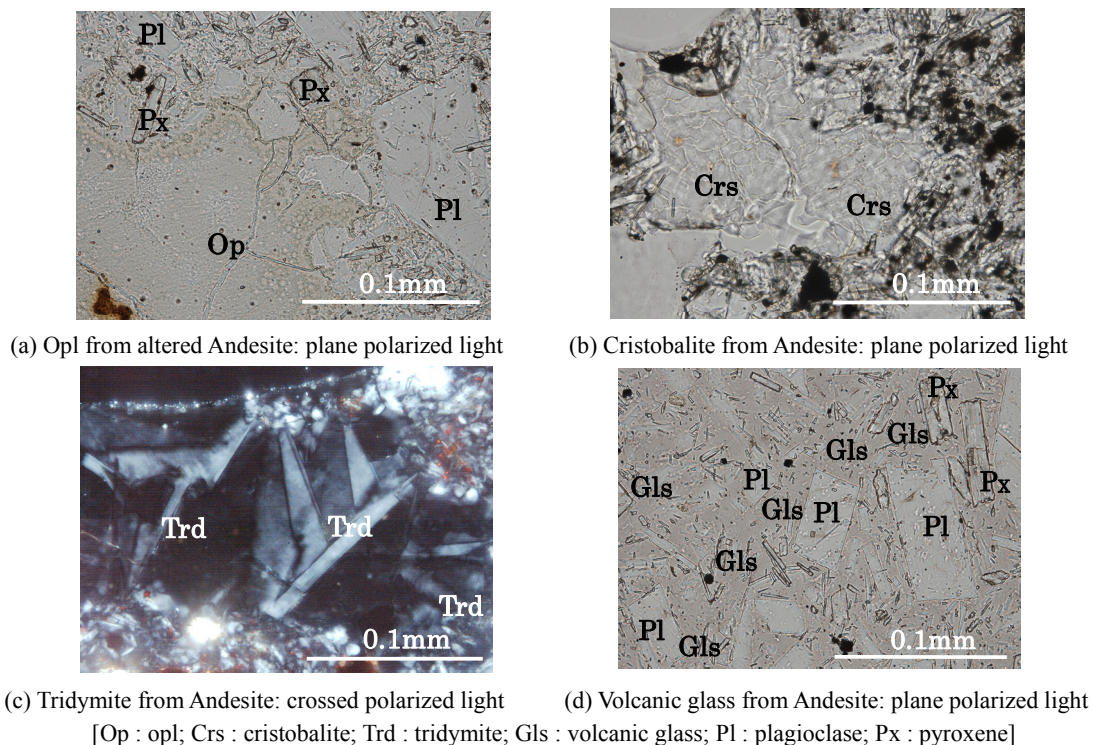
The photomicrograph of reactive minerals and other materials in the Jouganji river gravel is presented in **Fig. 2**. In the petrographic survey on mineralogical properties of the river gravel, it was found that they were mainly

Fig. 2 Photomicrographs of reactive minerals and non-reactive minerals in the river gravel used in the intake tower taken with a polarizing microscope observation.

constituted of granitic rocks and volcanic stones, in which the reactive minerals in typical andesite stones were cristobalite and/or tridymite, op1, and small amounts of volcanic glass, as shown in **Table 2**. The composition ratio of 30% andesite stones was roughly equivalent to the most pessimistic results gained by the mortar bar or concrete bar test of andesite stones in the river. Thus, it has become very clear that the reactive river sand and river gravel contain reactive minerals, especially op1, the most reactive mineral, and that its amount may be near the most pessimistic volume. A recent survey shows that in the bridges and buildings using this river sand and gravel, a severe ASR has still occurred after 2010 even in the case of total alkali content of 2 kg/m³ and less, which is considerably smaller than the JIS A5308 required value of less than 3 kg/m³.

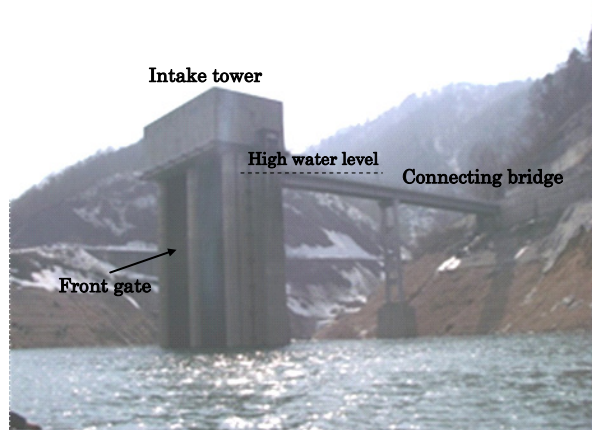
This intake tower is located at a dam in the upstream region of Jouganji river in Hokuriku District. **Figure 3** shows the actual site. 74m³/s of water can pass through the intake tower and 400 thousands kW can be generated by using this water at 3 power stations located downstream of the tower. This electricity corresponds approximately to the power needs of about 130 thousand households. Thus, this intake tower is a critical structure for the area and the company.

Fig. 3 Overview of actual site of the intake tower.

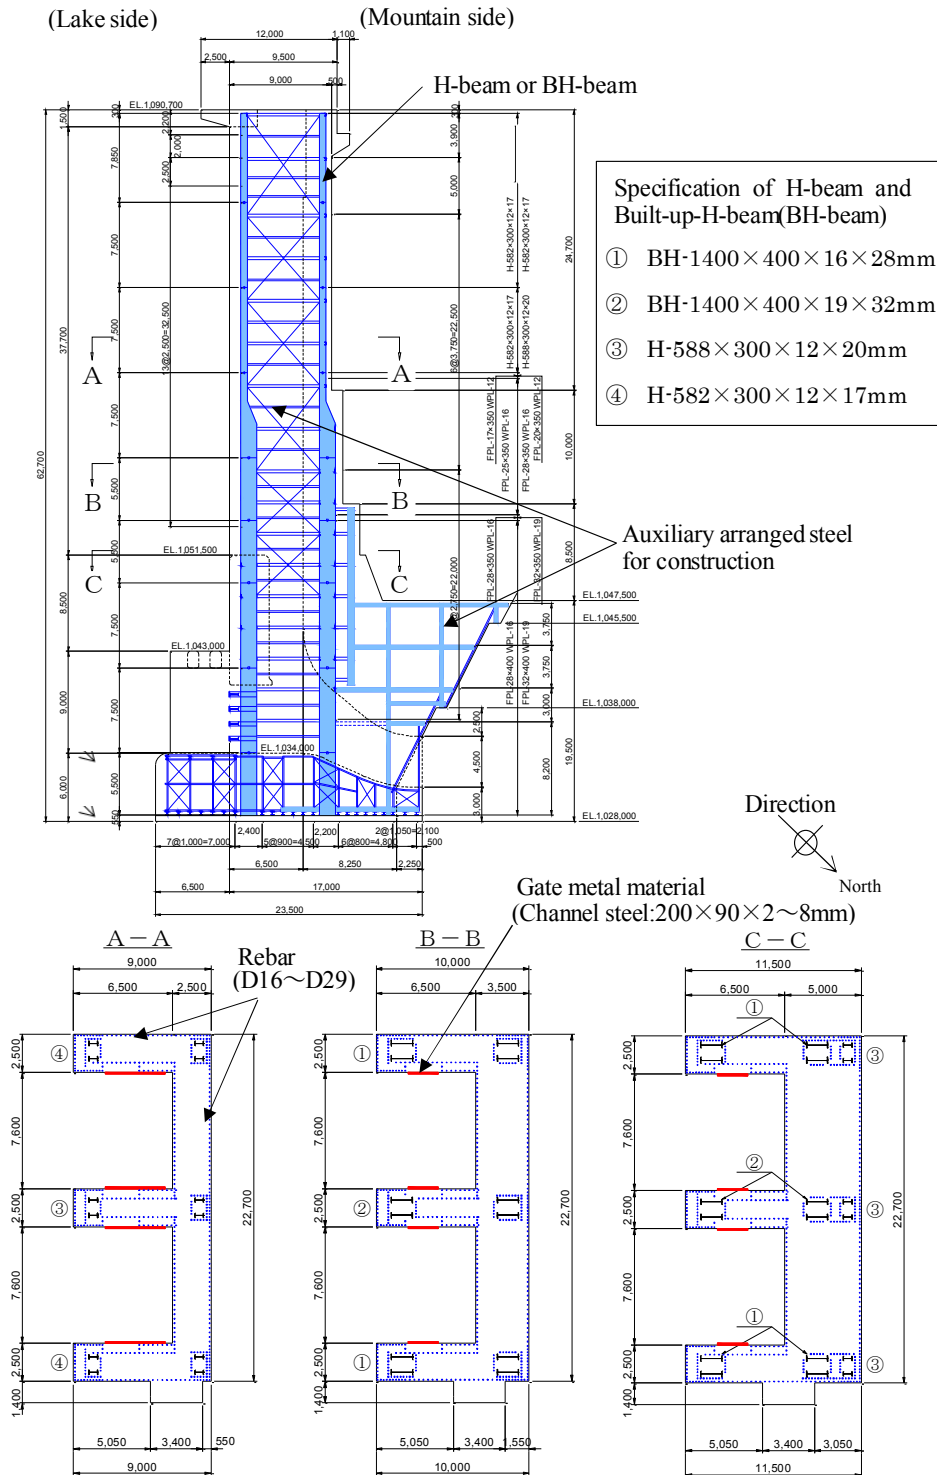
The intake tower is a SRC structure. **Figure 4** shows a cross-sectional view and a side view of the intake tower. The water level of the dam varies depending on the

Fig. 4 Cross-sectional view and side view of the intake tower.

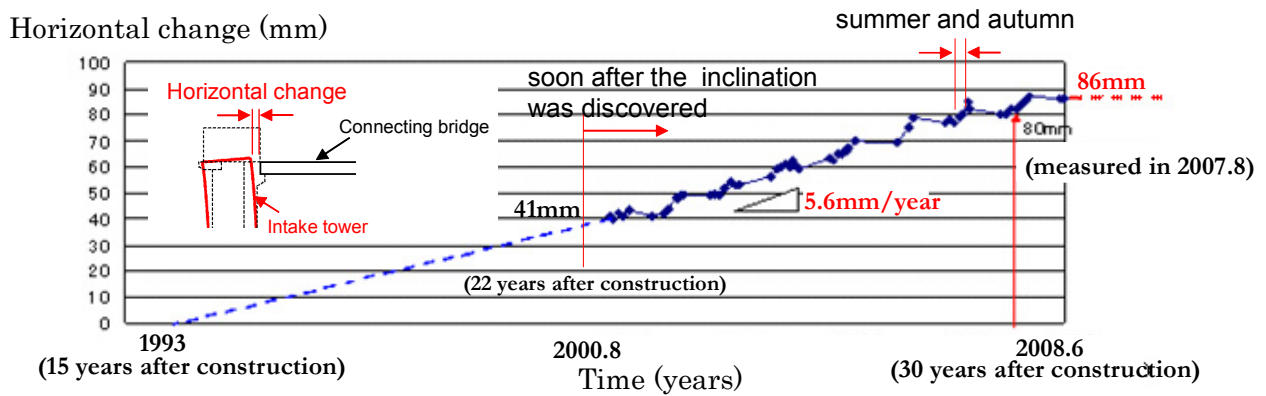
Figure 6 shows the horizontal change in distant over time at the top of the tower, and **Fig. 7** shows the vertical change over time at the top of the tower, which horizontal and vertical measurements were both conducted from 22 years after construction. During the 8-year period of 22 to 30 years following construction the rate of horizontal change at the top of the tower was 5.6mm per year. Assuming that the average rate of change was the same prior to the commencement of measurements and taking into account the currently measured change of 80mm, we estimate that the beginning of this deformation started about 15 years following construction. During the same 8-year period, the rate of vertical change was calculated to be 2.1mm per year. Thus, assuming that the deformation along the vertical axis of the tower also began 15 years after construction and assuming that the rate of deformation was uniform over time, we estimate that the

Fig. 6 Horizontal change in the position of the top of the tower over time.

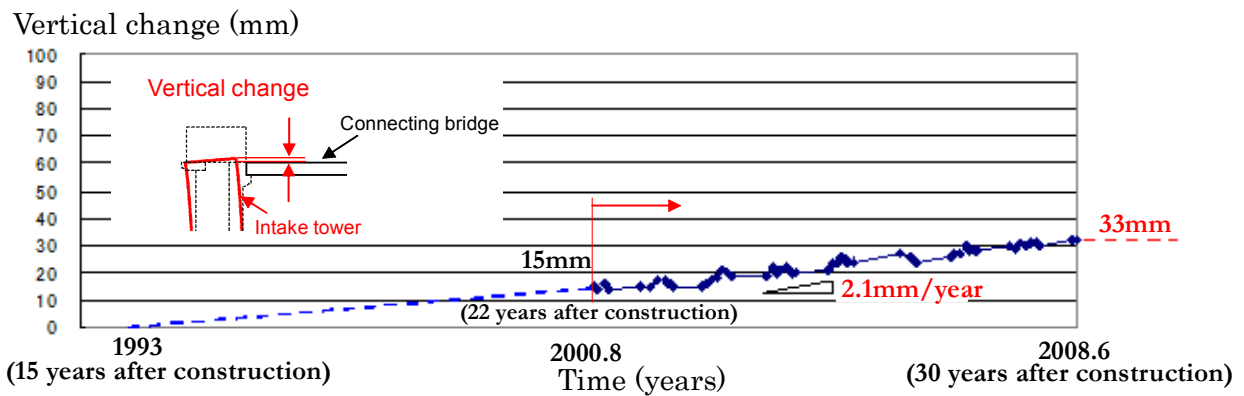
overall height of the tower at its top has increased by 33mm on the side of the connecting bridge.

Fig. 7 Vertical change in the position of the top of the tower over time.

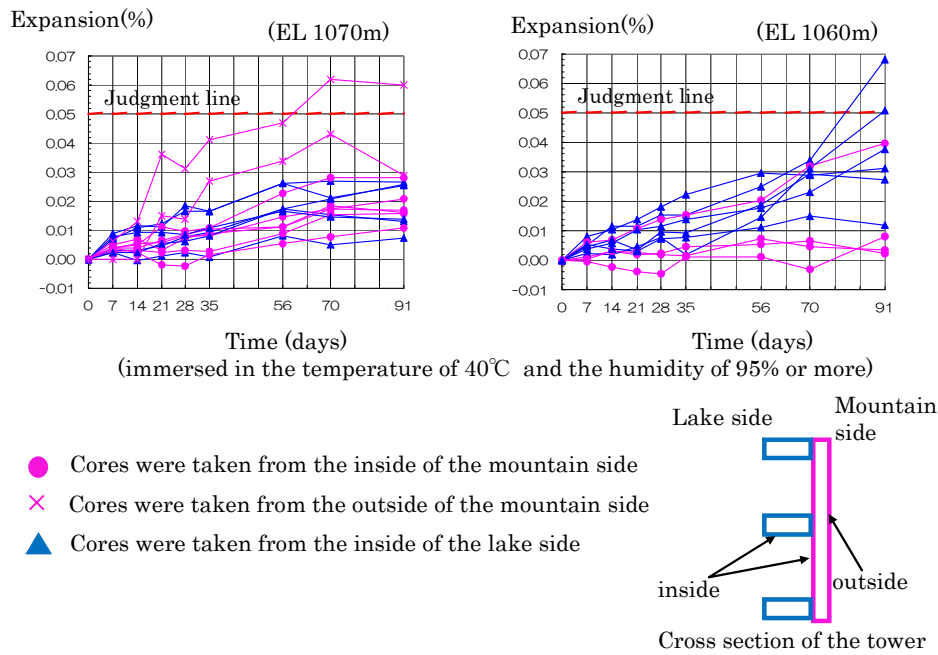
Figure 8 shows the results of the residual expansion test according to the JCI DD2 method. Each core was taken from the side of the tower at the heights of El 1070m and

El 1060m after 30 years of the construction. As shown in Figure 8, a slightly expansive tendency was observed at the heights of El 1070m and El 1060m.

Fig. 8 Result of the residual expansion test according to JCI DD2.

Therefore, it has been determined that it will be necessary to watch for the future expansion.

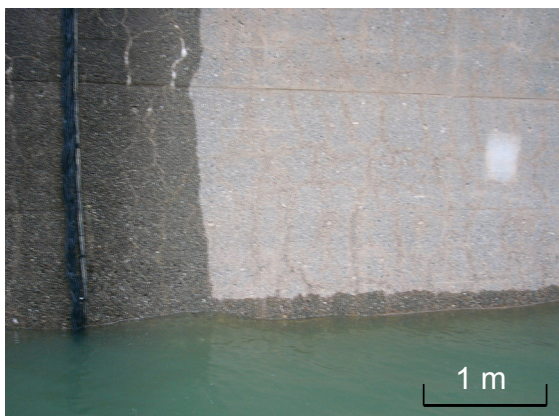
Figure 9 shows the condition of the surface of the intake tower's exterior wall. On the surfaces of the exterior and interior walls extensive mapping cracks were observed. The cracks were approximately 0.2mm in width at 20 to 30 cm intervals and were not severe.

Fig. 9 Condition of the surface of the intake tower's exterior wall.

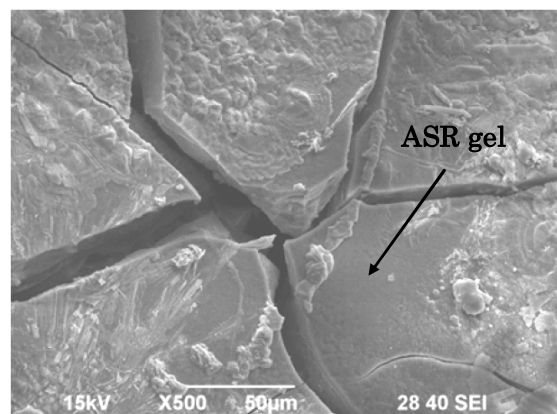
The intake tower concrete (at the levels of EL1035, 1047, 1060, 1070, and 1087) was investigated using an SEM-EDS. Figure 10 shows an example of an image at the level of EL1060. This investigation discovered ASR gel in all samples taken from all locations.

Fig. 10 Example of the observation of the concrete by SEM-EDS.

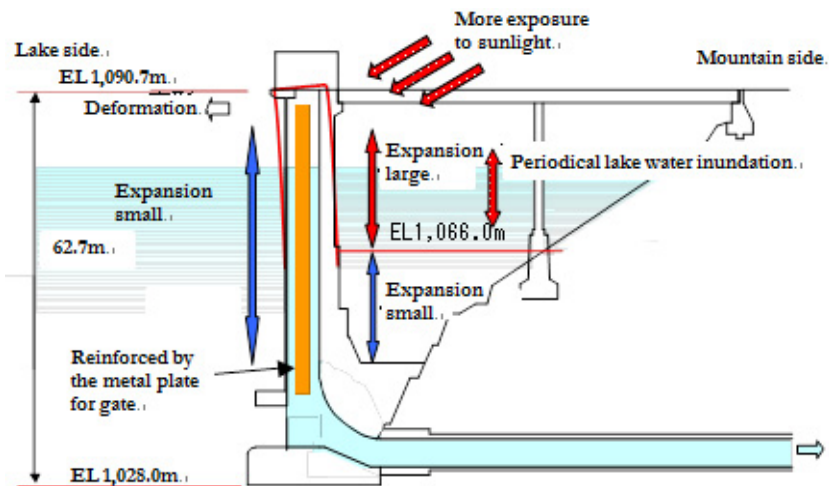
Fig. 11 Graphic illustration of the primary causes of the ASR.

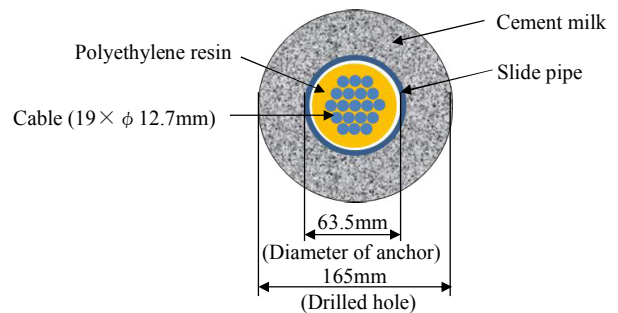
Figure 12 shows the cross-section of the hole after construction and Fig. 13 shows the situation of the construction. The anchors are inserted into the drilled holes. The anchor rods consist of 19 cables, which are each made from 7 PC steel wires. They have a diameter of 89mm and a length of 45.7m. The cable has a flexible structure. That is to say the cable (see cross sectional figure) is coated with anti-rust oil. This together with the polyethylene resin is inserted into the outer slide pipe. The lower parts of the rods are made from steel to fix the anchors at the bottoms of the holes. Throughout the holes cement milk is injected. First the upper parts of the rods

Fig. 12 Cross-section of the holes drilled for the post-tensioned tendons.

Concerning the specifications of the PC steel wire, the tension-adjustable SSEE anchor A type, 360TA (19×Φ12.7mm, yield point load of 2964kN, drilling diameter of Φ165mm), which was the maximum size available, was adopted. SSEE anchor is an anchor for PC

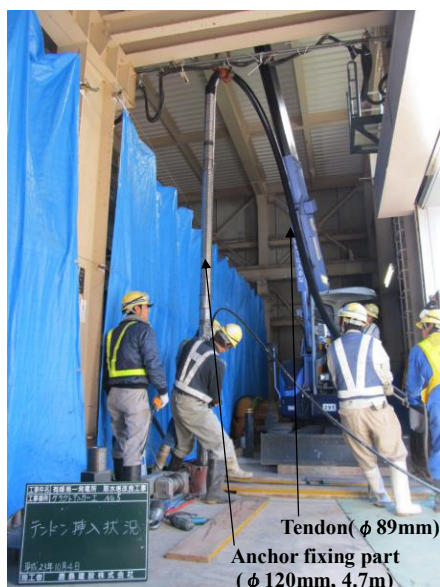
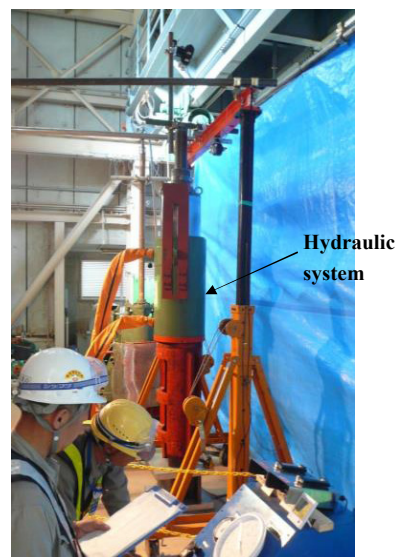
Fig. 13 Photographs documenting the construction.

During the insertion of the anchor

During the tensioning work

are hydraulically pulled, and then they are fixed in place with a nut. In other words, it is possible to create a compression force on the concrete by introducing a tensioning force to the rods. The anchors adopted this time have a screw on their tops. They are a type of anchor with adjustable tensioning force. Additionally, after considering margins corresponding to potential ASR development in the future, the largest anchor available in our country was adopted.

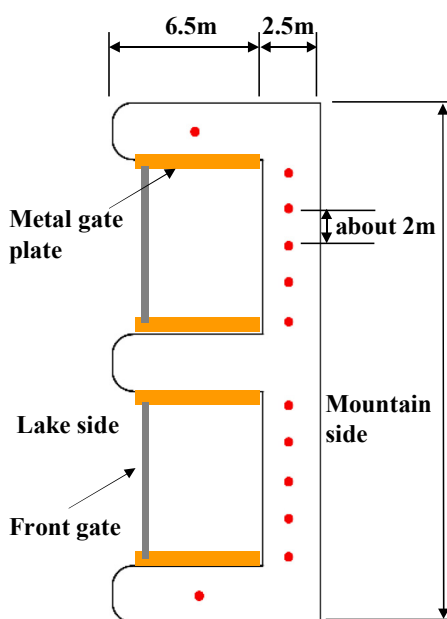
Figure 14 shows the construction location plan view, and Fig. 15 shows the drilling depth view. Drilling on the mountain side was, as much as possible, evenly spaced with 10 places, each place spaced at a distance of about 2m from the next. Furthermore, in order to balance the whole structure, two anchors were placed on the lake-side. The anchors' base positions of immobilization are set at near EL1045m close to the bottom portion of the tower structure, and in this way tension was applied to the entire structure. Thus, 45.7m drilling depth was needed.

Fig. 14 Top view of the locations of the holes for the post-tensioned tendons (holes represented by red dots).

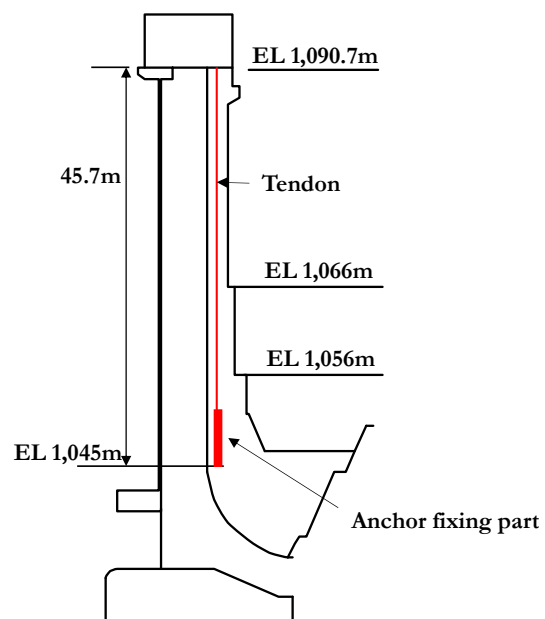
Fig. 15 Side view indicating the depth of the holes for the post-tensioned tendons.

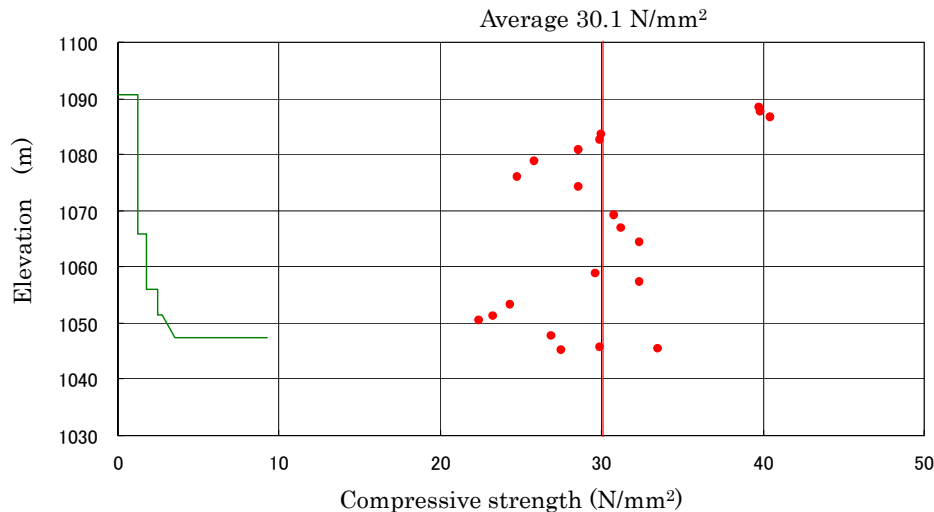
Figure 16 shows the test results for the compressive strength of a core sample from the tower, and Fig. 17 shows the test results for static modulus of elasticity. Please note that in Figs.16 and 17, the green outline of the tower on the left illustrates the relative locations in the tower structure where the various compressive strength measurements were taken. The compressive

strength results were on average higher than the planned average standard strength($\sigma_{28}:24\text{N/mm}^2$). Also, the results for compressive strength and static modulus of elasticity were both even higher at the 1,090 meter level. The compressive strength of the core from the intake tower's center showed a relatively high value. This is because the restraining force of the steel is stronger at the center of the tower.

Fig. 16 Compressive strength measurements of the cores taken at various locations in the tower.

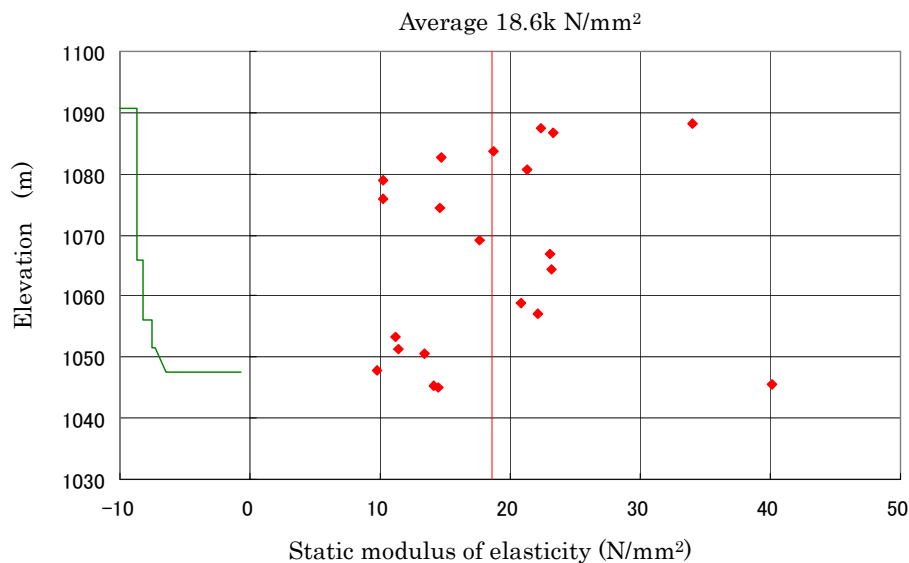
Fig. 17 Static modulus of elasticity measurements of the cores taken at various locations in the tower.

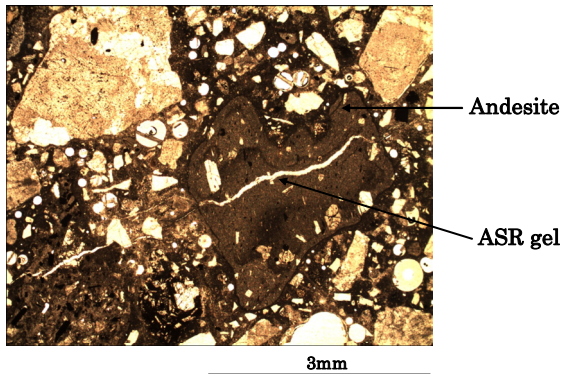
Some thin pieces made from cutting the core (40mm × 25mm) were observed under a polarizing microscope. These pieces were made one by one, each from the core in the vicinity of EL1086.5m, EL1080.6m, EL1076.1m, EL1071.3m, EL1068.4m, EL1061.9m, EL1057.1m, EL1052.4m, EL1050.5m and EL1046.4m. **Figure 18** shows an example of a micrograph (EL1061.9m). As a result, since cracks through the fine aggregate were observed in slices from all the elevations, it has become clear that ASR has occurred throughout the whole interior of the intake tower.

Fig. 18. Reactivity of Andesite in a micrograph (EL 1061.9m) : plane polarized light.

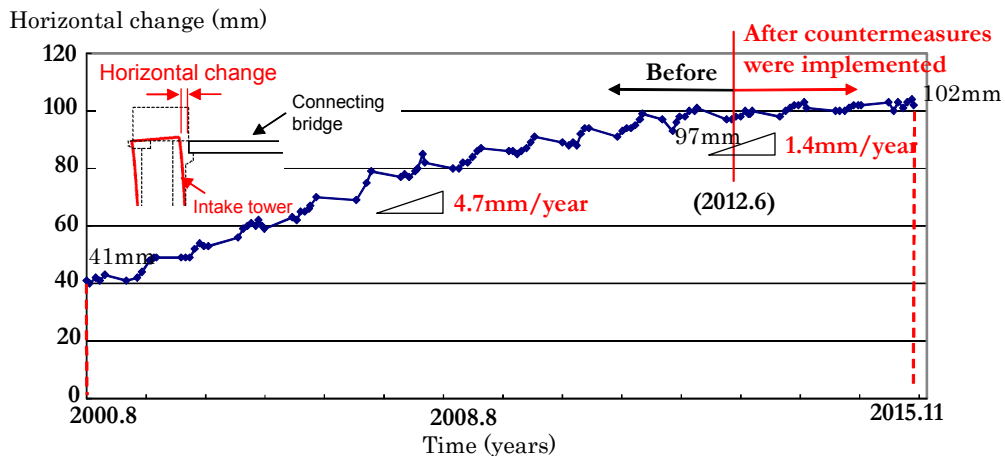
Figure 19 shows the horizontal change in distant over time at the top of the tower, and Fig. 20 shows the vertical change over time at the top of the tower, including after the countermeasure was implemented. As described above, because of the severe environmental conditions at

In these figures, if the horizontal displacement had continued to progress in the same manner as had been shown through previous measurements between June 2012 and November 2015, it is estimated that the horizontal displacement at the top of the tower should have progressed an additional 16mm. However, after countermeasures, only 5mm of further progression in the horizontal displacement were observed. Thus, we confirmed that the suppression effect of the countermeasures was the reduction of further horizontal displacement by 11mm, which corresponds to 3mm per year. In brief, horizontal changes to the top of the intake tower after the countermeasure was implemented have decreased.

Fig. 19 Horizontal change in distant over time at the top of the tower.

Please note that the primary purpose of the reinforcement is to suppress the horizontal deformation. Therefore, it can be said that the effect of the countermeasure has been confirmed.

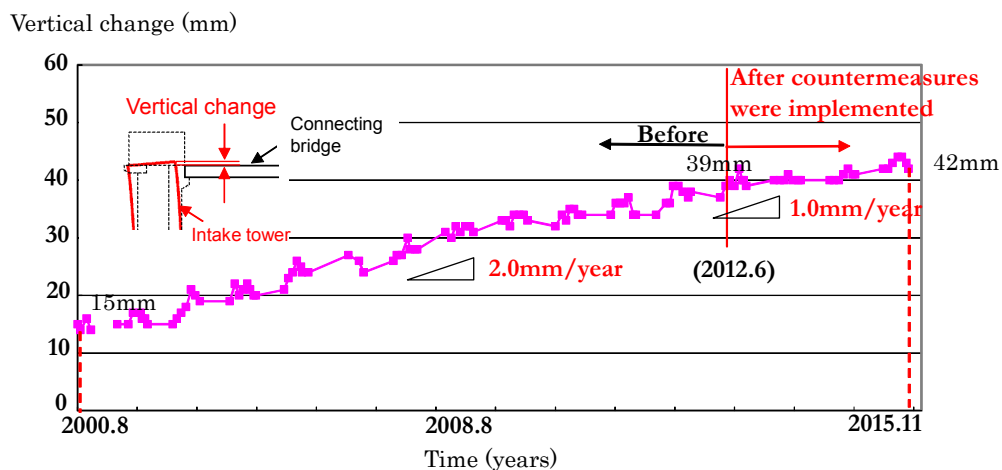
As described above, although the horizontal displacement greatly suppressed, the suppression of the vertical displacement appears to be less. Essentially the horizontal displacement is due to the difference between the vertical expansions on the mountain side and on the

Fig. 20 Vertical change in distant over time at the top of the tower.

lake side of the tower. Although the results of this reinforcement have had a small inhibiting effect on the amount of vertical displacement, the difference in vertical expansion rate between the mountain side and the lake-side of the tower has been reduced, and this has effectively suppressed the horizontal displacement.
