*Journal of Advanced Concrete Technology*, volume 11 (2017), pp. 579-594

# Effects of Fly Ash on Mechanical Properties of PC Girder Using Reactive Andesite Aggregates

Tuan Minh Ha<sup>1\*</sup>, Saiji Fukada<sup>2</sup> and Kazuyuki Torii<sup>2</sup>

## Abstract

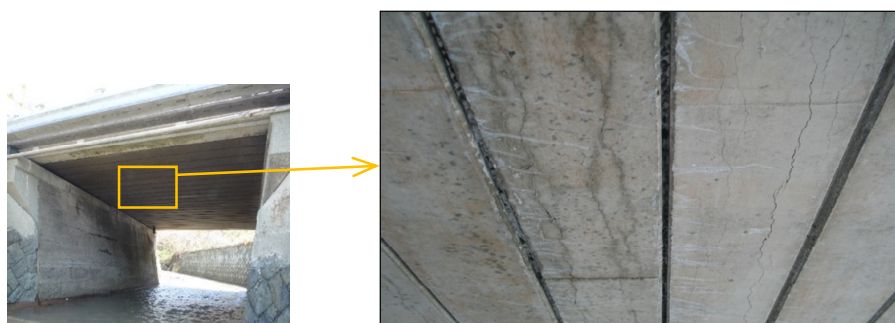
Fig. 1 Cracks occurs along with the PC strands (bottom surfaces).

In addition, for the investigation and inspection of an actual bridge in which main girders were placed side by side as shown in **Fig. 1**, concrete cores are usually taken from side surfaces which might not provide enough information about the load-carrying capacity and stiffness of the girder accurately. As the development of cracks in PC girders is also governed by the restraints of the PC strands, the mechanical properties of concrete might differ from prestressing direction (girder-axis direction) to transverse direction (Kunitomi *et al.* 2015). Therefore, it is necessary to study this anisotropy of concrete in degraded PC girders.

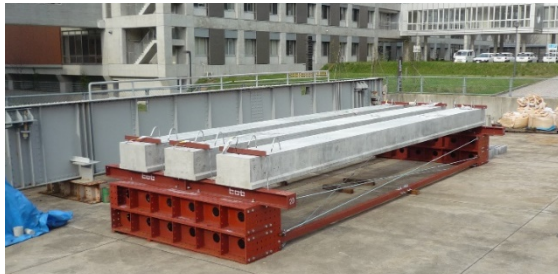
Fig. 3 Exposure condition of the PC girders at Kakuma campus.

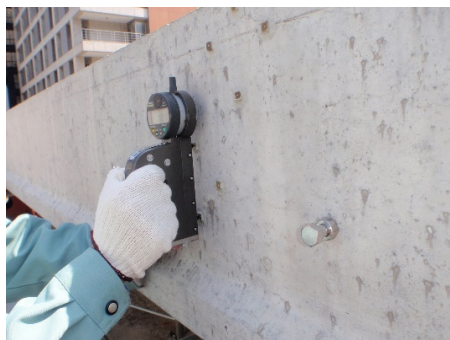
(a) Contact micron strain gauge

(b) Gauge chip setup

Fig. 8 Expansion rate measurement.

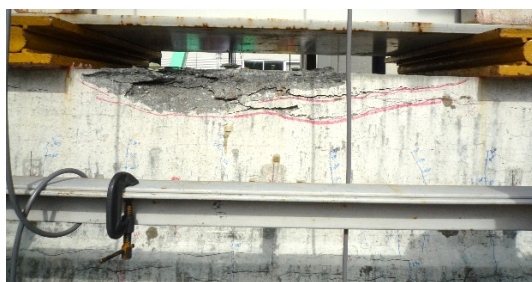
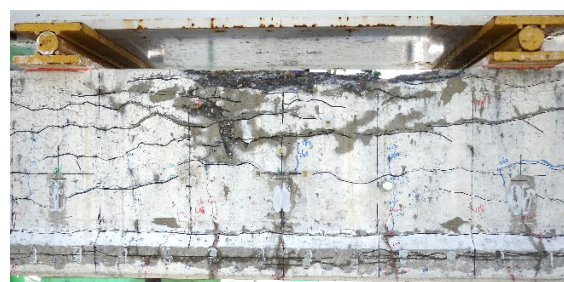
(a) FA girder

(b) H girder

Fig. 13 Compressive failure mode at the span center of girders at the final loads.

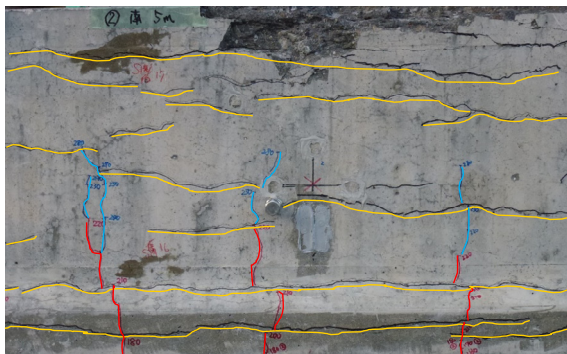
Fig. 16 Crack pattern at the span center after loading test.

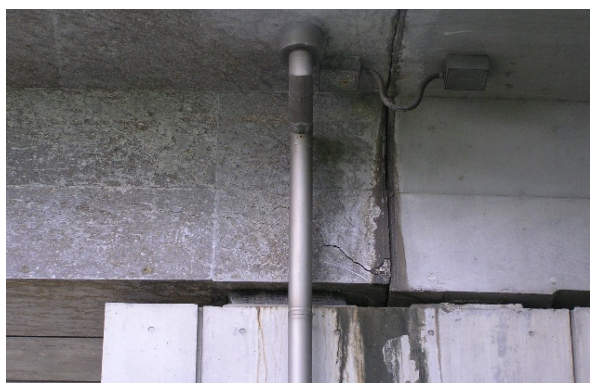
Fig. 25 Cracks occurred at the end of PC girder due to ASR-induced deformation.

Furthermore, as can be seen in **Fig. 25**, the difference in expansion rate between the upper and the lower sides of a girder induced a large deformation (upward warpage), and it might lead to new damage. Therefore, it is desirable to check the damage caused by local destruction at the girder end and by dismantling of PC anchoring parts simultaneously at the time of inspection for PC bridges. Regarding long-term prospects, further research should be carried out on the subject.
