# Structural health assessment for ASR-deteriorated PC girders using static and dynamic examinations

学位請求論文 (Dissertation)

題名 (Title) STRUCTURAL HEALTH ASSESSMENT FOR ASR-DETERIORATED PC GIRDERS USING  
STATIC AND DYNAMIC EXAMINATIONS

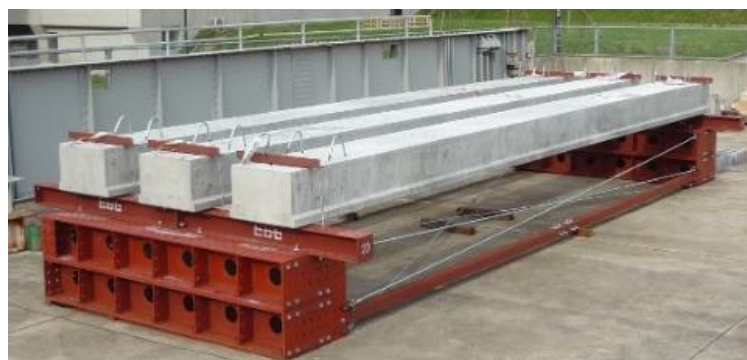
*Figure 1 Exposure condition of the PC girders at Kakuma campus*

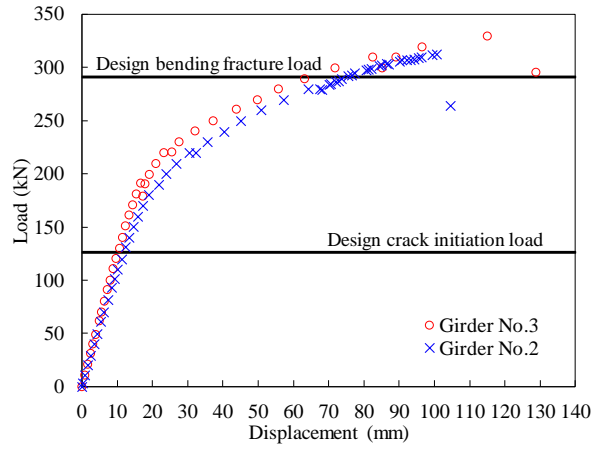
Figure 3 Load-displacement relationship at midspan.

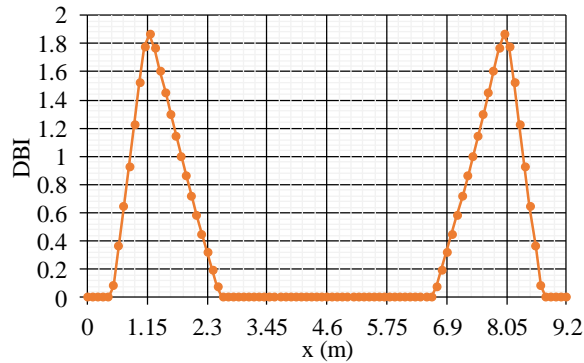
(b) Damage localization chart of Scenario 5

Figure 5 A damage scenario for the two-span continuous girder (unit: mm).

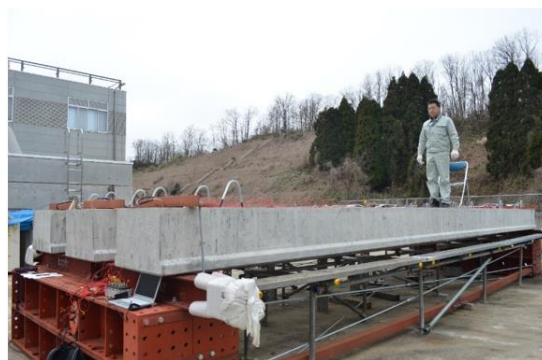
Figure 7 Impact test and sensor layout on the PC girder.

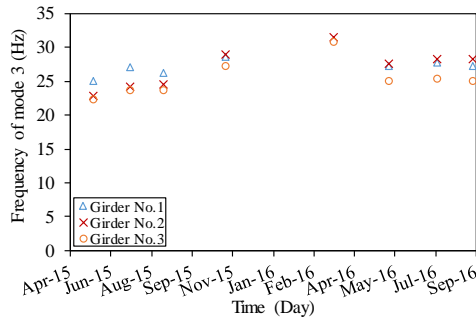
(a) The 1<sup>st</sup> bending mode (b)) The 2<sup>nd</sup> bending mode

(c) The 1<sup>st</sup> torsional mode

Figure 8 Difference in natural frequencies of three girders.

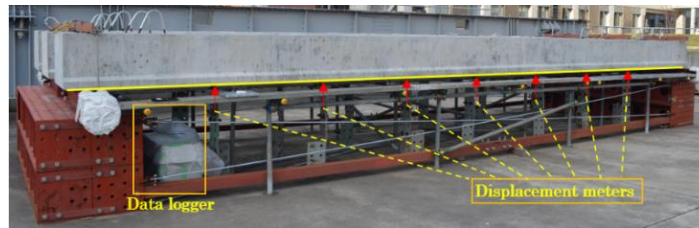
Figure 10 Experiment layout

This chapter presents the long-term camber behavior at midspan of full-scale PC girder affected by ASR considering fluctuations due to change in the ambient temperature gradient. The present study reports the camber behaviors of girders No.1 and No.3. **Figure 10** shows a graphic of the laboratory set-up used to investigate this upward movement. To obtain the temperature-induced displacements, seven displacement meters were mounted at different points under the girder with a constant interval of 1.15 m, as shown in **Fig. 11**. Moreover, the ambient temperature was recorded simultaneously during the test using a thermometer. To track the variation in camber owing to diurnal temperature, the signal was collected once automatically from the sensor every 30 minutes, 24 hours for an observation day. Seven measurements were performed from October 2015 to September 2016 in Kakuma campus with 14762 valid sets of data. The obtained data were then analyzed using linear regression models concerning the variations in measured ambient temperature. Moreover, the measured cambers were compared to predicted values obtained using finite element analysis procedures and trend line (empirical-linear). The finite element method was employed for conducting the analysis utilizing the computer code DIANA. This study presents preliminary considerations for estimating the

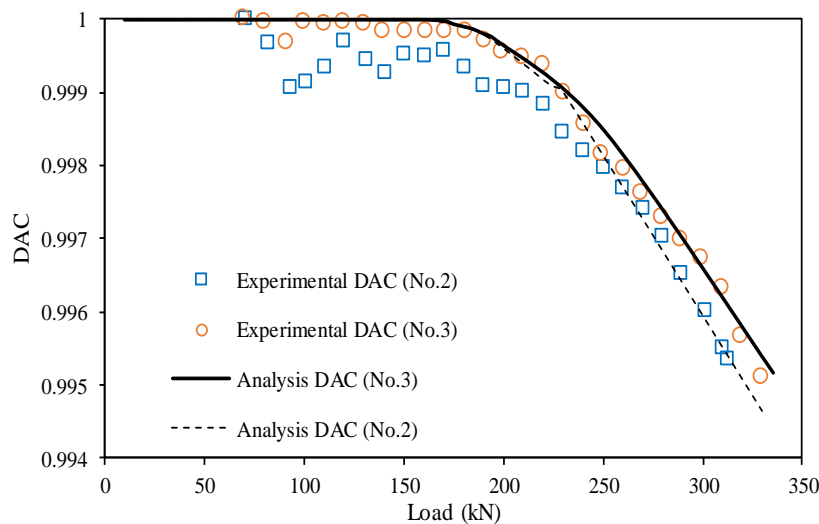
Figure 14 Variation in DAC with respect to the increased loading

The decreases in the analytical results of DAC of girders No.2 and No.3 in **Fig. 14** agreed well with the results of loading test. DAC values of girder No.3 were higher than those of girder No.2, and the deviations increased significantly with the increased loading. These results demonstrated that there was a relation between damage severity and changes in nodal displacement, represented as the DAC index. In addition, the employed approach for numerical calculation could reproduce the loading tests on the PC girder affected by ASR and provide reasonable results. From now on, by employing the DAC value obtained by the loading test as the threshold value (such as 0.9985), there is a possibility that the proposed method that can express change of displacement shape due to change of rigidity as one numerical value and find abnormal value. In the future, further studies about DAC need to be implemented in practice in order to produce the most accurate threshold value for DAC index.
