Dissertation

STRUCTURAL HEALTH ASSESSMENT
FOR ASR-DETERIORATED PC GIRDERS
USING STATIC AND DYNAMIC EXAMINATIONS

Graduate School of
Natural Science & Technology
Kanazawa University

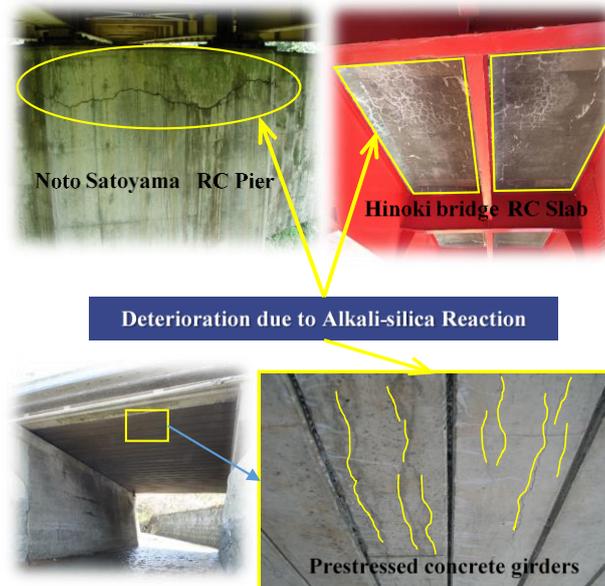
Figure 1.1 ASR Deterioration in the Hokuriku region, Japan

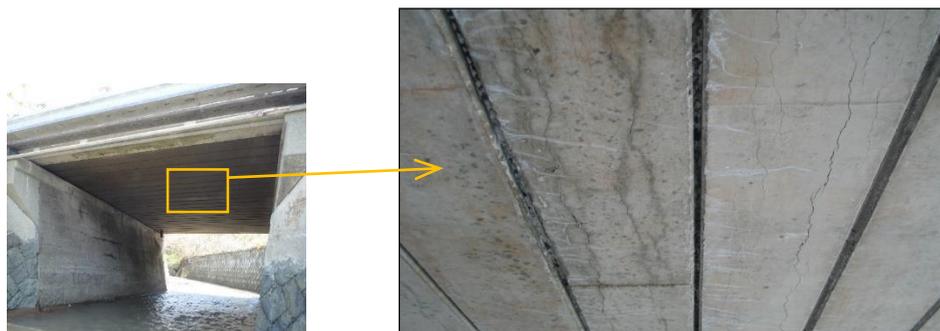
Figure 2.1 Cracks occurs along with the PC strands (bottom surfaces).

In addition, for the investigation and inspection of an actual bridge in which main girders were placed side by side as shown in **Fig. 2.1**, concrete cores are usually taken from side surfaces which might not provide enough information about the load-carrying capacity and stiffness of the girder accurately. As the development of cracks in PC girders is also governed by the restraints of the PC strands, the mechanical properties of concrete might differ from prestressing direction (girder-axis direction) to transverse direction [20]. Therefore, it is necessary to study this anisotropy of concrete in degraded PC girders.

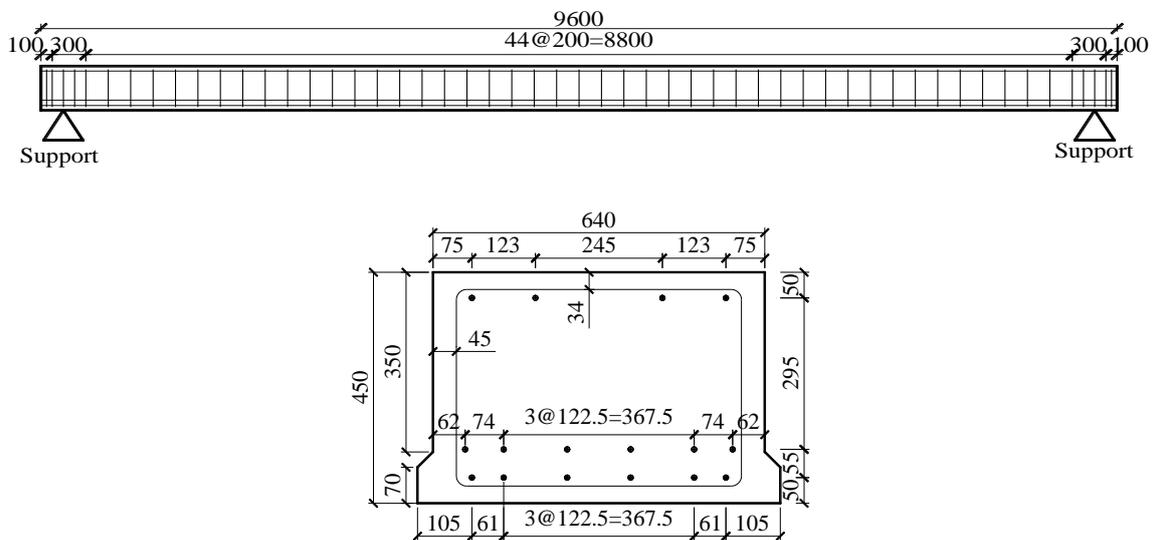
Figure 2.2 Diagram of PC girders (unit: mm).

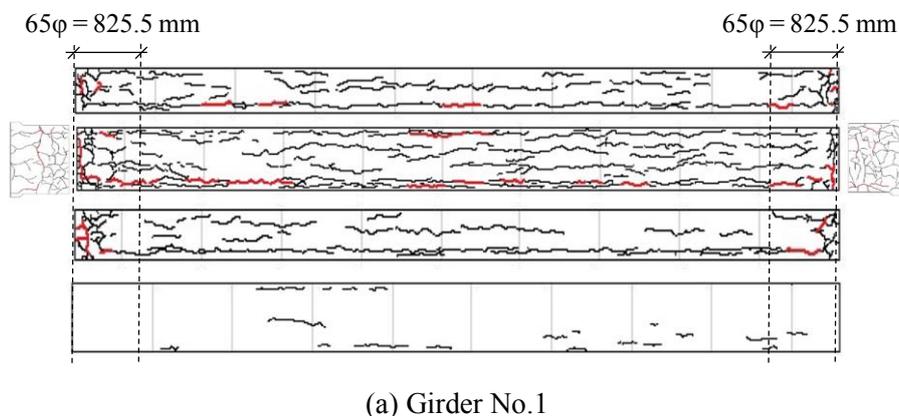
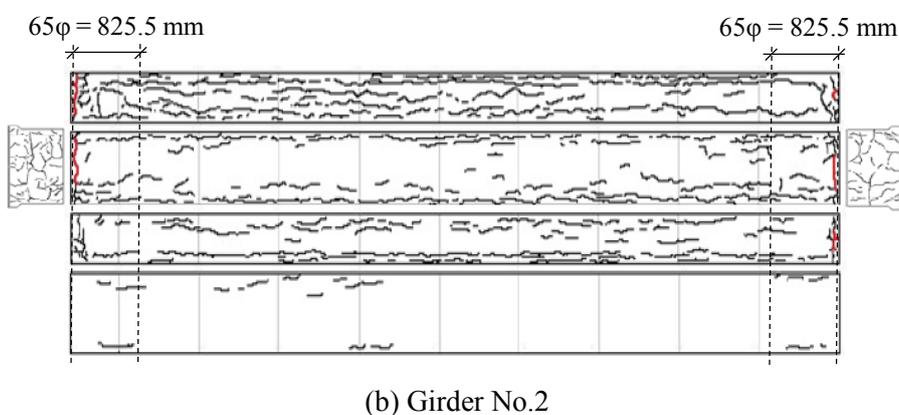
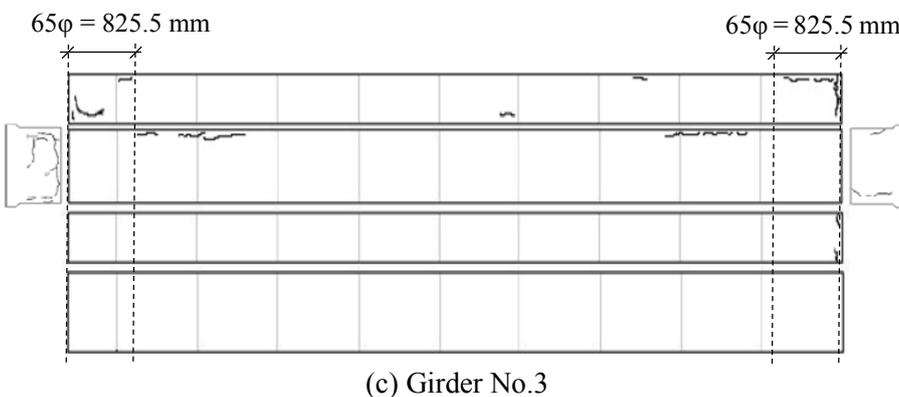
Figure 2.4 Crack patterns of the three girders (From top to down: north side surface, top surface and both surfaces near both ends, south side surface and bottom surface) and the adhesion transmission length of tendons (approximately 825.5 mm) (unit: mm).

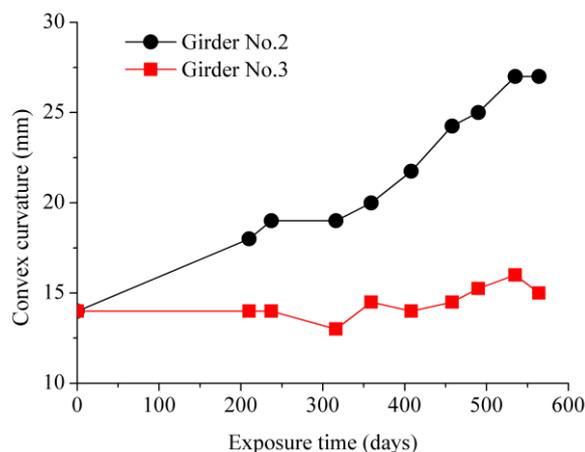
Figure 2.5 Changes in the convex curvature.

Figure 2.5 shows changes in convex curvature (upward vertical deflection) in the middle of the span of girders No.2 and No.3 during the exposure period, which was measured by stretching a leveling string (**Fig. 2.6**) between both ends. As regards girder No.2, the convex displacement increased up to approximately 13 mm before starting the load test. Meanwhile, almost no variation of the convex curvature over time was observed in girder No.3 mixed with fly ash. This monitoring result was also confirmed by previous researches [20,36]. Based on monitoring development of cracks in girder No.2, this study considered that ASR was accelerated by the penetration of water and the insolation. Because the top surface and both side surfaces were directly exposed to the sun, they suffered higher influences of solar radiation and rain than the bottom surface. Consequently, there were differences in ASR-induced expansion ratio of concrete between surfaces. Changes in the expansion ratio during the follow-up period of both girders are discussed in the following section. In addition, regarding the detail of PC strands, four strands were put as the first layer in the compression area while the other two layers consisted six strands in each were arranged in the tension area, as indicated in **Fig. 2.2**. Therefore, the upward curvature was generated not only by the difference in expansion amount but also by the difference in the tensioning forces of the PC strands between the upper and the lower concrete parts.

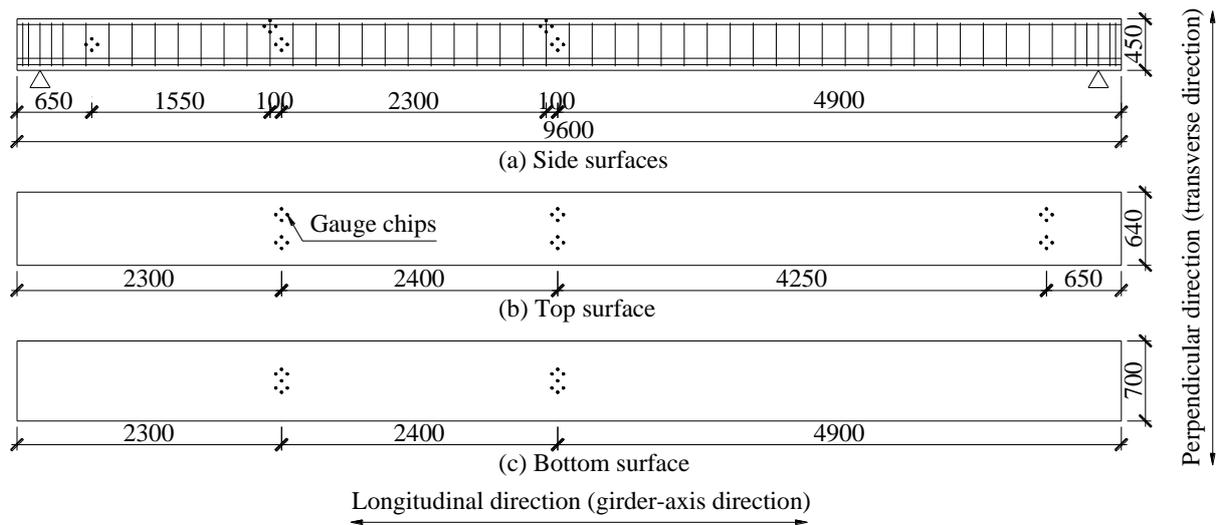
Figure 2.7 Measurement locations (unit: mm).

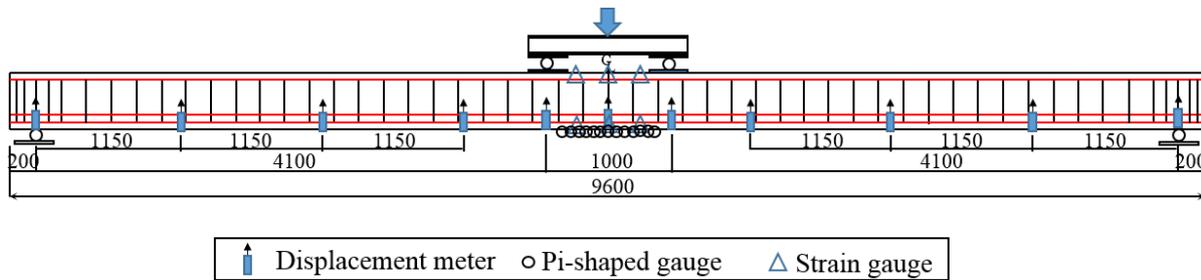
Figure 2.11 Overview of loading test setup (unit: mm).

Regarding the test setup, as shown in **Fig. 2.11**, each specimen with a span length of 9200 mm was subjected to the four-point bending test in which loads were applied at two points in the middle of the span. The testing girder was simply supported by two round steel bars. In addition, measurement items were load, deflection (vertical direction), crack development (girder axis direction) and concrete surface strain. The arrangement of measurement points is also summarized in this figure.

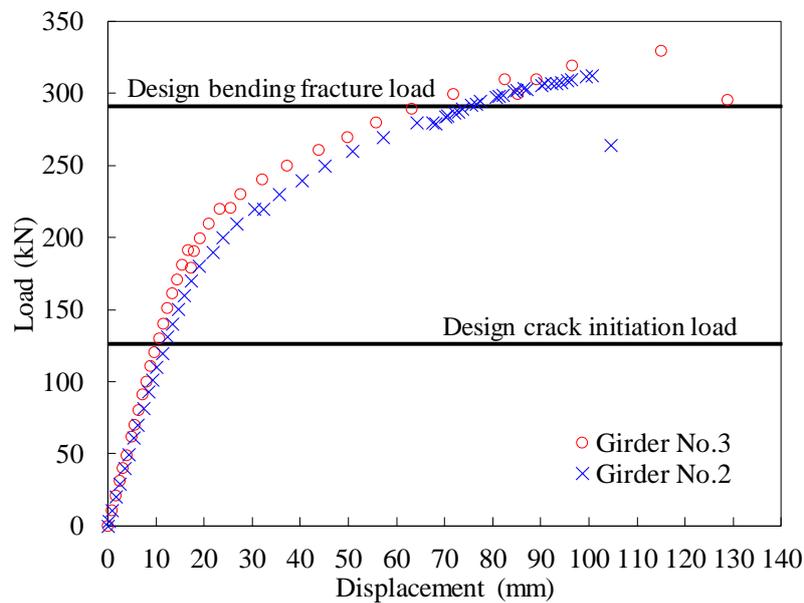
Figure 2.12 Load-displacement relationship at midspan.

and No.3 were calculated as 11.5 kN/mm and 12.8 kN/mm when the applied load reached 50 kN, respectively. As the results of the loading tests, the final load of girders No.2 and No.3 were recorded as ~312 kN and ~330 kN, respectively, which causing failure in the upper extreme fiber of concrete as showed in **Fig. 2.13(a)–(b)**. Therefore, the load-carrying capacity of the girder without fly ash (No.2) was smaller by about 5% than that of the girder with fly ash (No.3). Compared to the specimen mixed with fly ash, the toughness of girder No.2 was deteriorated by the influence of ASR. This 5% reduction in the loading capacity is consistent with results of previous studies conducted in actual bridges [32,37]. However, a prior research of Onozato et al. [36] proved that the flexural strength did not decrease because the expansion of ASR was restrained by prestressing force. This outcome was not confirmed in the present study.

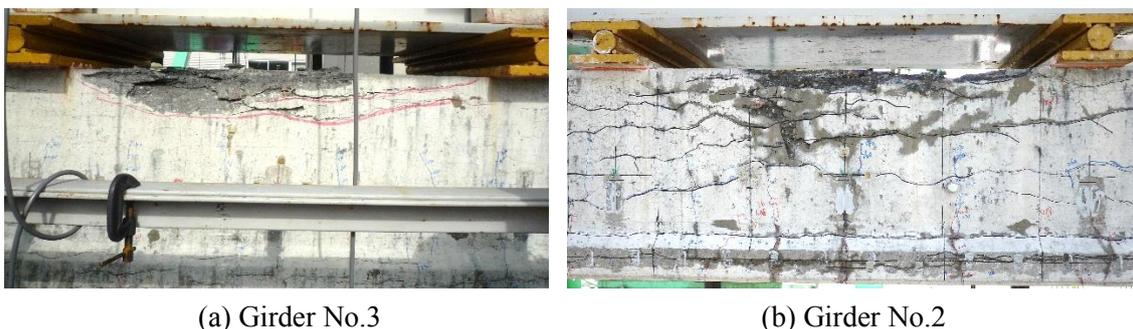
Figure 2.13 Compressive failure mode at the span center of girders at the final loads.

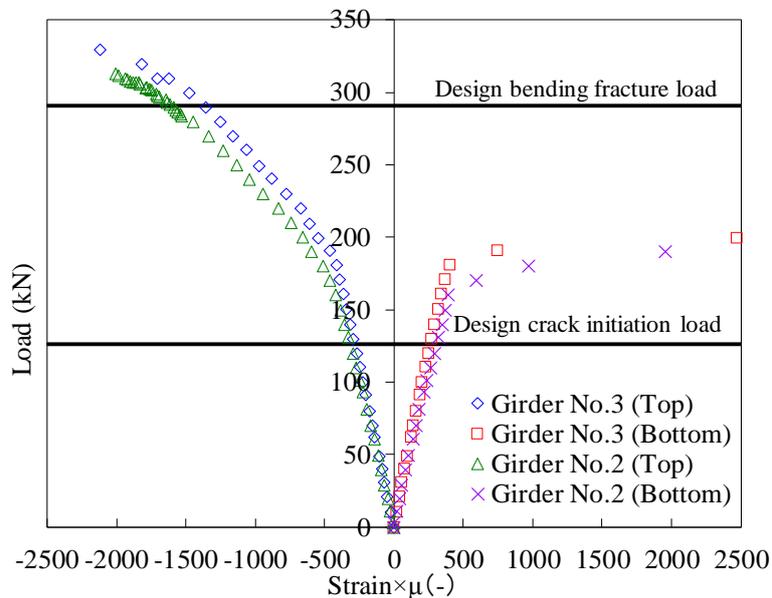
Figure 2.14 Load-strain relationship.

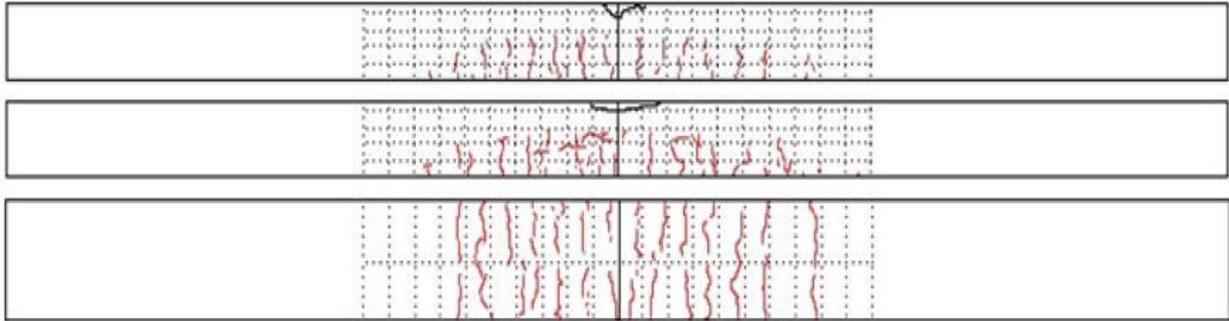
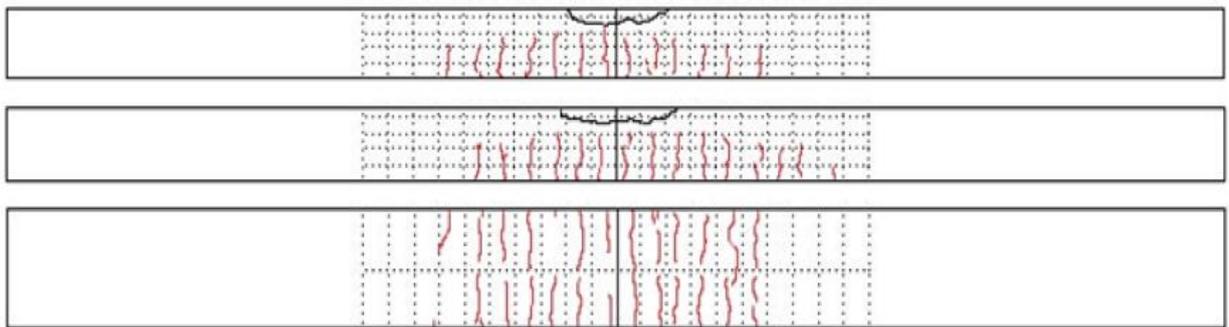
Figure 2.15 Crack pattern due to loading test (from top to down: north-side, south-side and bottom surfaces).

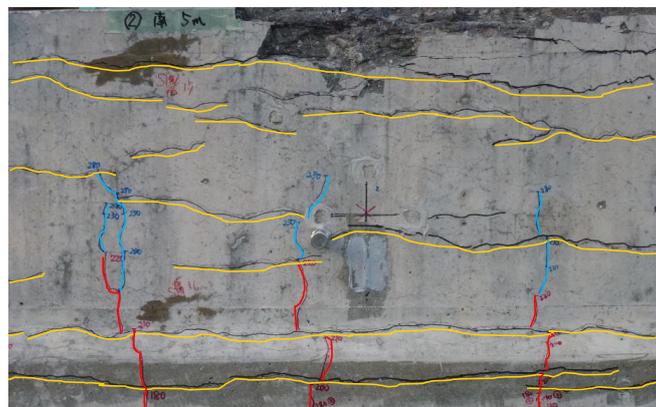
Figure 2.16 Crack pattern at the span center after loading test.

of girder No.2, vertical cracks owing to applied loads did not continuously propagate upward (**Fig. 2.16**). Therefore, it was thought that longitudinal cracks interrupted the development of bending cracks. However, an investigation of cut cross sections, which is described in the next section, shown that due to the shallow depth, longitudinal cracks could not hinder the progress of bending cracks.

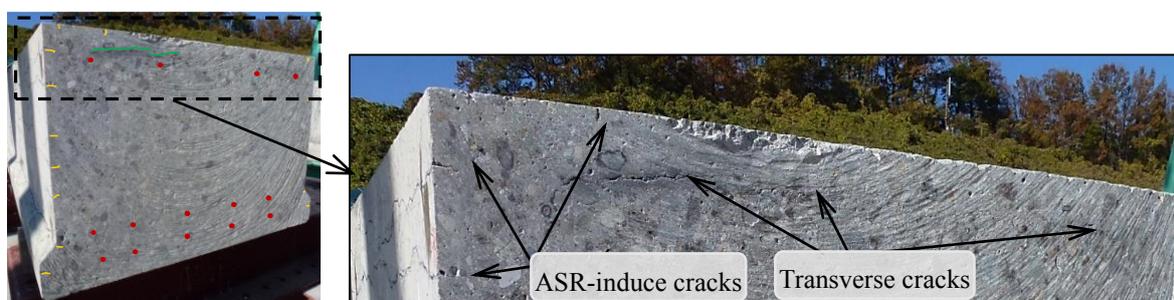
Figure 2.17 A cut cross-sectional view of girder No.2.

To evaluate the condition of inner surfaces after the load test, each girder was cut into three pieces with lengths of 3150 mm, 3300 mm and 3150 mm by a wire saw. **Figure 2.17** shows a cut surface of girder No.2 between its support and the span center. In this figure, yellow lines show ASR-induced cracks, and green lines show transverse cracks observed on the upper side of tendons in the compression area. Red dots indicate PC strands. From observation results, the depth of ASR-induced cracks along the girder-axis direction varied from 5 to 20 mm on the side surfaces and the top surface, whereas no crack was found out in the area surrounded by stirrups. Moreover, no breaking of tendons was confirmed, whereas transverse cracks were significantly observed on the upper side of tendons in the compression area. After the bending test, for ascertaining the corrosion condition of PC strands, peeled concrete areas of both samples were taken away. However, no steel corrosion could be observed.

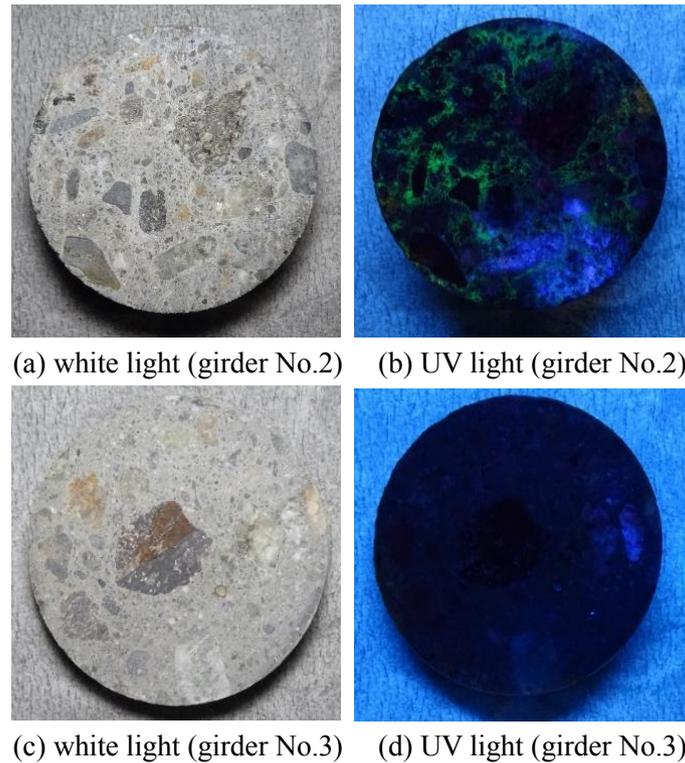
Figure 2.19 Observation results of concrete cores by gel fluorescence method.

Figure 2.19(a)–(d) indicates observation results of concrete cores of both girders obtained by the fluorescent method. The tested cores were the upper cores taken longitudinally in the central parts of the girders. As the results, regarding the specimen of girder No.2, the ASR gel under UV light appeared as yellow-green around andesite particles. However, no fluorescence was observed on samples taken from girder No.3. In addition, **Figure 2.20** shows observation results by a polarized microscope. Regarding girder No.2, andesite particles from sand and gravel of the Jogajji River reacted strongly, and many fine cracks (about 0.02 mm in width) occurred from broken pieces of aggregates to cement paste. Conversely, andesite particles reacted slightly while no trace of ASR was observed with respect to girder No.3 with fly ash. In both girders, no formation of ASR gel was found in the surface layer (about 20 mm) of both specimens. It was inferred that ASR was suppressed in the surface layer of concrete due to alkali outward flow and immobilization under alternation of drying and moistening processes [43].

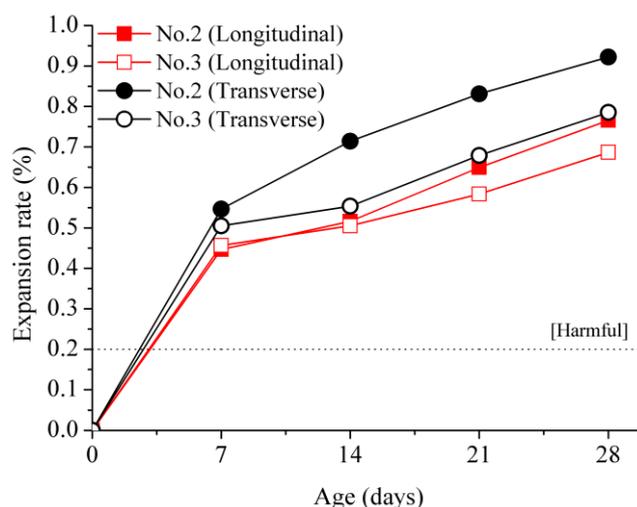
Figure 2.21 Expansion rate of cores.

Fig. 2.21, the expansion rate of girder No.2 in the transverse direction was higher than in the longitudinal direction. This result is considered to be influenced by the difference in generation degree of fine cracks due to the collecting direction and the influence of restraint of PC tendons, that is to say, by the difference in the permeability of NaOH solution at the time of the test. The effects of the confinement degree due to prestressing on mechanical properties of concrete are discussed in the next section. Regarding a reference threshold value of hydroxide ion (OH^-) concentration in a pore solution for ASR initiation, Diamond [44] proposed a value of 250 mmol/l (0.25 N), which was also confirmed and evaluated by other researchers [45–48]. Therefore, it can be considered that unreacted other particles also reacted and thereby accelerated ASR when the concrete cores were soaking in 1N NaOH solution. This conclusion is useful in diagnosing ASR deterioration of core utilizing the immersion method in 1N NaOH solution at 80 °C. Meanwhile, regarding girder No.3, because of a slight generation of ASR, together with a low penetration of alkaline solutions, and an additional effect of alkaline adsorption of CSH with a low C/S ratio generated during pozzolan reaction, the measured expansion rate was remarkably lower than that of girder No.2.

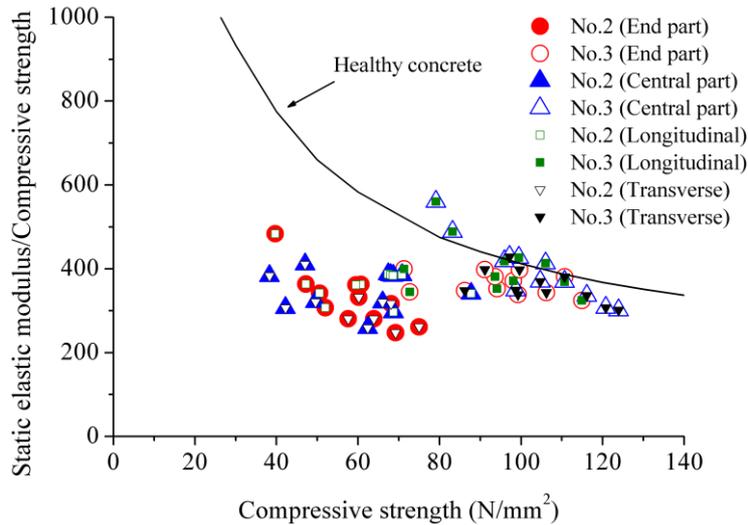
Figure 2.22 Relationship between compressive strength and static elastic modulus/compressive strength ratio.

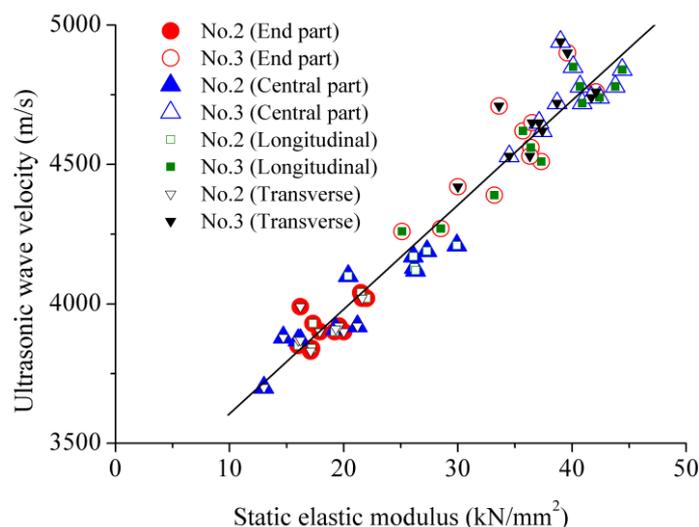
Figure 2.24 Relationship between static elastic modulus of core and ultrasonic propagation velocity.

concrete cores, respectively. Because ultrasonic wave propagation can be easily measured on site, it is commonly used in structural health evaluation. As can be seen in **Figs. 2.23 to 2.24**, along with the ASR progression, the compressive strength and the static elastic modulus decrease linearly, and both parameters have a substantially proportional relationship to the ultrasonic wave velocity.

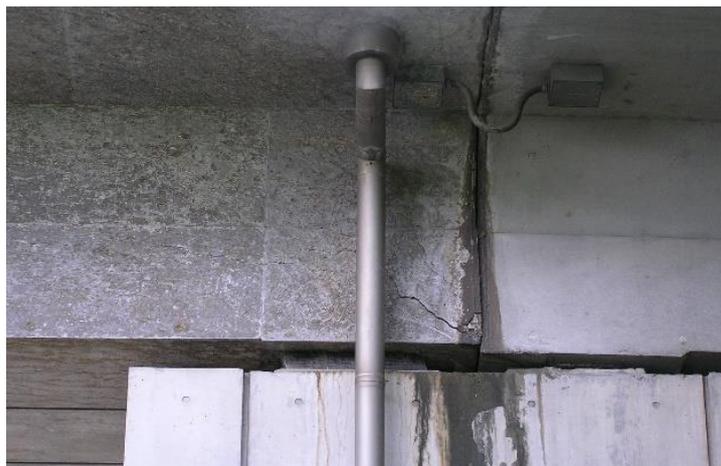
Figure 2.25 Cracks occurred at the end of PC girder due to ASR-induced deformation.

Furthermore, as can be seen in **Fig. 2.25**, the difference in expansion rate between the upper and the lower sides of a girder induced a large deformation (upward warpage), and it might lead to new damage. Therefore, it is desirable to check the damage caused by local destruction at the girder end and by dismantling of PC anchoring parts simultaneously at the time of inspection for PC bridges. Regarding long-term prospects, further research should be carried out on the subject.

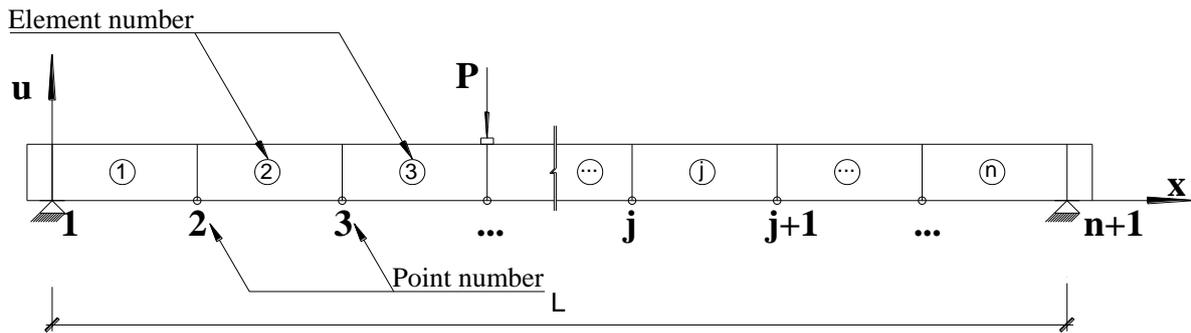
Figure 3.1 Girder's segments and measuring positions

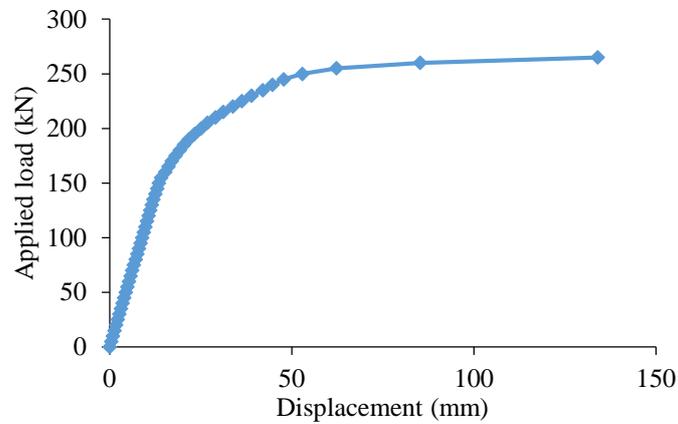
Figure 3.5 Relationship between load and displacement

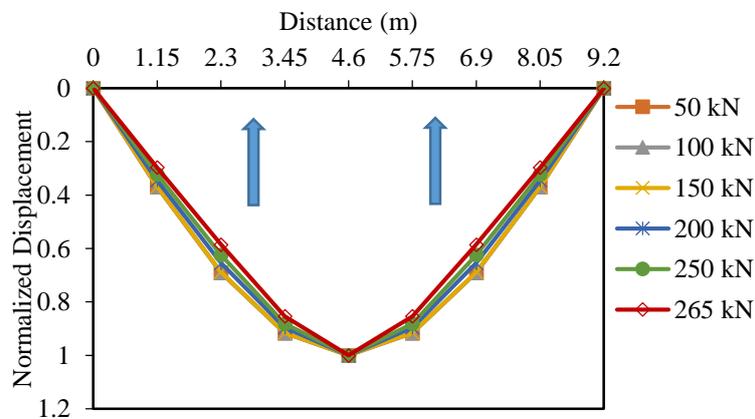
Figure 3.7 Normalized displacement at some load cases

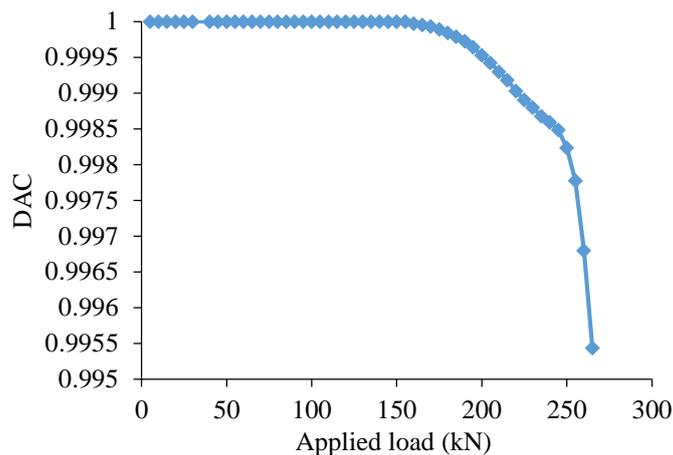
Figure 3.8 Decrease of DAC with the increasing of applied load

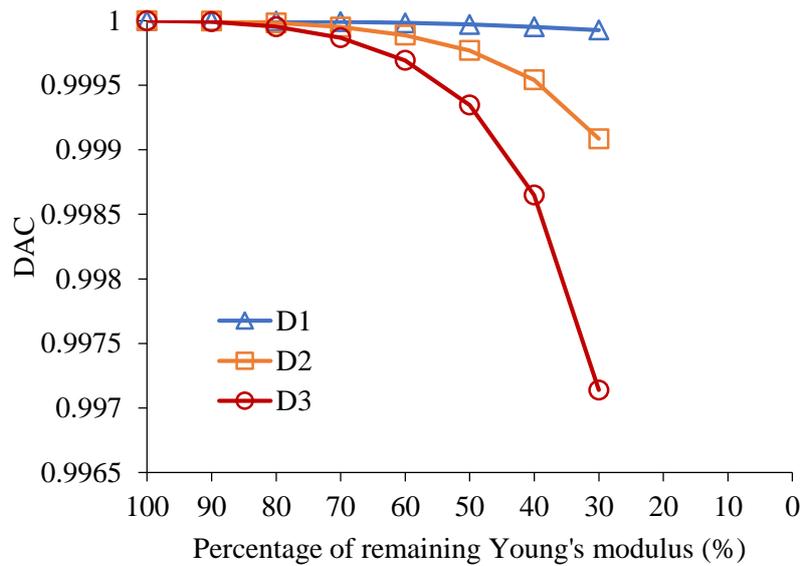
Figure 3.10 Sensitive of DAC on the damage detection

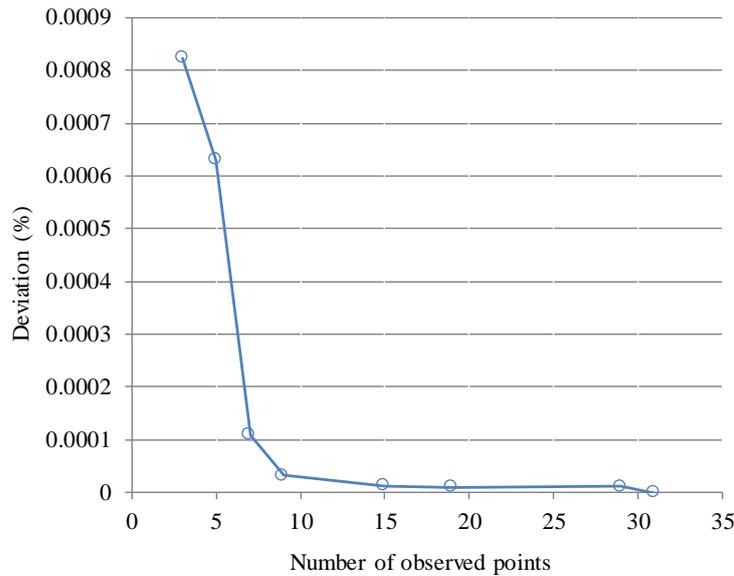
Figure 3.12 Effect of the number of measurements upon DAC coefficient

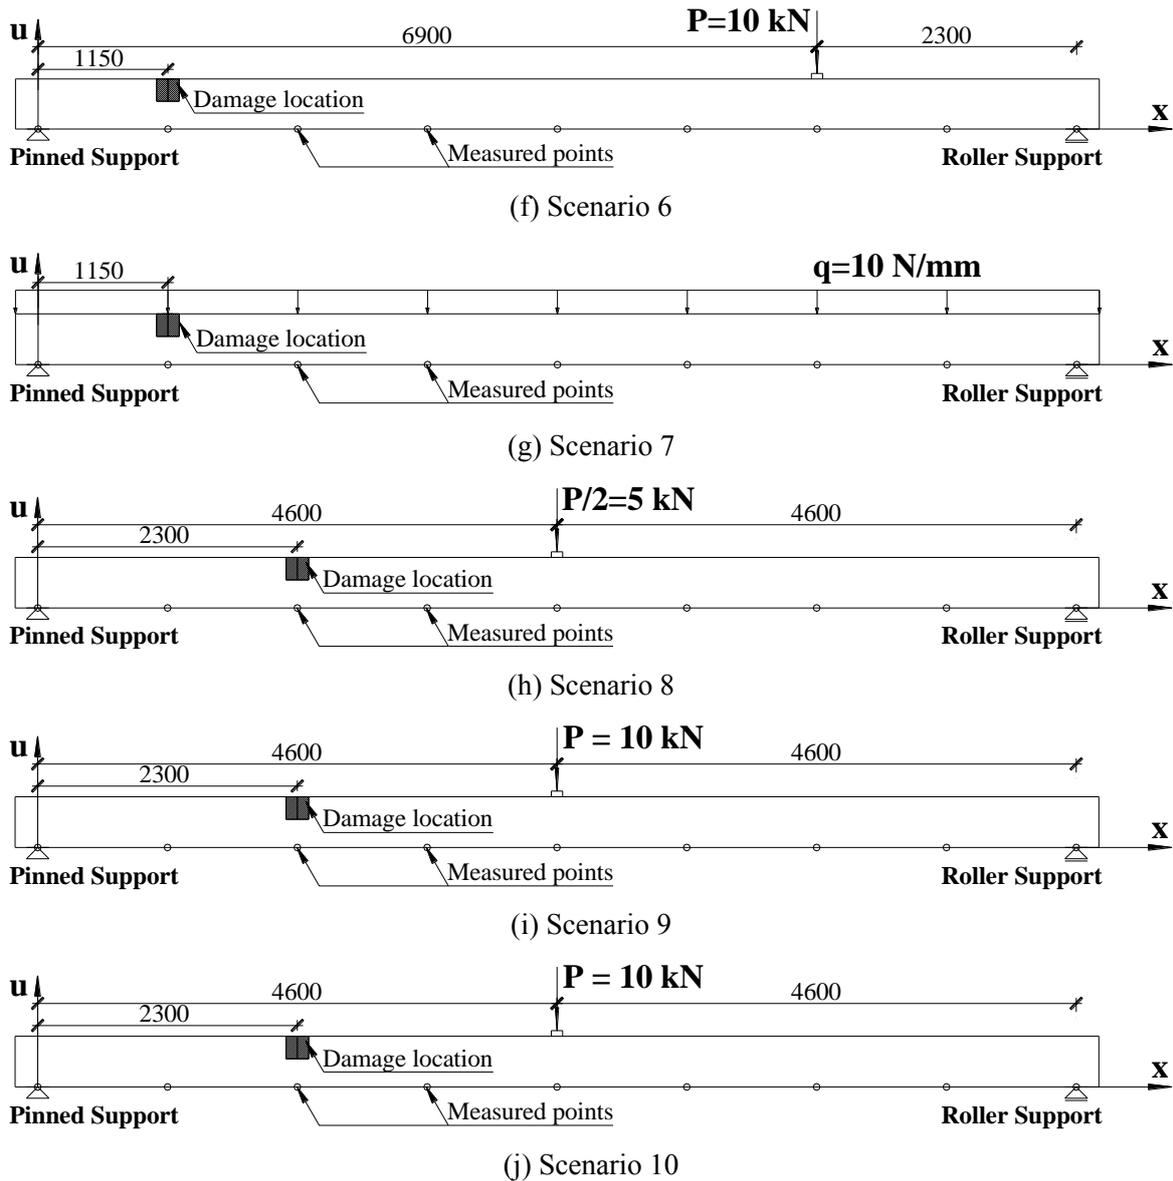
Figure 3.13 Ten different damage scenarios for the simply supported girder (unit: mm).

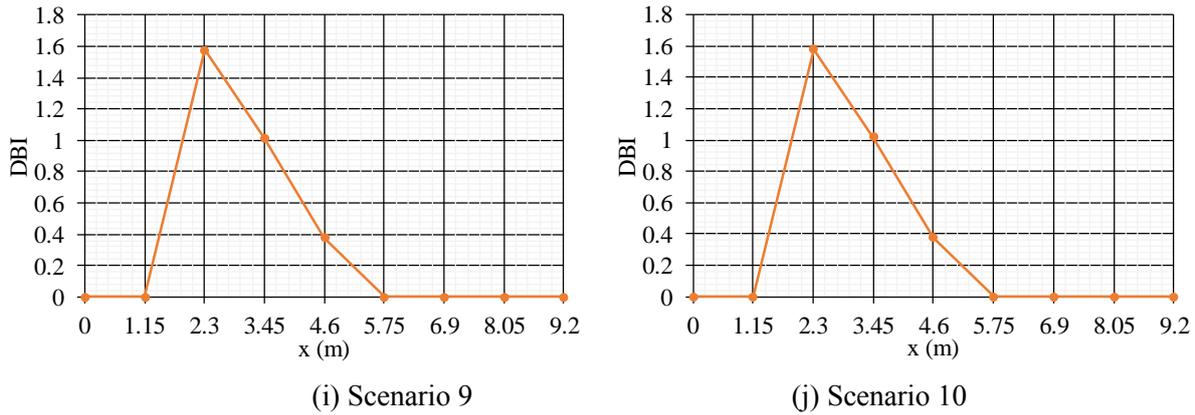
Figure 3.14 Damage localization for ten different damage scenarios of the simply supported girder.

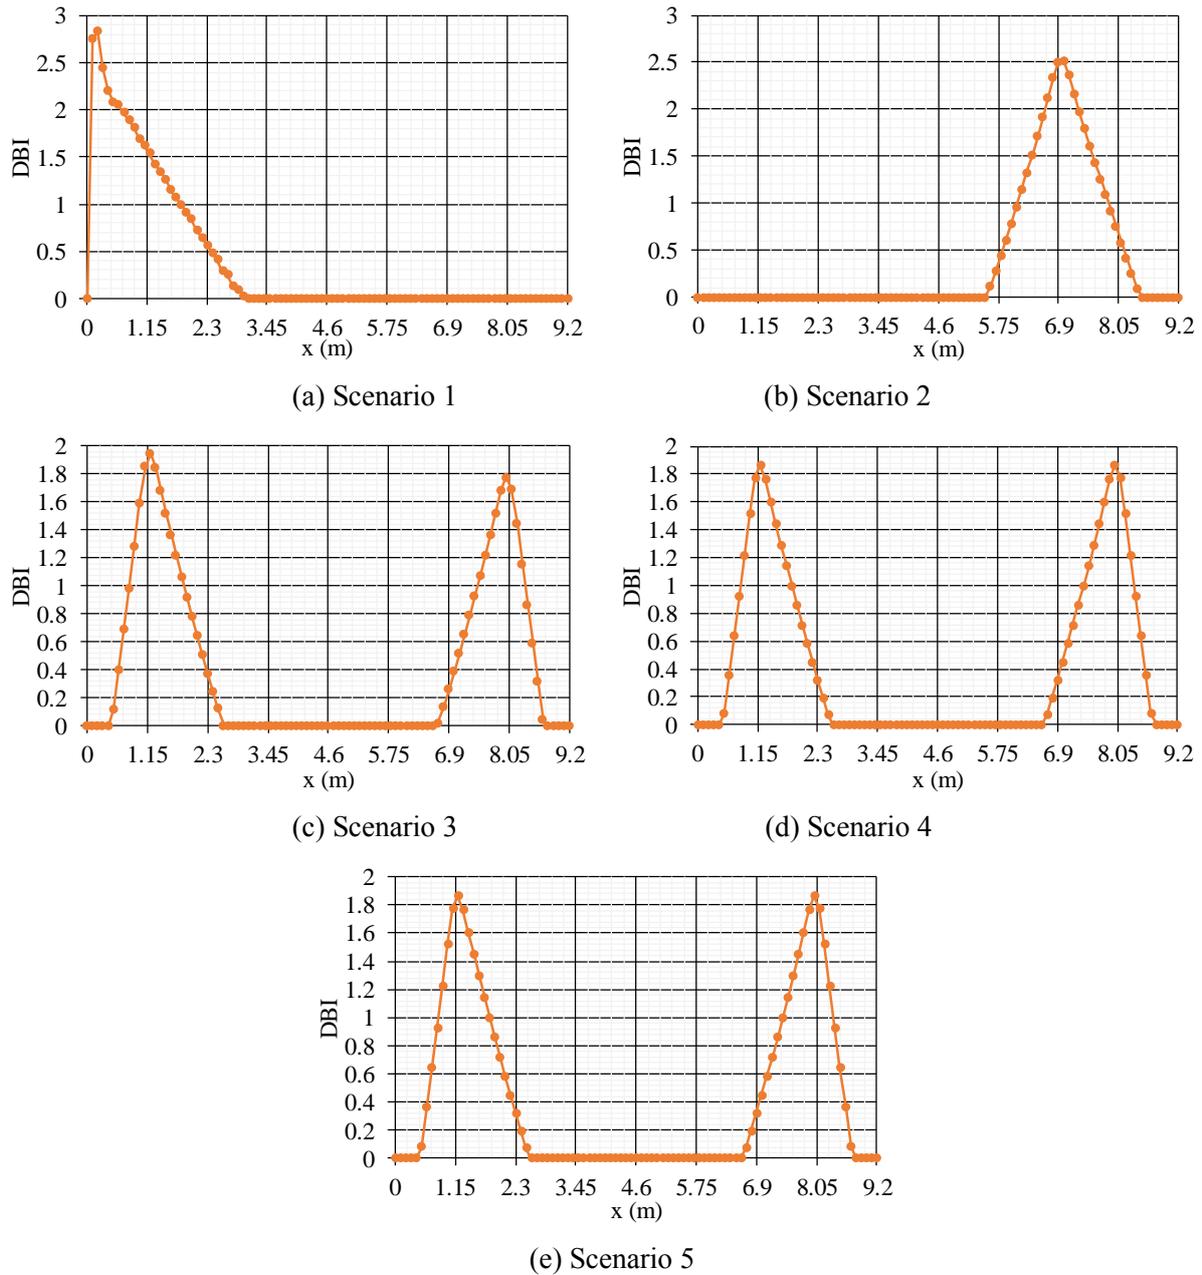
Figure 3.17 Damage localization for five different damage scenarios of the two-span continuous girder.

As mentioned earlier, the first two scenarios of damage represent single damage with different locations, whereas Scenarios 3–5 are studied to show the capability of the proposed algorithm to pinpoint multiple damage using different cases of loading. The DBI values for the differences in nodal displacement between the intact and the deteriorated girder under five scenarios of damage are sketched in **Fig. 3.17(a)–(e)**. As can be seen in these figures, the DBI values develop considerable peaks at some positions of damage. In particular, Scenarios 1 and 2 show similar damage localized on the pin-roller supported and the roller–roller supported parts, respectively. The results described in **Fig. 3.17(a) and 3.17(b)** show that the damage can be localized even if the applied load is on a different portion. In regard to multiple damage identification, **Fig. 3.17(c)–(e)** presents the assessment results for dual damage scenarios ($x = 1200\text{ mm}$ and $x = 8000\text{ mm}$) of the target girder subjected to loading Cases 1, 2, and 3, respectively. As can be seen in these figures, the DBI values at the deteriorated positions form significant peaks, while the values of the other elements remain unchanged as zero. The results show that the locations of damage, which are illustrated by the two peaks, are accurately identified in the three loading circumstances of this example. Because all damages are successfully recognized as significant peaks in these figures, it can be stated that the DBI approach can accurately locate different damage characteristics. Therefore, the applicability of the proposed method for damage detection is confirmed in the statically indeterminate case.

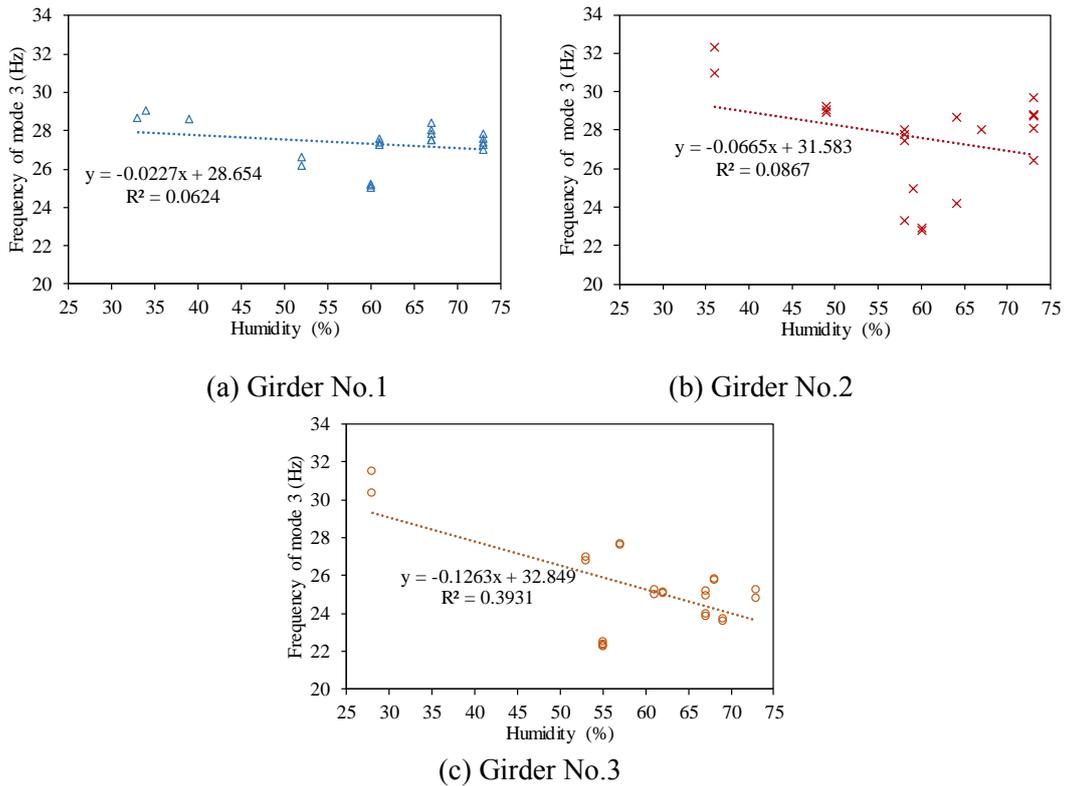
Figure 4.9 Relation of frequencies of mode 3 to humidity.

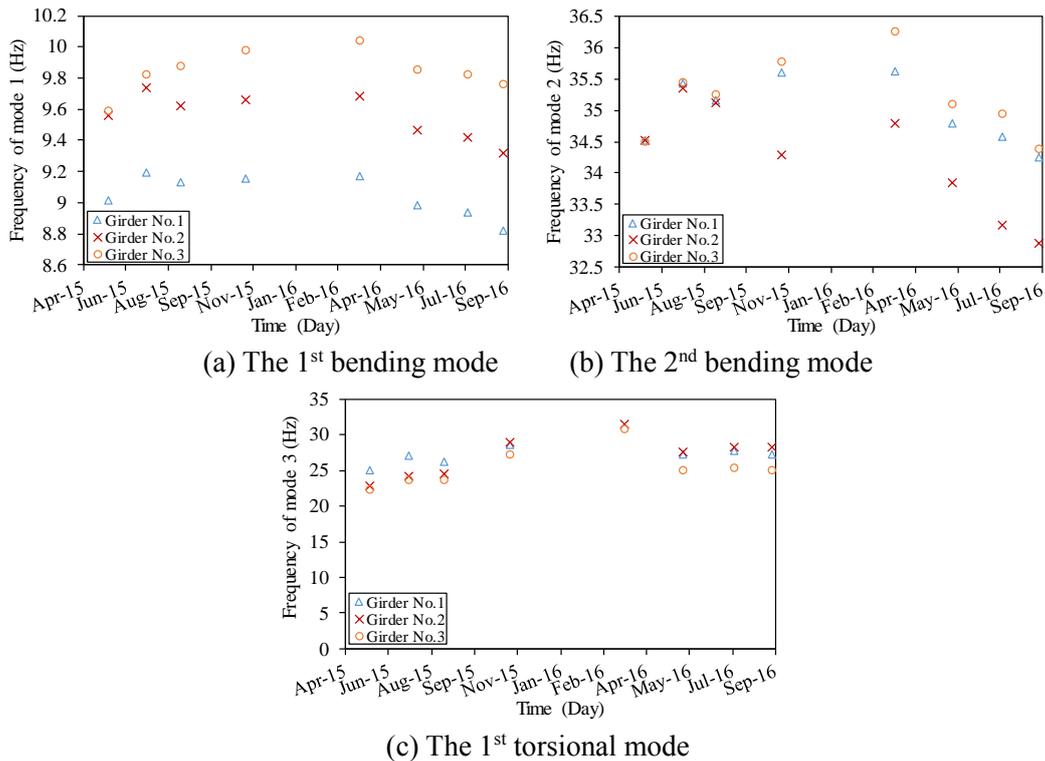
Figure 4.10 Difference in natural frequencies of three girders.

effects. Within one and a half years of investigation, as the ambient temperature and humidity varied by approximately 21.55 °C and 45%, respectively, the bending modal frequencies of girder No.3 varied in the range of ~3–5%, which is considerable compared to those due to the structural damage. Hence, the effects of the environmental conditions should be considered carefully when using the variation in the vibrational frequency to evaluate the health of structures.

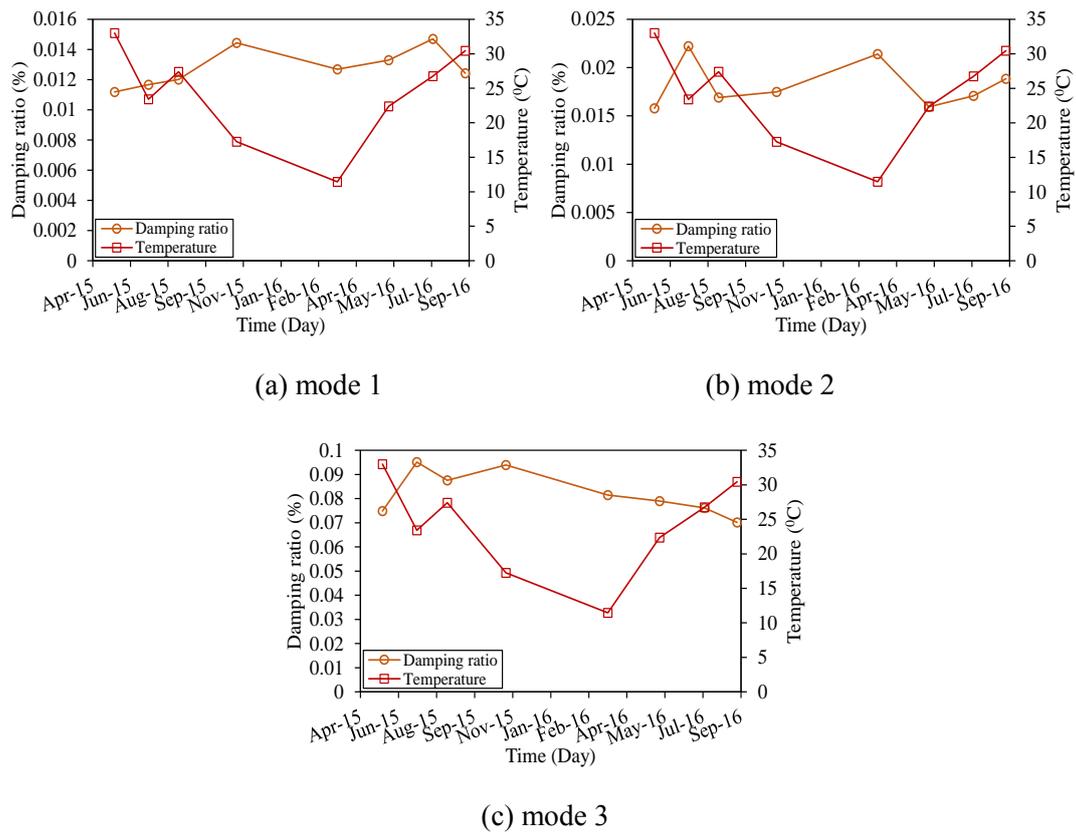
Figure 4.13 Variations in average damping ratios of girder No.3 over one and a half years.

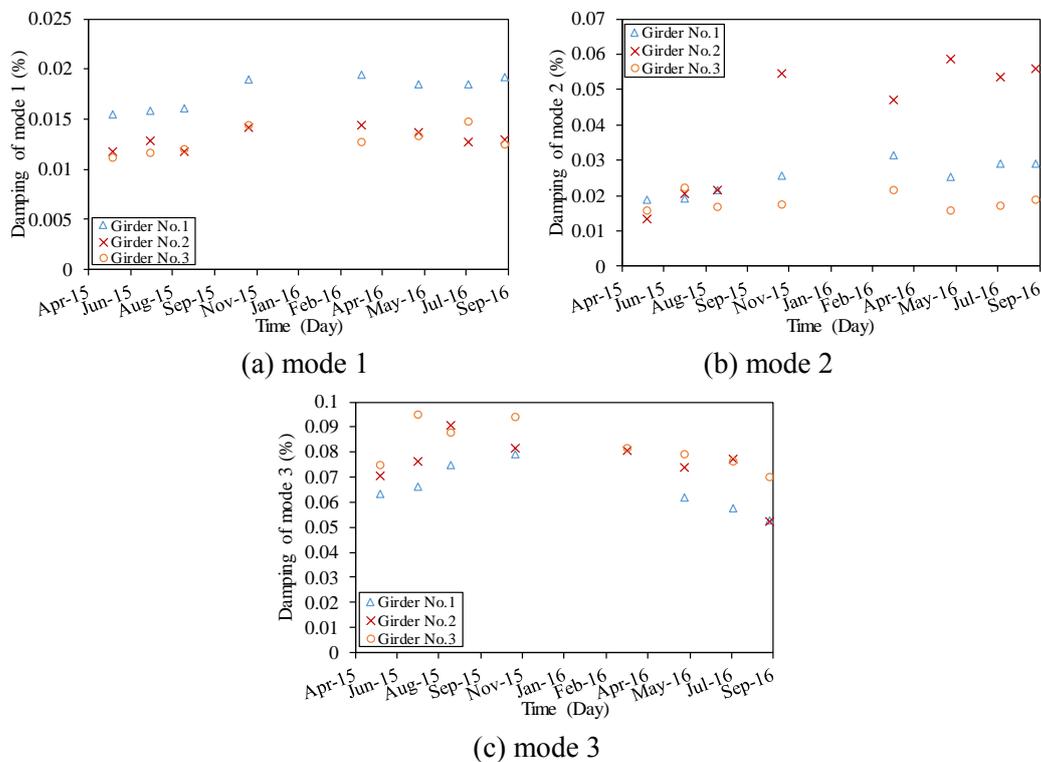
Figure 4.14 Difference in damping ratios of three girders.

wherein the difference in the amplitude was insignificant, the damping ratios of the other modes changed considerably, representing the difference between the girders. With regard to the damping of the first bending mode (mode 1), all the identified values of girder No.1 were clearly higher than that of girders No.2 and No.3, which were similar in terms of the amplitude. With regard to the second bending mode (mode 2), the damping ratios of the three girders were largely equal at the three initial measurements. The differences became apparent since November 2015. From the data of September 2016, the average damping ratios of the girders No.2 and No.1 were approximately 2 and 1.5 times, respectively, greater than the identified value of girder No.3. As the correlations with the changes in the ambient environmental parameters were low, the difference in the damping coefficients in the two bending modes of the three girders was probably due to the increase in the longitudinal crack propagation due to the ASR-induced expansion, which led to the increase in the number of plastic zones in girders No.1 and No.2.

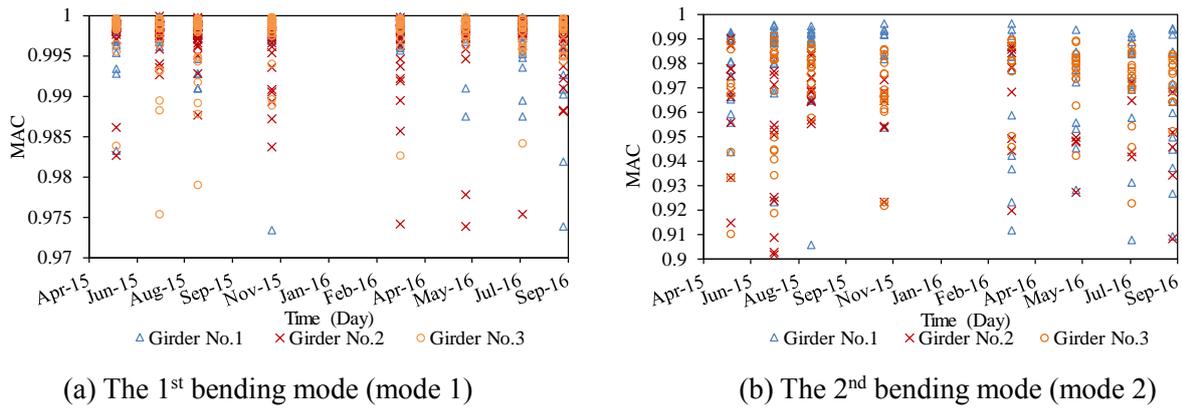
Figure 4.18 Time histories of MAC values for three girders.

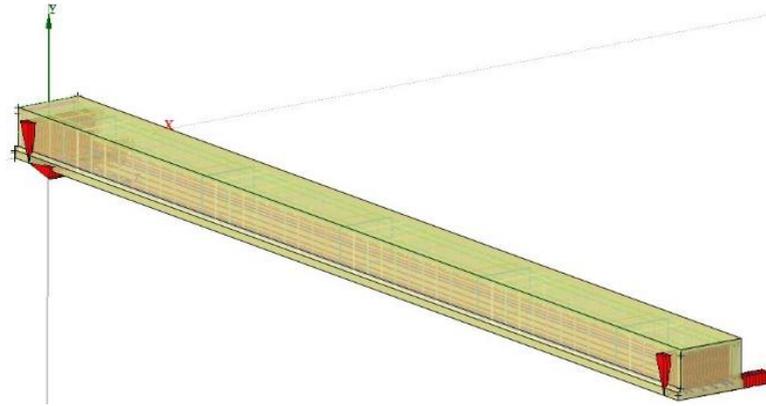
Figure 4.19 A 3D model of the PC girder.

To evaluate the accuracy of the measurement, a three-dimensional (3D) model was produced using FX+ for DIANA, which is a commercially available program for FE analysis. The properties and boundary conditions of the numerical model were the same as those of the actual PC girder. **Figure 4.19** shows the diagram of a 3D model used for the eigenvalue structural analysis in DIANA [25]. The objective model was a PC girder supported by two points with a span length of 9200 mm. As a PC girder, it contained 16 PC steel strands (SWPR7BL1S 12.7 mm). The strands had D10-type stirrups arranged around them. The PC strands and stirrups were modeled as bars in the beam elements. The bonding forces between the concrete and strands were assumed complete. **Table 4.12** lists the parameters of the concrete for the analysis. Moreover, the stirrups were assumed as linear elastic materials with a Young's modulus $E_s = 210000 \text{ N/mm}^2$ and Poisson's ratio $\nu = 0.3$. Moreover, the PC steel material was considered made of steel with Young's modulus $E_s = 210000 \text{ N/mm}^2$ and Von Mises yield stress $\sigma_y = 1580 \text{ N/mm}^2$. The mass density for the steel materials was selected as $7.7 \times 10^{-9} \text{ T/mm}^3$. Regarding the prestressing force for reinforcement, a value of 1225.3 N/mm^2 was assigned to the first layer of PC strands in the compression area (4 strands) while the other two layers in the tension area (6 strands) were subjected to a prestress of 1166.7 N/mm^2 . **Figures 4.20(a) and 4.20(b)** show the modal shapes of the two bending modes of girder No.3 and the corresponding frequencies, which are quite similar to the measured modes shown in **Figs. 4.3(a) and 4.3(b)**, respectively.

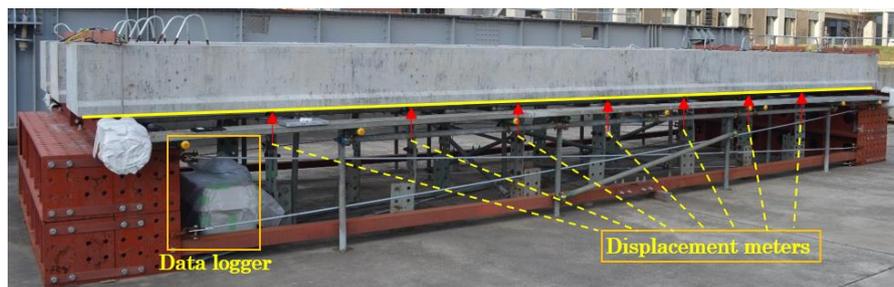
Figure 5.4 Measured point layout under the PC girder (Unit: mm)

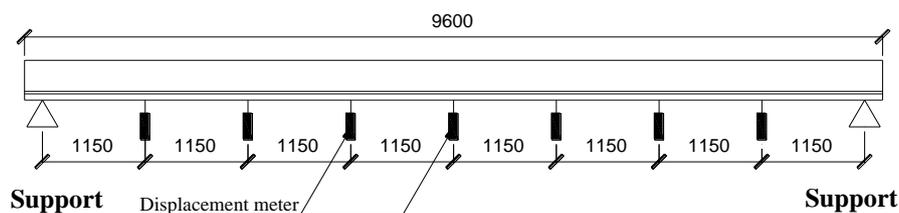
Figure 5.5 Experiment layout.
