Dissertation

STRUCTURAL HEALTH ASSESSMENT
FOR ASR-DETERIORATED PC GIRDERS
USING STATIC AND DYNAMIC EXAMINATIONS

Graduate School of
Natural Science & Technology
Kanazawa University

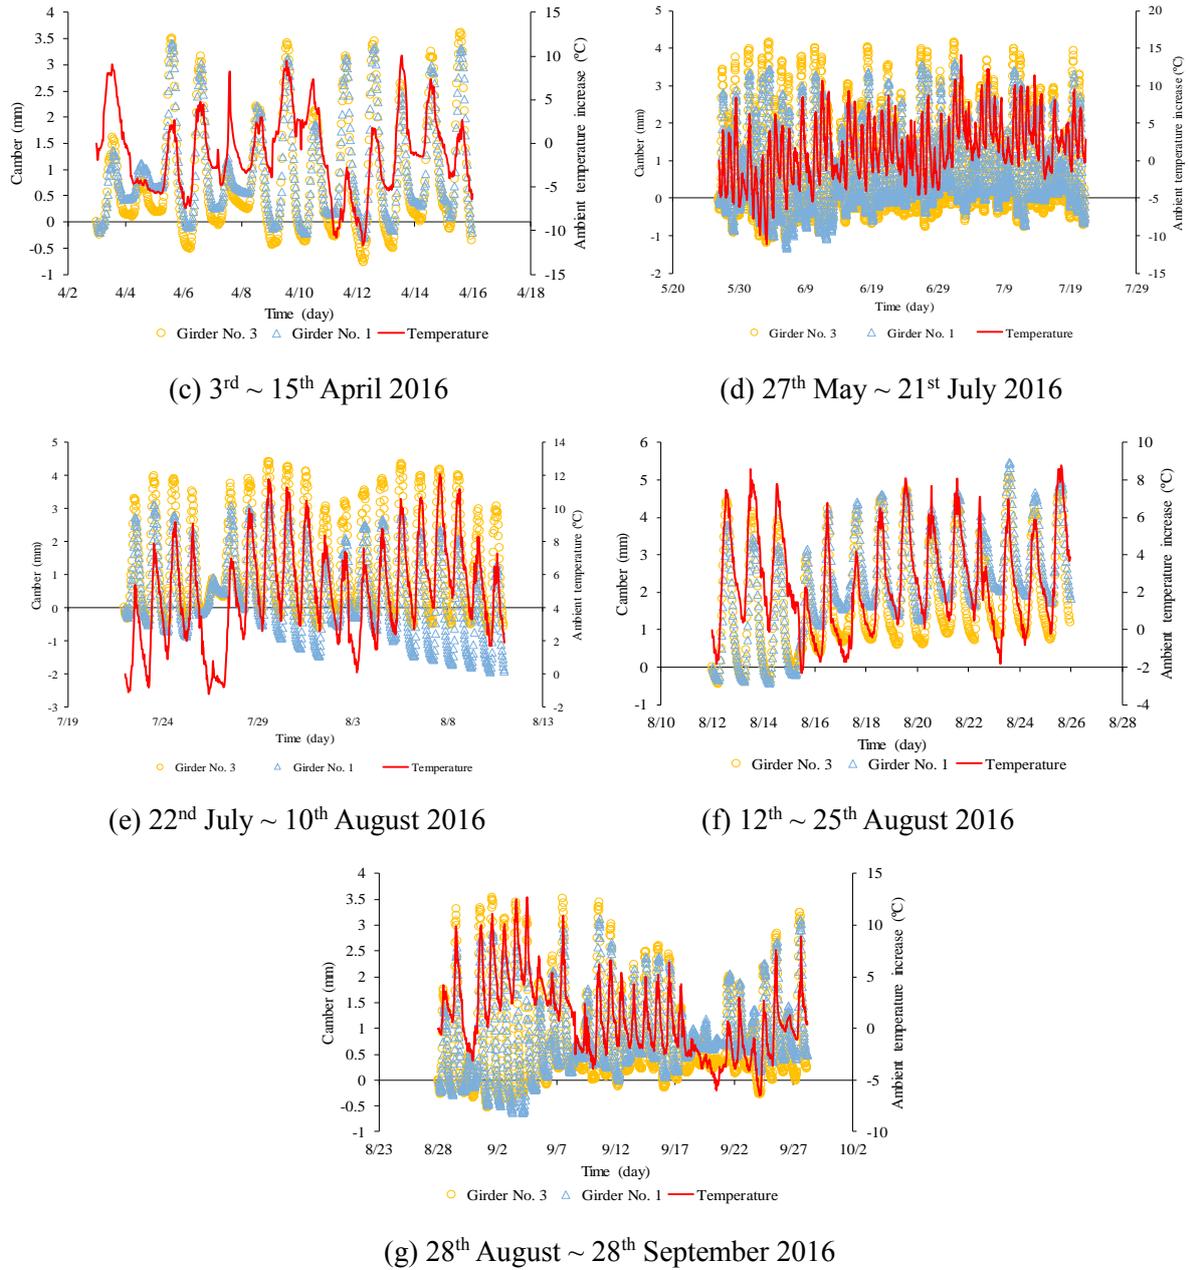
Figure 5.6 Changes in nodal displacement at span center during monitoring period

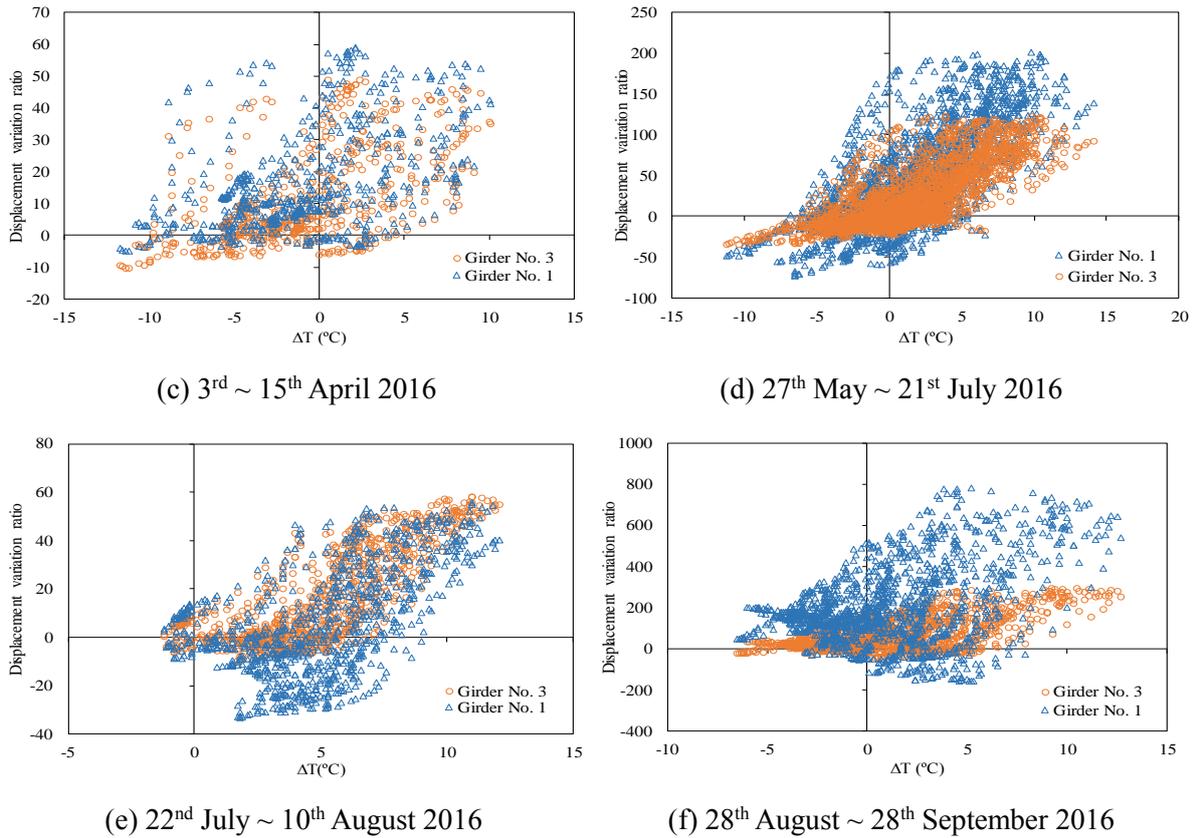
Figure 5.10 Changes in displacement variation ratio at span center during monitoring period.

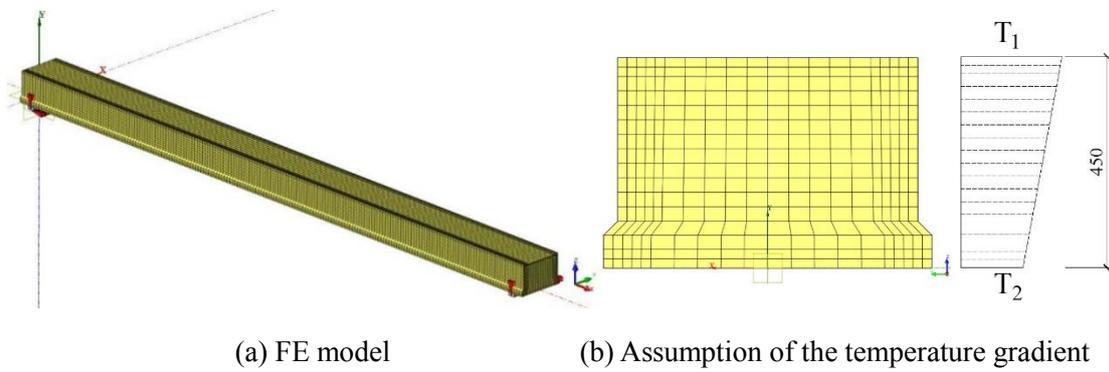
Figure 5.11 FE model set up

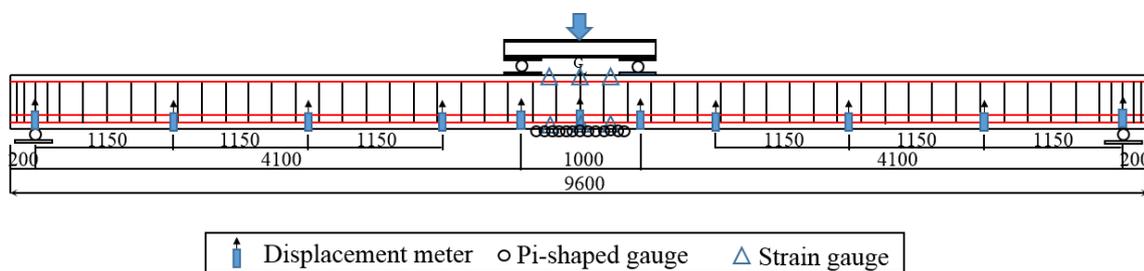
Figure 6.1 Overview of loading test setup (unit: mm).

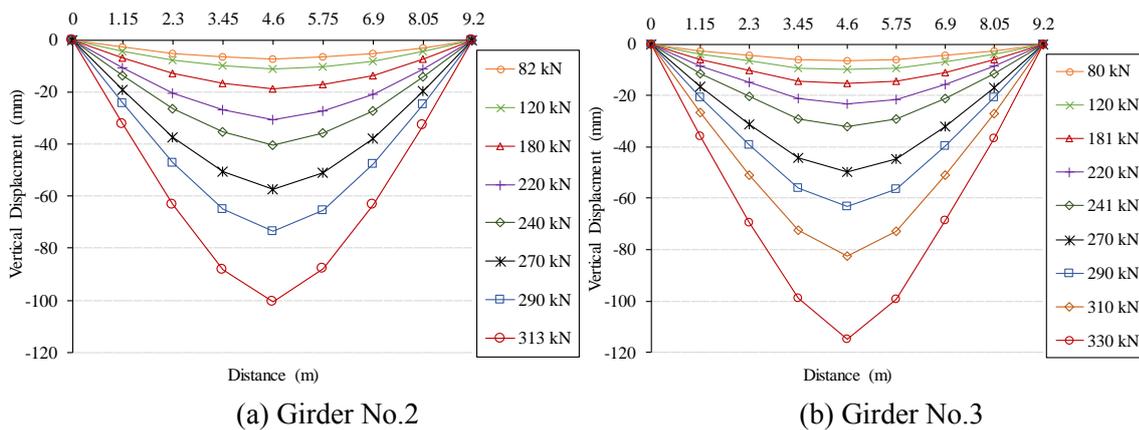
Figure 6.3 The measured deflection curves

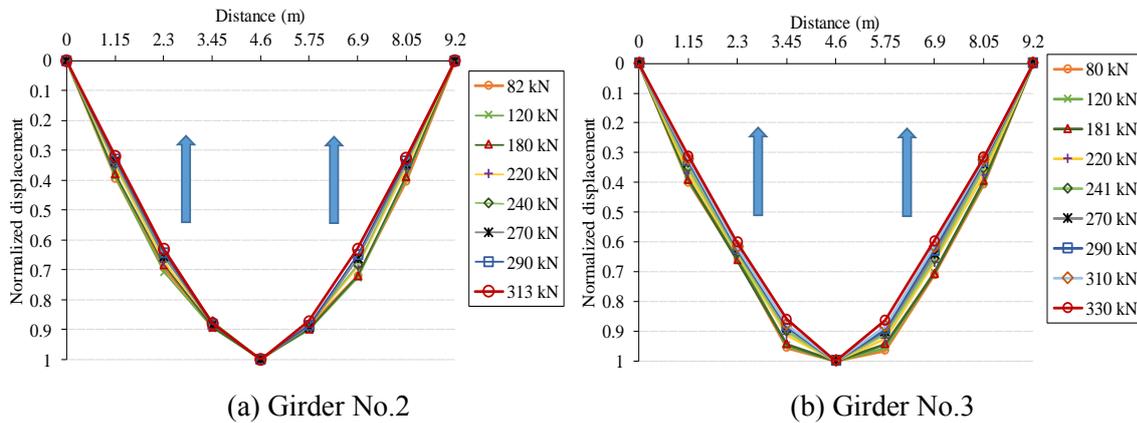
Figure 6.4 The normalized deflection curves

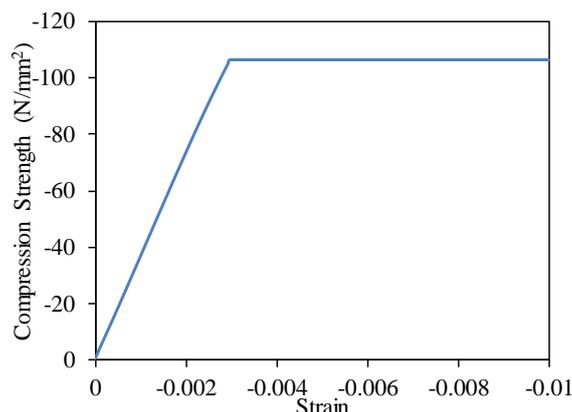
Figure 6.7 Stress-strain relationship of concrete of girder No.3

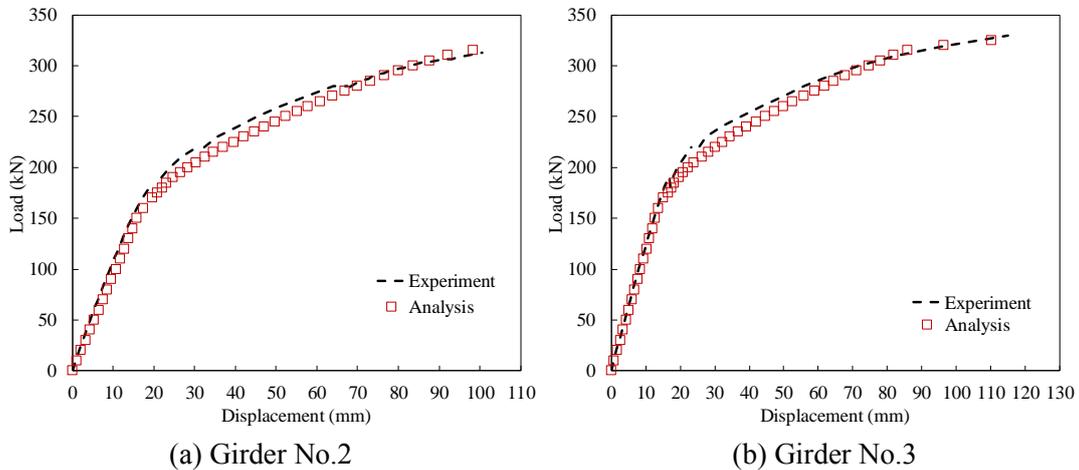
Figure 6.8 Displacement-load relationship at midspan of the numerical models

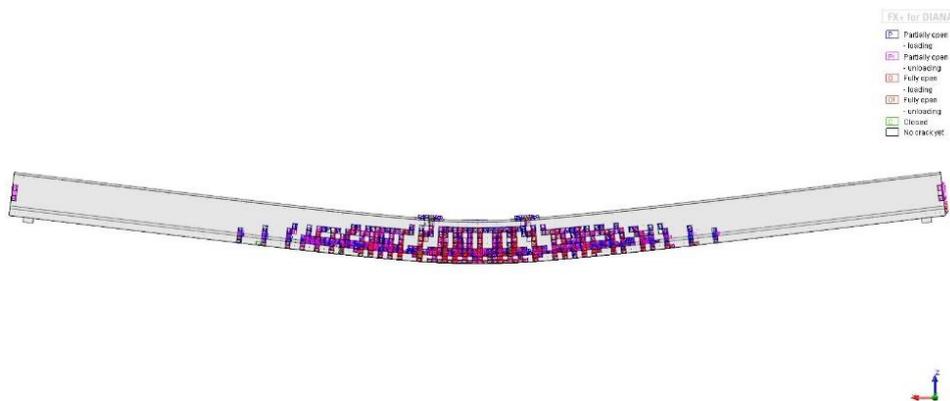
Figure 6.9 Crack pattern after the destructive load

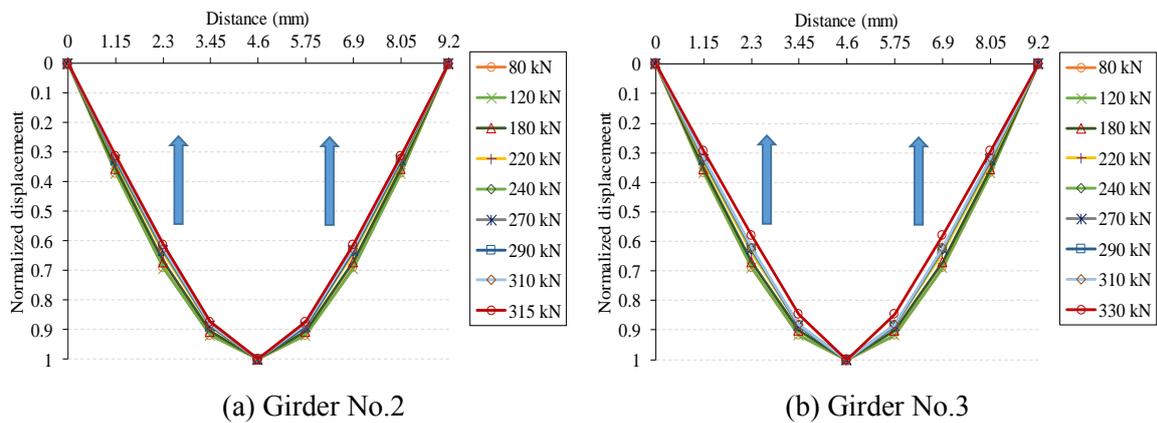
Figure 6.10 The normalized analytical deflection curves

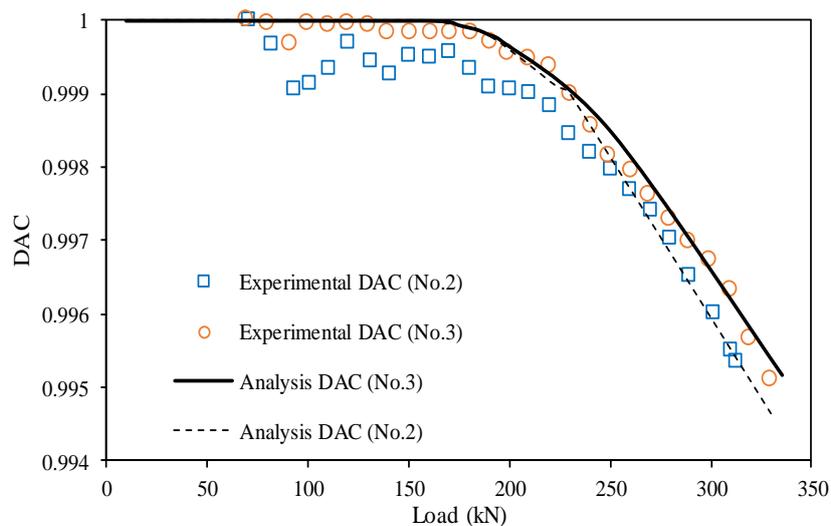
Figure 6.11 Variation in DAC with respect to the increased loading
