**EXPERIMENTAL STUDY ON MITIGATION OF
LIQUEFACTION-INDUCED GROUND DEFORMATION BY
USING GRAVEL AND GEOSYNTHETICS**

Graduate School of
Natural Science and Technology
Kanazawa University

Date of Submission: June 2018

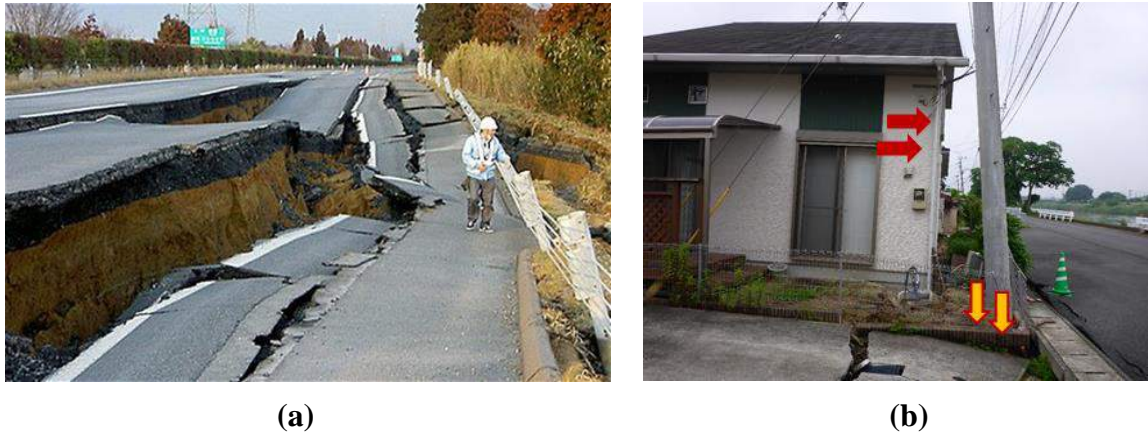
Figure 1.1 Liquefaction-induced damages:
 (a) The damaged road in the 2011 Great East Japan earthquake
 (b) Tilted residential house in the 2016 Kumamoto earthquake

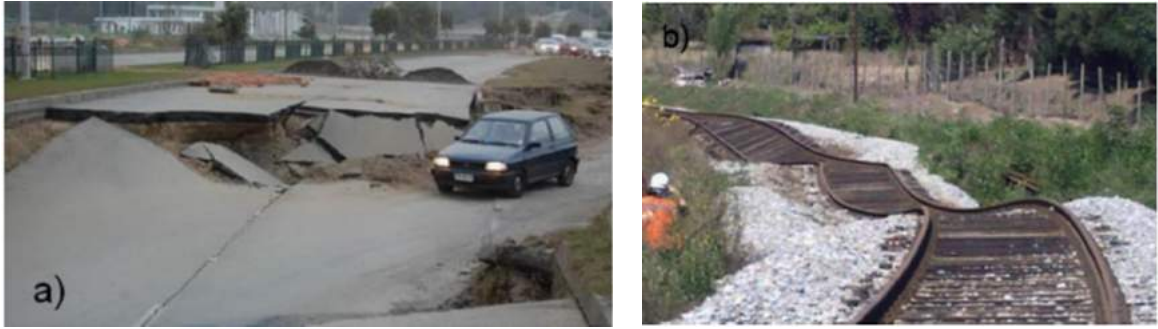
Figure 2.1 Post-liquefaction settlements in the 2010 Chile earthquake:
(a) Costanera route in Concepcion City
(b) Near Concepcion City

One of the reasons for resulting damages is linked with liquefaction and the substantial soil dislocations that are typical of this phenomenon. Liquefaction happened in some sites and caused major damages in road infrastructure, railroads system, ports, buildings and houses, irrigation channels, and tailing dams. Ramon Verdugo and Javiera Gonzalez (2015) carried a study and a field survey to observe the ground damages caused by liquefaction during this earthquake. They reported that ground deformation triggered by liquefaction caused the severe damages in some particular areas. They also observed the region affected by liquefaction covers an area with a length close to 1000 km in the North-South direction. Figures 2.1(a) and 2.1(b) describe the post-liquefaction settlements that developed on the ground surfaces and damage the roads and railways severely in Concepcion City, Chile.

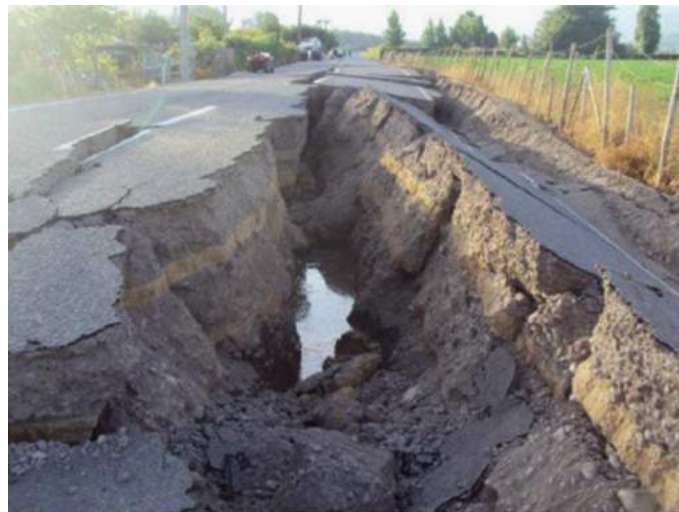
Figure 2.2 Damaged road due to lateral spreading

Furthermore, horizontal ground deformation observed in some locations. Longitudinal rupture related with the lateral spreading were constantly detected for a couple of kilometers along the river banks. Figure 2.2 shows the characteristic cases of damages caused by lateral spreading on mild slopes, where shallow blocks of dry soil broke up internally, moving downward and floating above the liquefied soil. Around 45 km to the south of Santiago, lateral spreading caused the hospital overpass collapsed as shown in Figure 2.3. The horizontal displacement up to 87 cm was measured at the north abutment and generated the collapse of the bridge deck.

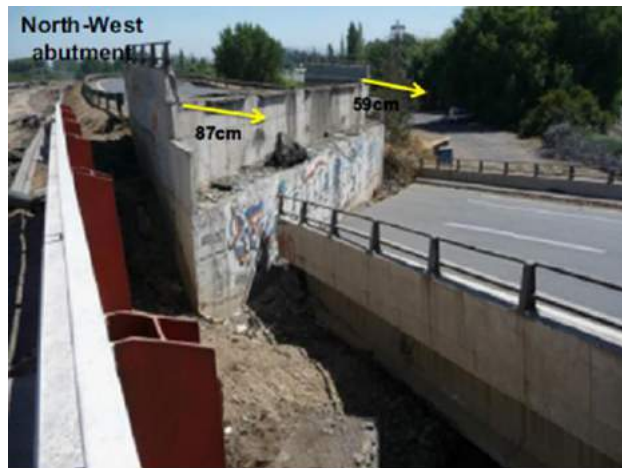
Figure 2.3 Collapse of the Hospital overpass

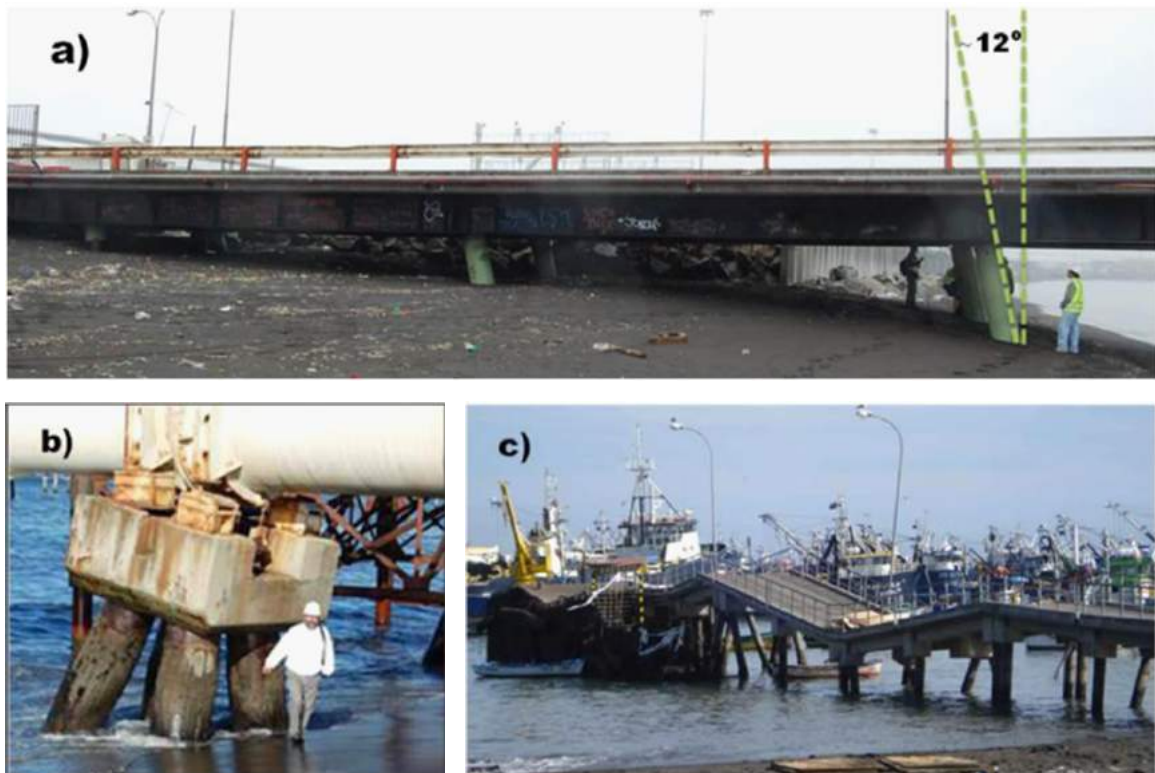
Figure 2.4 Damaged ports due to lateral spreading:
 (a) Coronel Port, (b) Bocamina Port, (c) Fishermen's Port

Lateral spreading triggered by liquefaction also affects pile foundations of several port facilities as shown in Figure 2.4. This port damage is generally linked with a huge economic loss, which is mainly caused by the stopped operations of the port.

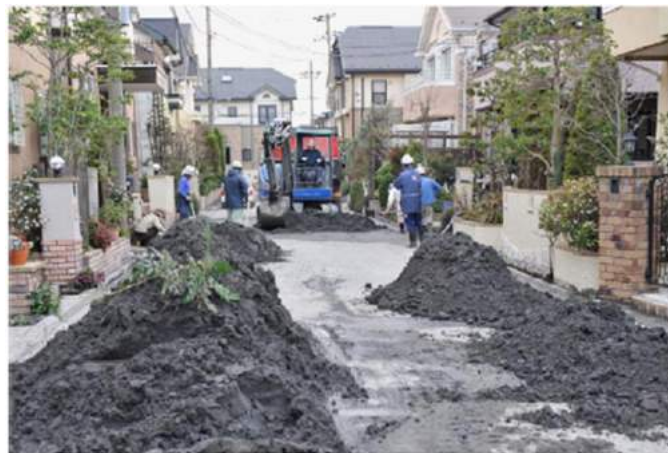
Figure 2.5 Boiled sand on the road in the 2011 Great East Japan earthquake

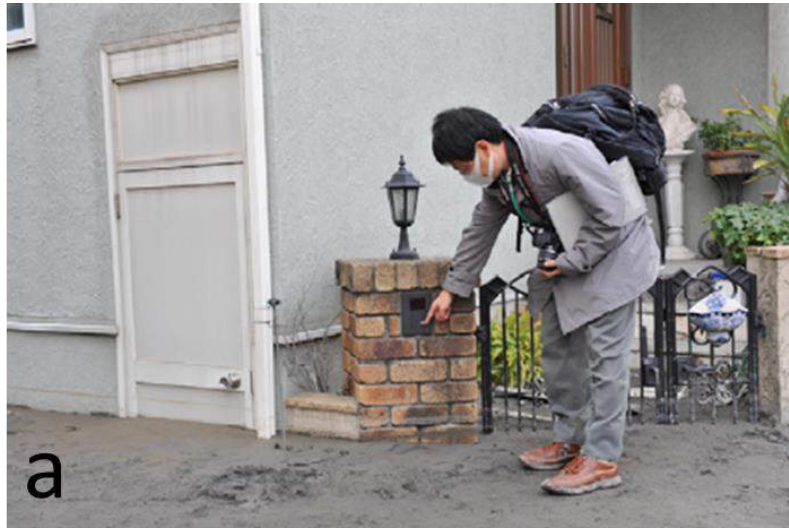
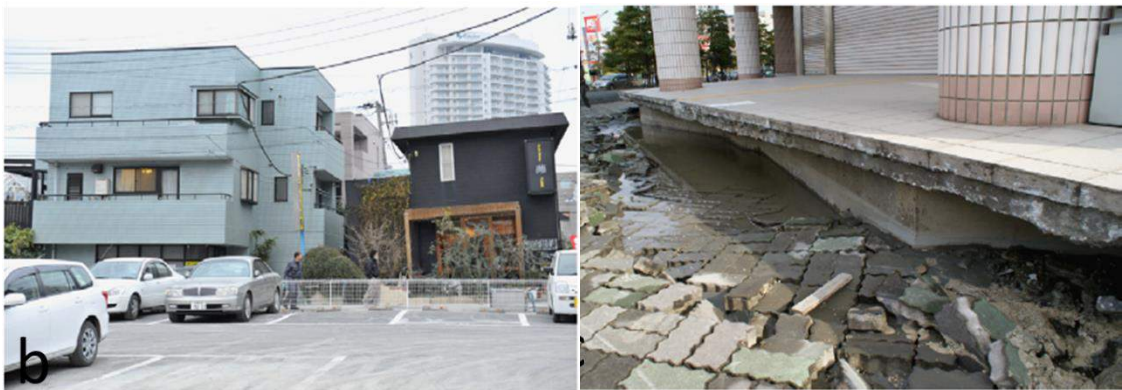
Figure 2.6 Damages caused by liquefaction in the 2011 Great East Japan earthquake:
 (a) A large settlement of the building
 (b) Tilted building
 (c) Ground settlement around the pile-supported building

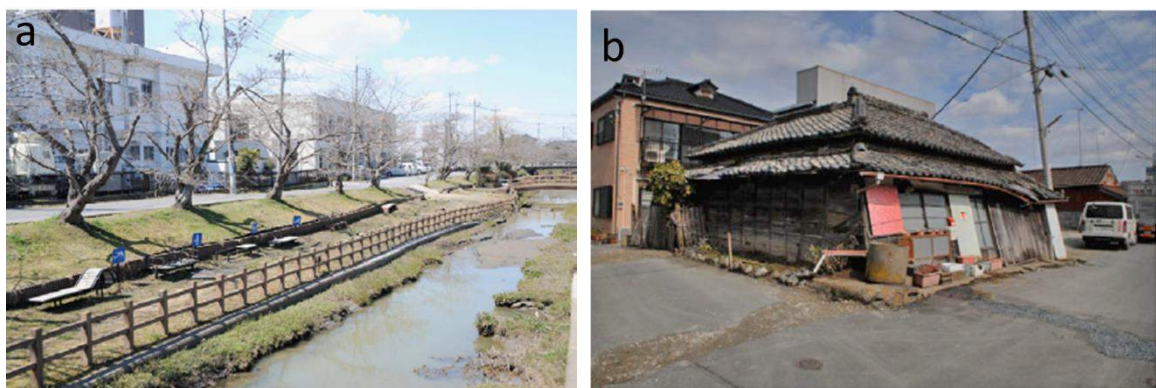
Figure 2.7 Liquefaction-induced lateral spreading in the 2011 Great East Japan earthquake
 (a) Lateral ground spreading towards the river
 (b) Damaged house caused by lateral spreading

Furthermore, in the Tone River area, damage induced by liquefaction also happened. By the side waterways, liquefaction-induced lateral spreading appeared and caused the stream became narrow and the riverbed lifted, as shown in Figure 2.7(a). Moreover, the land following the embankment also settled significantly and moved horizontally, affecting damage to a bridge. Lateral spreading also caused the foundations of the houses and other buildings near the embankment tilted as if pushed toward the stream, as can be seen in Figure 2.7(b).

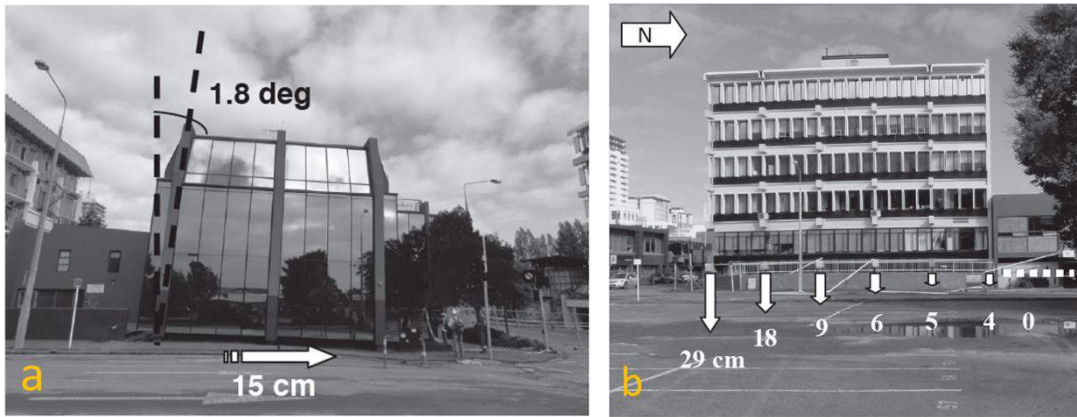
Figure 2.8 Tilted buildings due to liquefaction-induced differential settlements

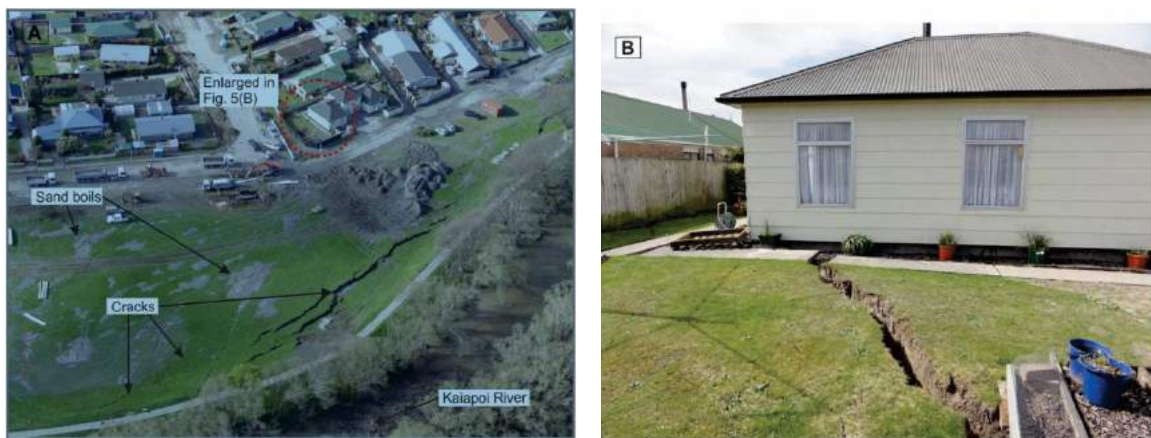
Figure 2.9 Lateral spreading occurred in the 2010-2011 Canterbury earthquakes, New Zealand

- (a) Aerial photo of liquefaction and lateral spreading impacts in the north of Kaiapoi
- (b) Lateral spreading cracks affected the residential house

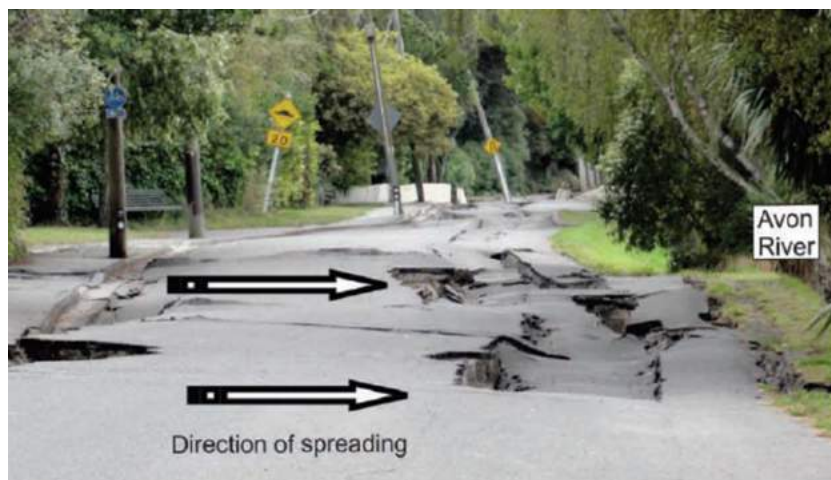
Figure 2.10 Road surface cracks due to lateral spreading towards the Avon River

Correspondingly, in the following year, Cubrinovski et al. (2012) presented a study of lateral spreading and its impacts in urban areas in the 2010-2011 Christchurch earthquakes. Figures 2.9(a) and 2.9(b) show the inflight view of North Kaiapoi lateral spreading and cracks influencing residential houses located around 50 m away from the Kaiapoi River. Liquefaction-induced lateral spreading also triggered ground cracks and deformation of the road surface along the Avon River. The ground horizontally moved toward the river as shown in Figure 2.10.

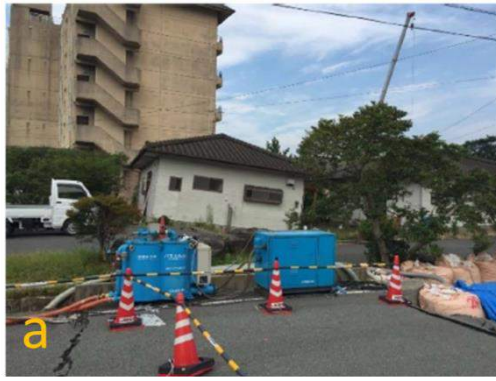
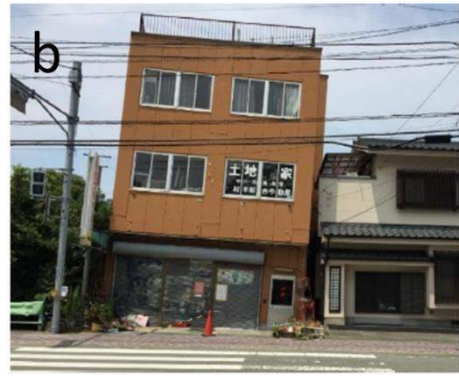
Figure 2.11 Buildings suffered from differential settlements due to liquefaction

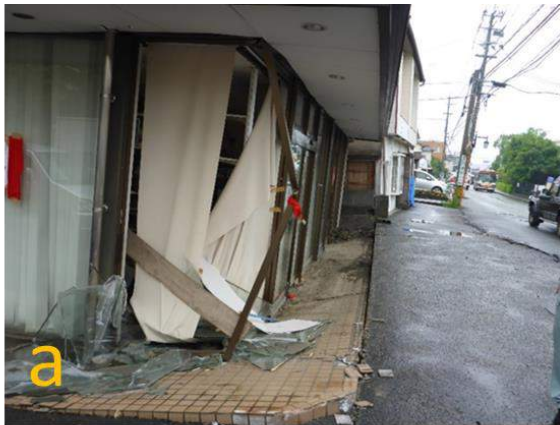
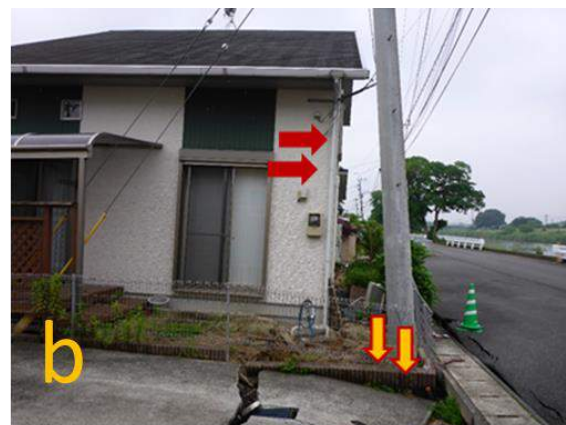
Figure 2.12 Damaged buildings caused by liquefaction-induced ground deformation

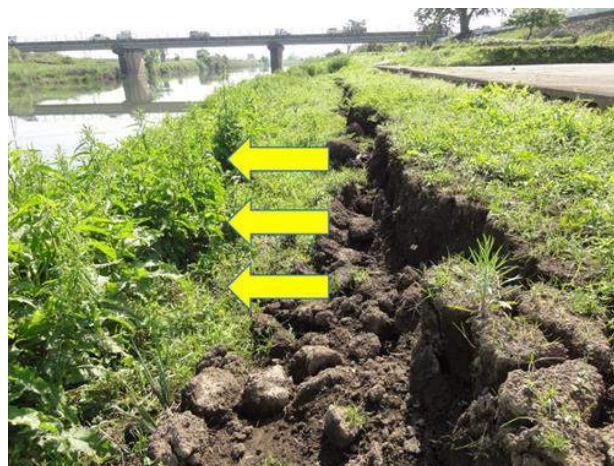
Figure 2.13 Lateral spreading in the river bank of Kiyama River, Akitsu Town, Kumamoto

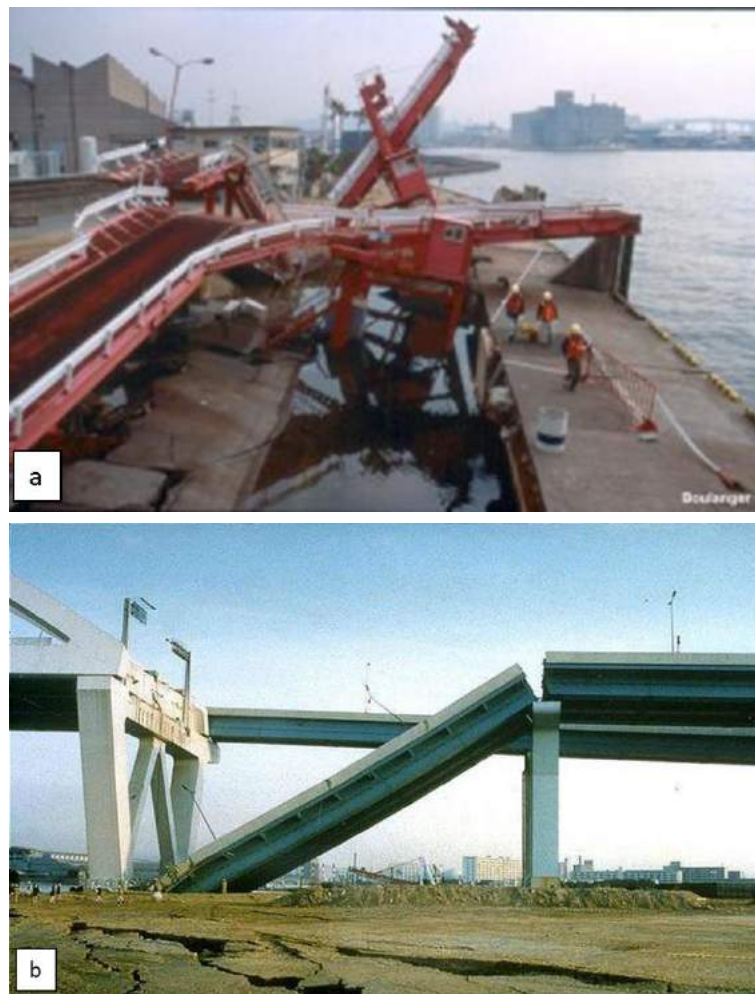
Figure 3.1 The lateral spreading due to liquefaction during the 1995 Kobe earthquake
(a) The collapsed ferry terminal
(b) The collapsed Nishinomiya bridge

and the 2010-2011 Canterbury earthquakes. **Figure 3.1** presents the lateral spreading incidences in the 1995 Kobe earthquake. **Figure 3.1(a)** shows the collapsed of ferry terminal caused by liquefaction and the quay wall moved outwards. **Figure 3.1(b)** The Nishinomiya Bridge collapsed due to liquefaction and triggered foundation deformations. Ground cracks behind the quay walls and parallel to the water edge are indicative of the lateral ground movements occurred. Furthermore, damages caused by liquefaction-induced lateral ground movements in 2010-2011 Canterbury earthquakes are shown in **Figures 3.2(a)** and **3.2(b)**.

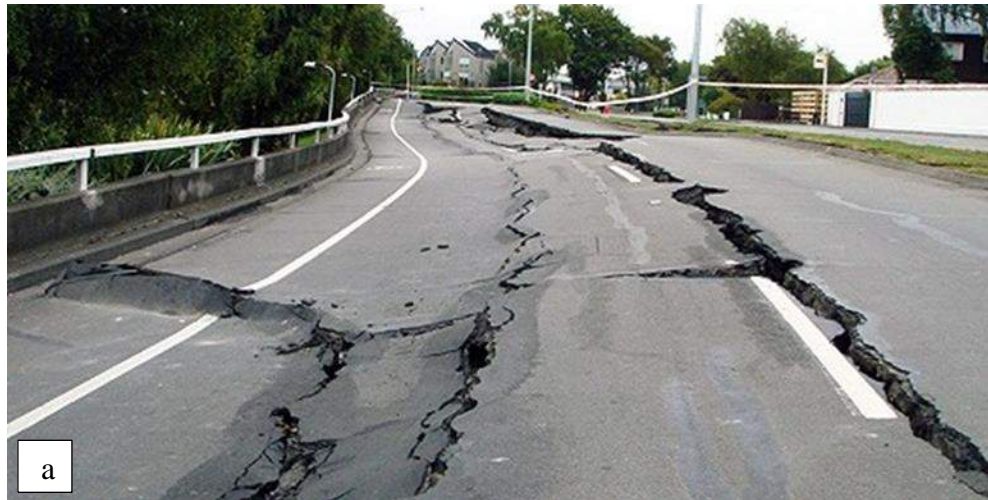
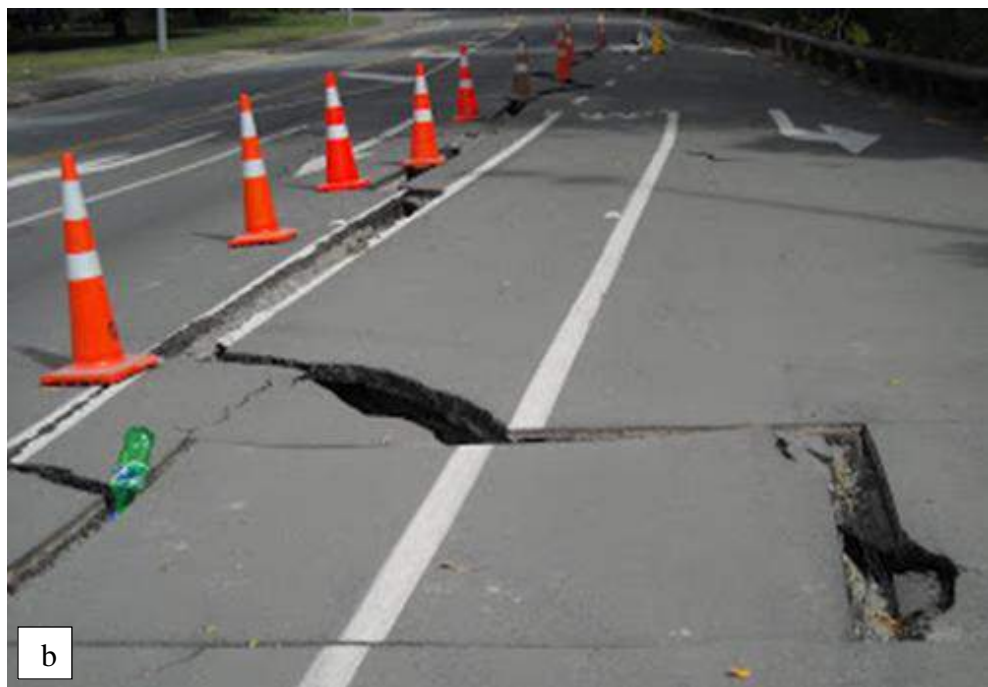
Figure 3.2 the lateral spreading due to liquefaction during the 2010-2011 Canterbury earthquakes

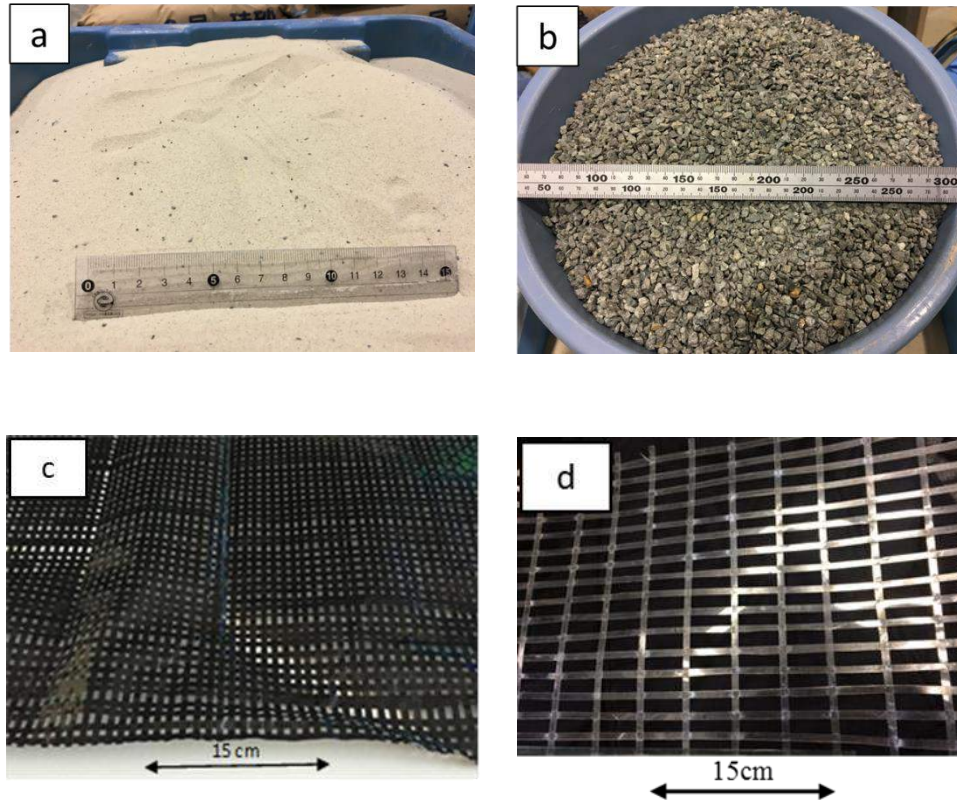
Figure 3.4 The photograph of the materials used
 (a) Silica sand No.7, (b) Crushed stone No.5,
 (c) Geosynthetic Type I, (d) Geosynthetic Type II

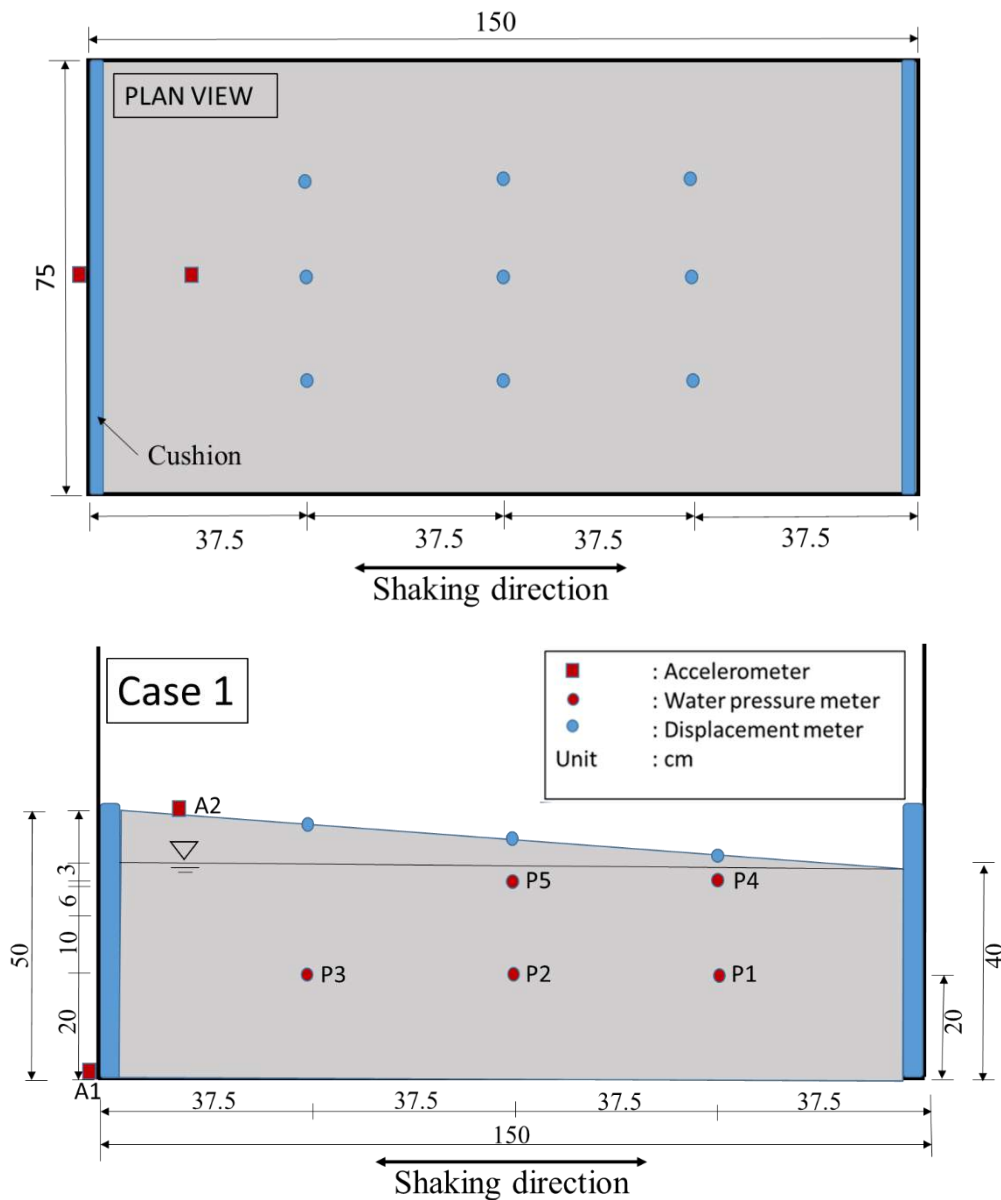
Figure 3.5 The plan view and cross-section of the unreinforced model

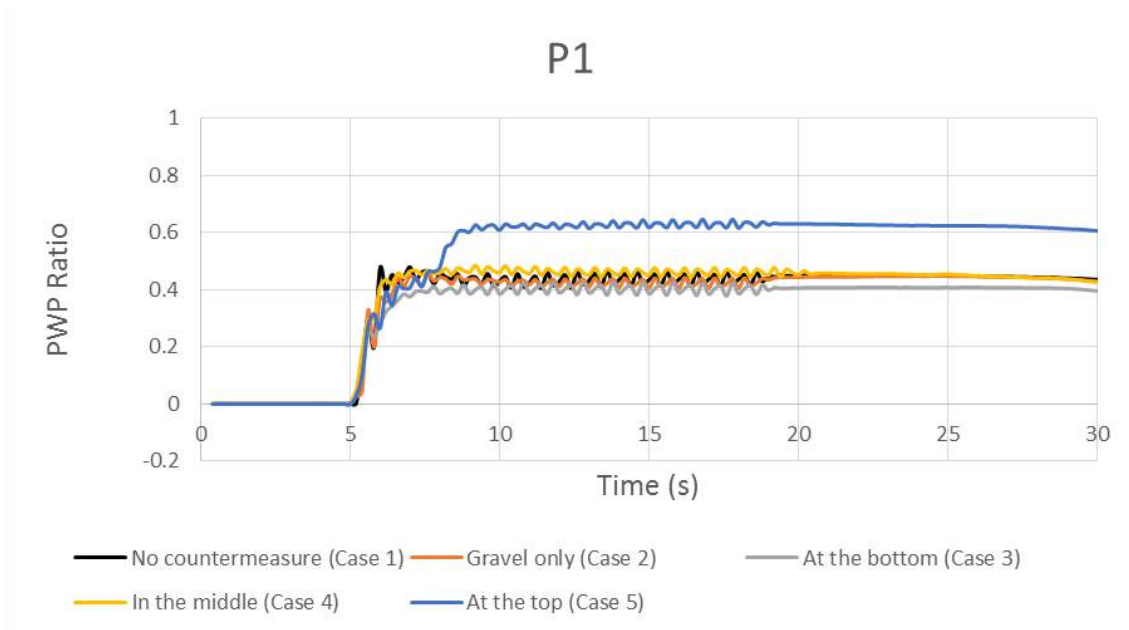
Figure 3.9 Excess pore water pressure time histories for P1

Pore water pressures were observed by installing five pore water pressure transducers at two different levels. P1, P2, and P3 were located below the gravel layer, around 20 cm from the bottom of the sand container, while P4 and P5 were sited above the gravel layer about 37 cm from the bottom of the sand container. Excess pore water pressure measured were converted to excess pore water pressure ratio by dividing excess pore water pressure with initial vertical effective stress (σ_v'). Excess pore water pressure ratio time histories are shown in **Figures 3.9 – 3.13**.

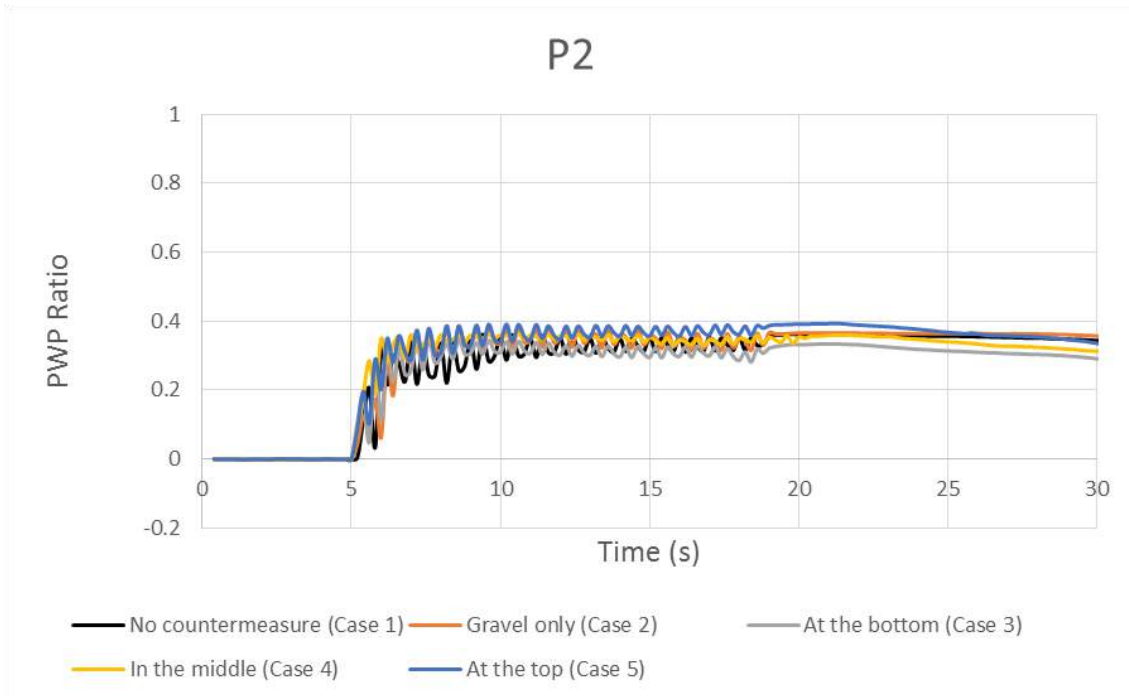
Figure 3.10 Excess pore water pressure time histories for P2

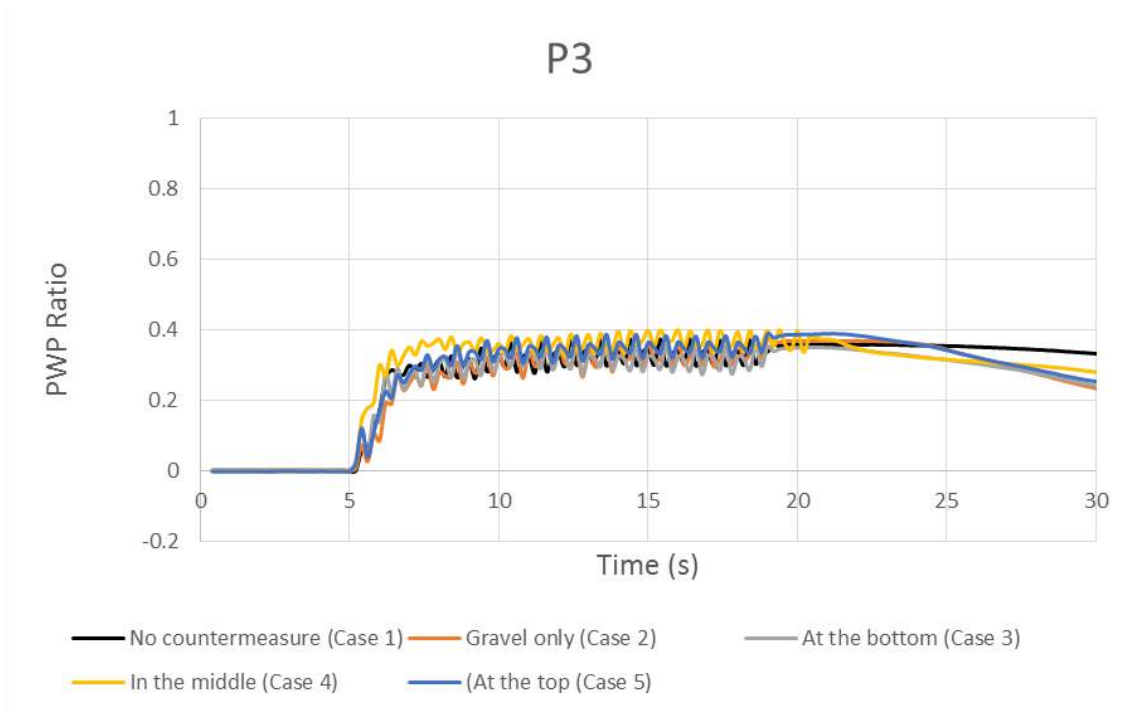
Figure 3.11 Excess pore water pressure time histories for P3

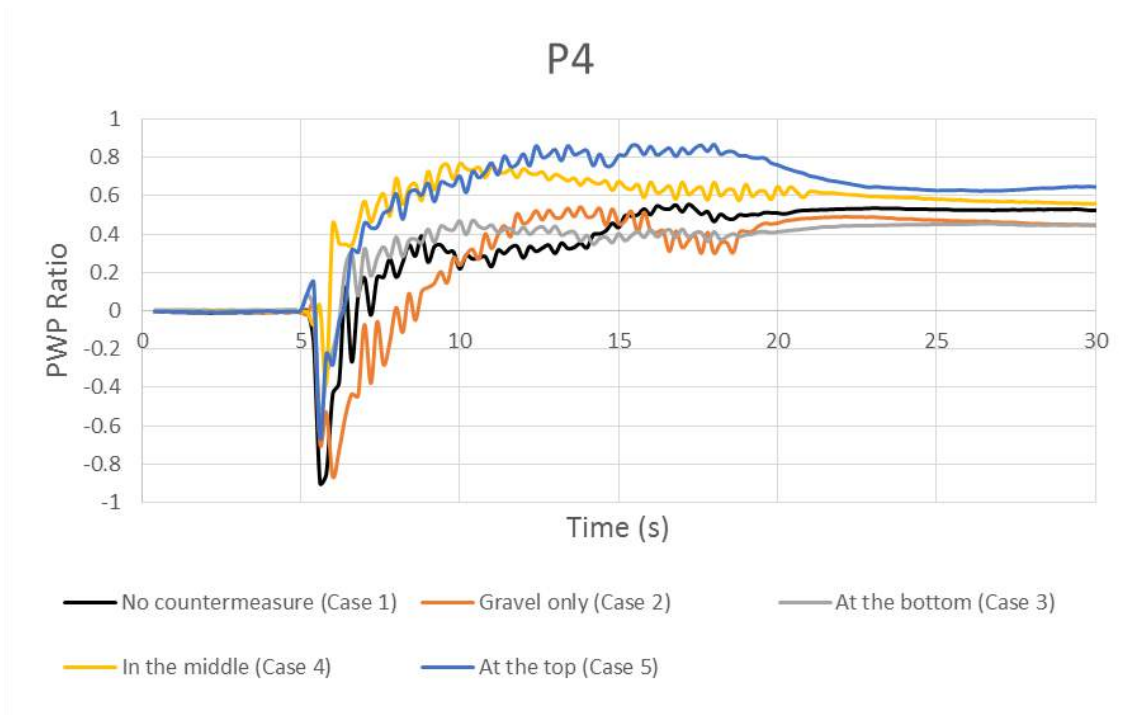
Figure 3.12 Excess pore water pressure time histories for P4

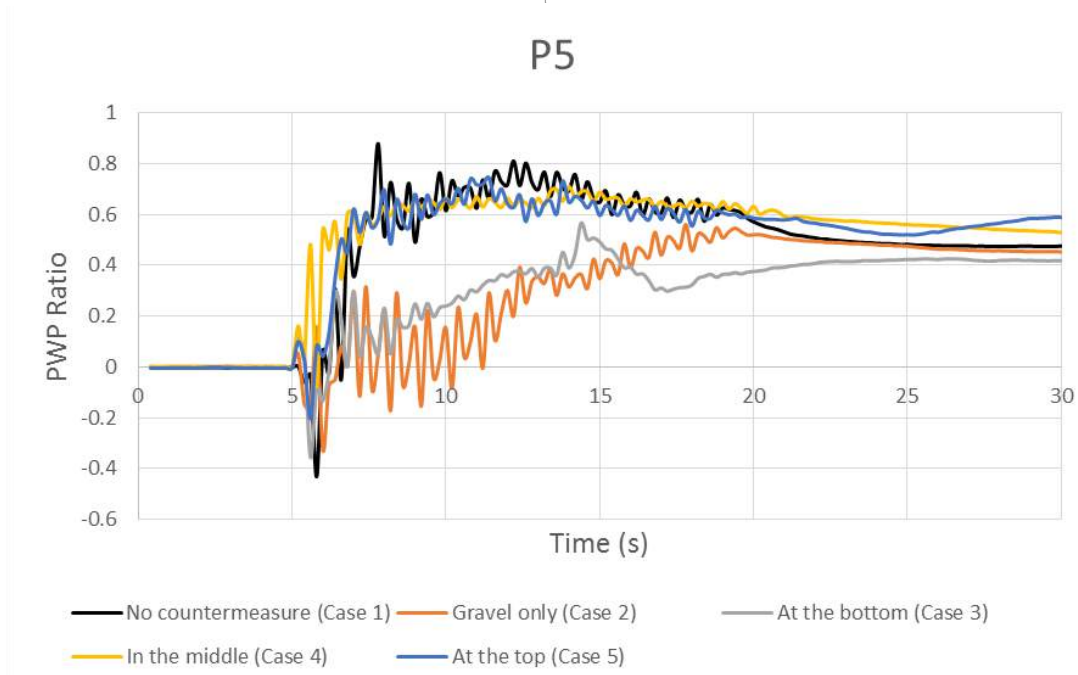
Figure 3.13 Excess pore water pressure time histories for P5

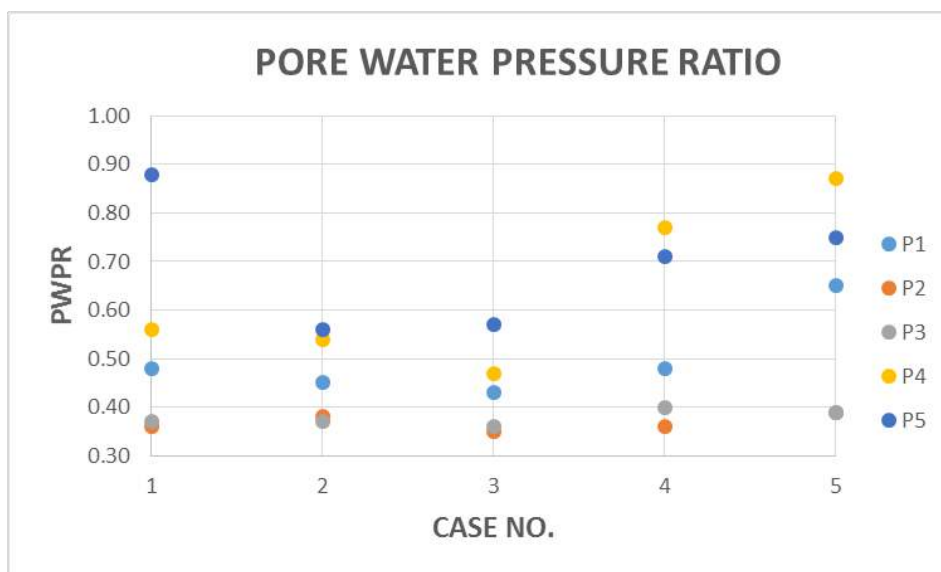
Figure 3.14 Pore water pressure ratio of 5 Cases for P1 – P5

Generally, regarding the value of the excess pore water pressure ratio, the difference for all cases is insignificant. However, for the models with the improvement layer (Case 2 – Case 5), the dissipation of the pore water pressure was observed immediately as the shaking stops, particularly for the P2 and P3 which are located close to the gravel layer. To simplify, the pore water pressure in the graph above is simplified in the **Figure 3.14**.

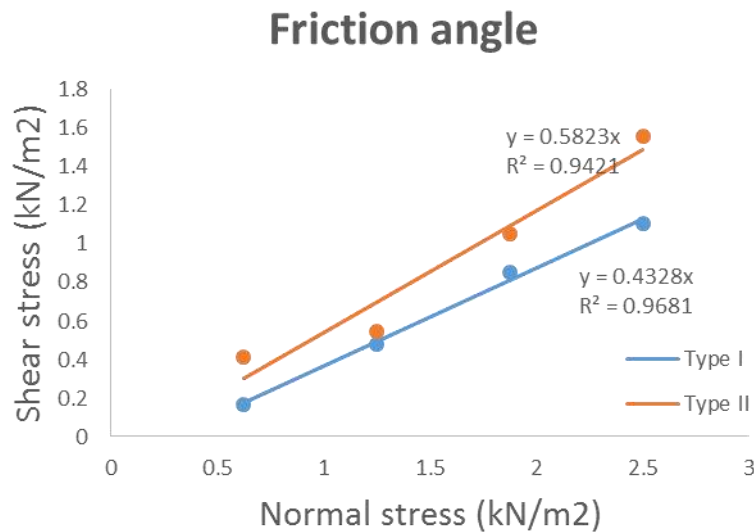
Figure 3.23 Friction angle of the geosynthetics used

which is around 30.2° , compared to geosynthetics type II of only about 23.4° . This can be justified due to the thicker and the larger aperture of geosynthetics Type II compared to Type I. This advantage combined with its high tensile strength and tensile stiffness, resulting geosynthetics type II more cohesive when blended with other materials, for example, sand and gravel.

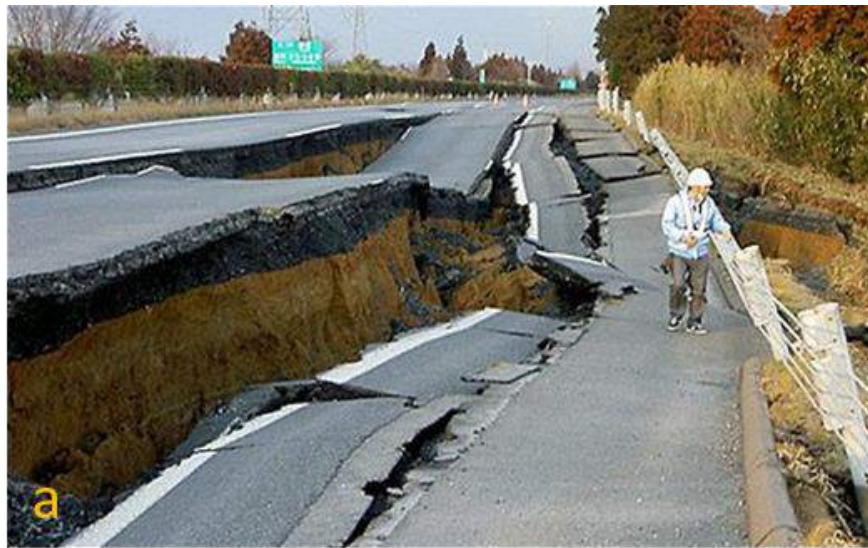
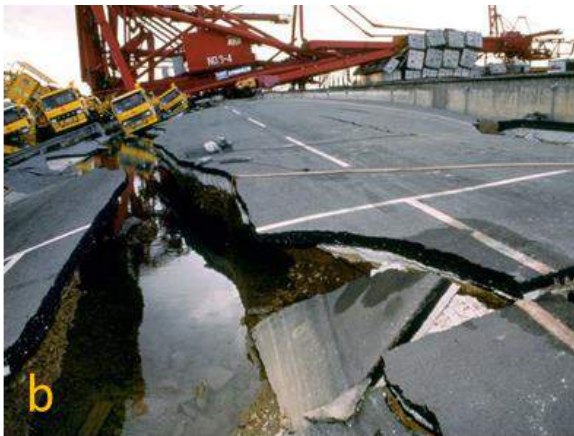
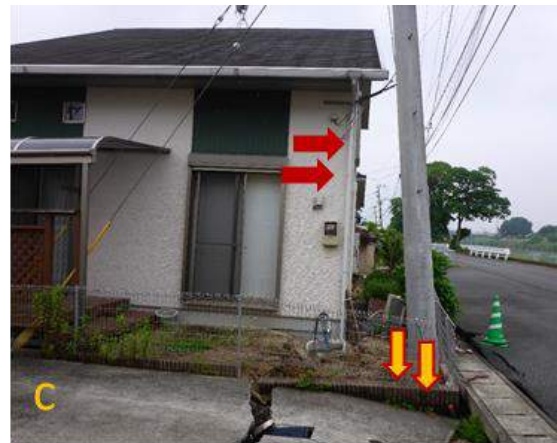
Figure 4.1 Damaged constructions due to liquefaction-induced ground displacements;

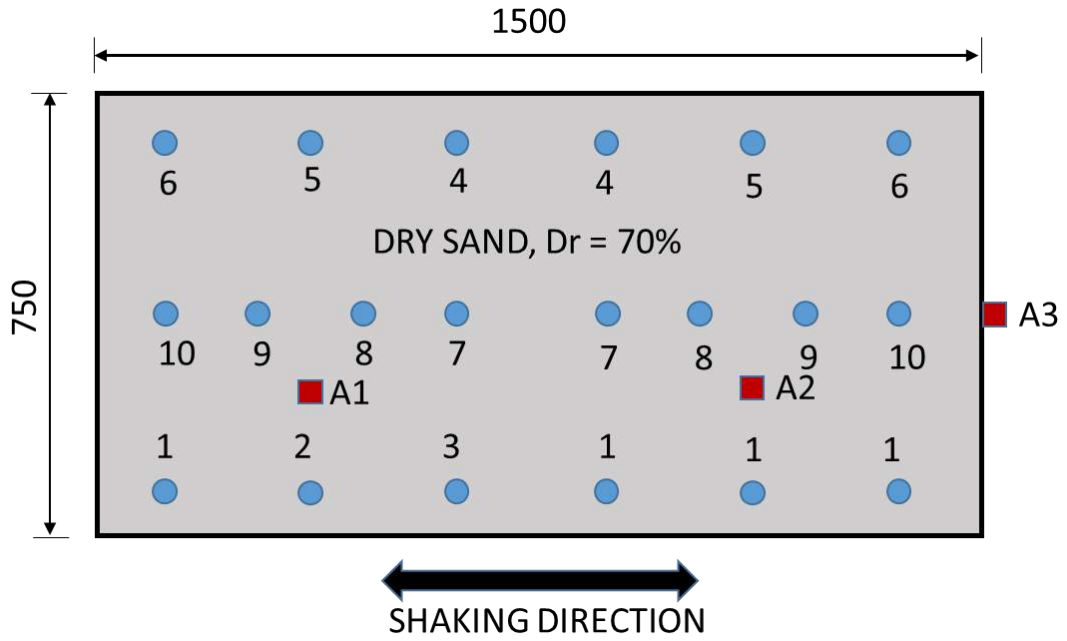
Figure 4.2 The top view of the sandbox

Figure 4.2 – Figure 4.5 shows the plan view, and the cross-section of the unreinforced model (Case 1), reinforced with gravel (Case 2) and gravel accompanied by geosynthetics type I and type II (Cases 3 and 4) along with the layout of accelerometers, water pressure meters, and displacement meters. The ground in the model composed of a liquefiable layer with a relative density around 50%, non-liquefiable part with a relative density of 90% in dense condition, and dry sand on the ground surface.

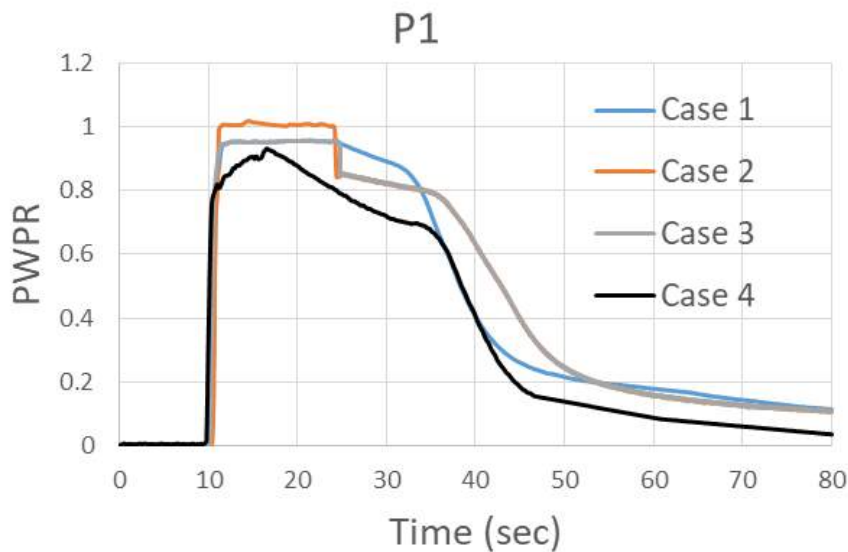
Figure 4.6 Pore water pressures time histories in the loose sand condition (P1)

According to the results, it can be said that the effect of the use of gravel and geosynthetics on pore water pressure is insignificant in these experiments. Since the main purpose of pore water pressure measurement is to determine the occurrence of liquefaction in the sand layer, therefore the influence of the use of gravel and geosynthetics on pore water pressure is not a major concern.

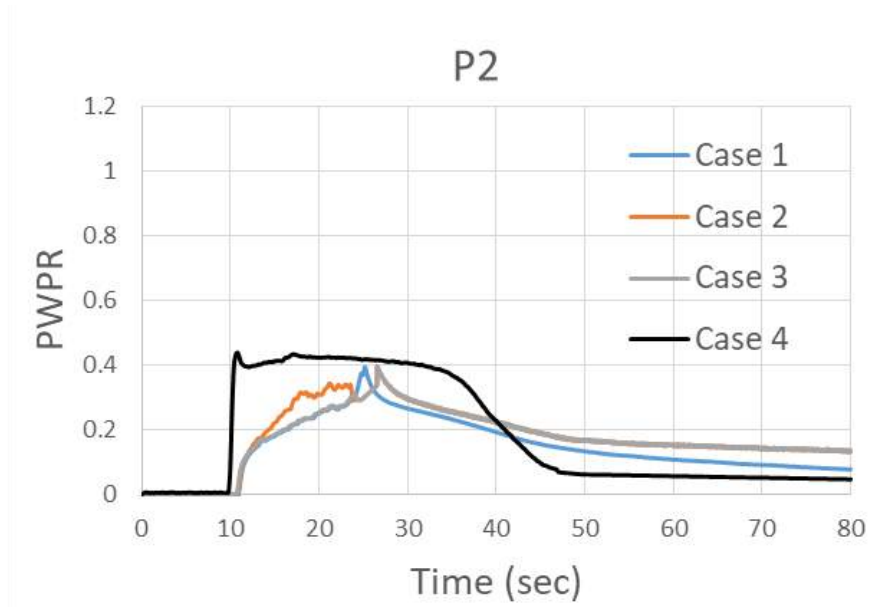
Figure 4.7 Pore water pressures time histories in the dense sand condition (P1)

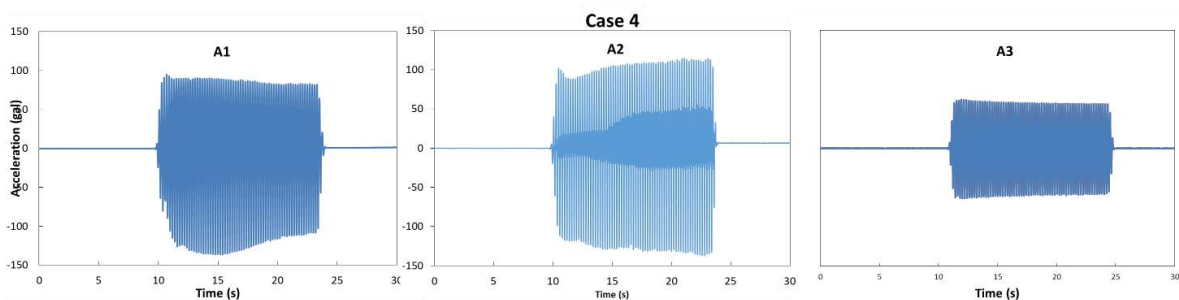
Figure 4.11 Acceleration time histories of gravel & geosynthetic type II -reinforced ground (Case 4)

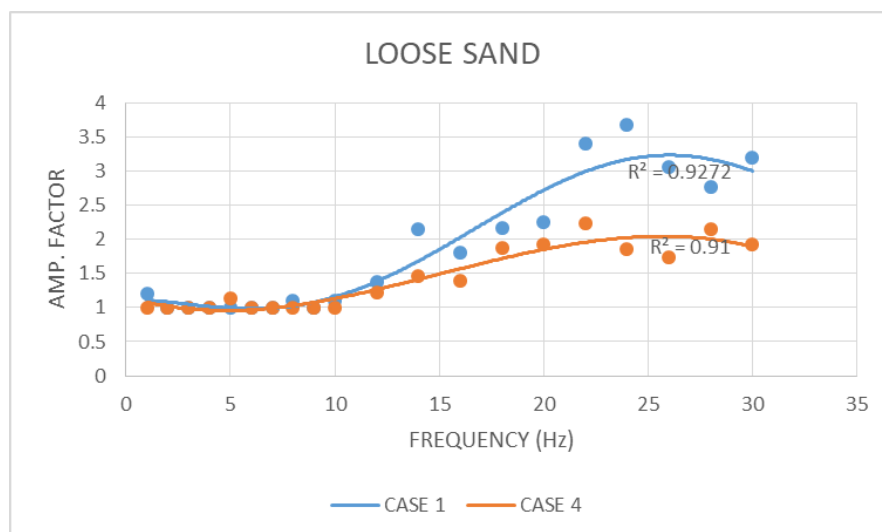
Figure 4.12 Amplification acceleration measured in the loose sand condition (A1)

Figures 4.12 and **4.13** also revealed that the effect of gravel and geosynthetic to reduce the acceleration amplification was found more significant in the dense soil conditions than that of the looser one. In the high-density sand, the maximum amplification factor ratios for Case 4 are around 1.9, whereas for Case 1 approximately 2.3. This can be attributed to the more efficient interaction between gravel, geosynthetics, and sand grains at high density. It is speculated that the thickness, apertures, the roughness, and tensile strength of the geosynthetics constituted a stronger interlock with the high-density soils than that of looser one due to loose sand corresponds to a higher void ratio and larger pore diameters. Furthermore, it can also be concluded that the soil density has a significant effect on the acceleration amplification. The looser soil conditions result in larger amplification which thought due to the higher void ratio of the looser soils.

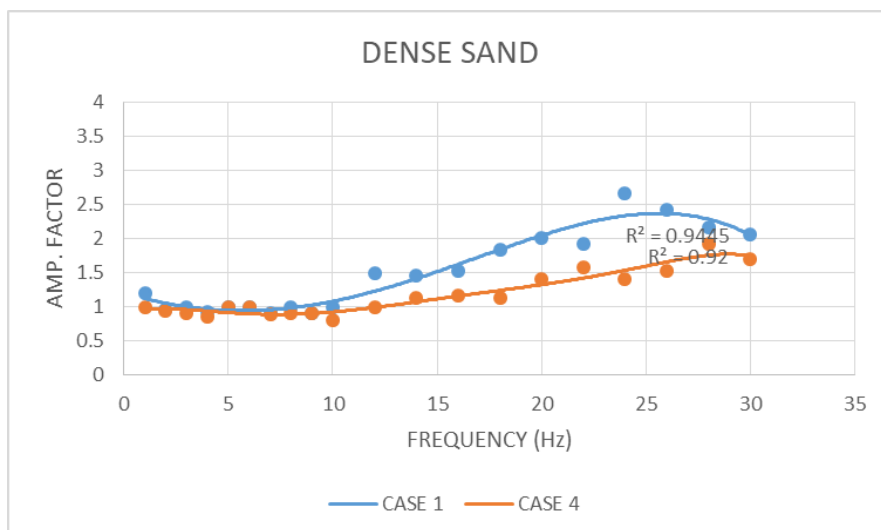
Figure 4.13 Amplification acceleration measured in the dense sand condition (A2)

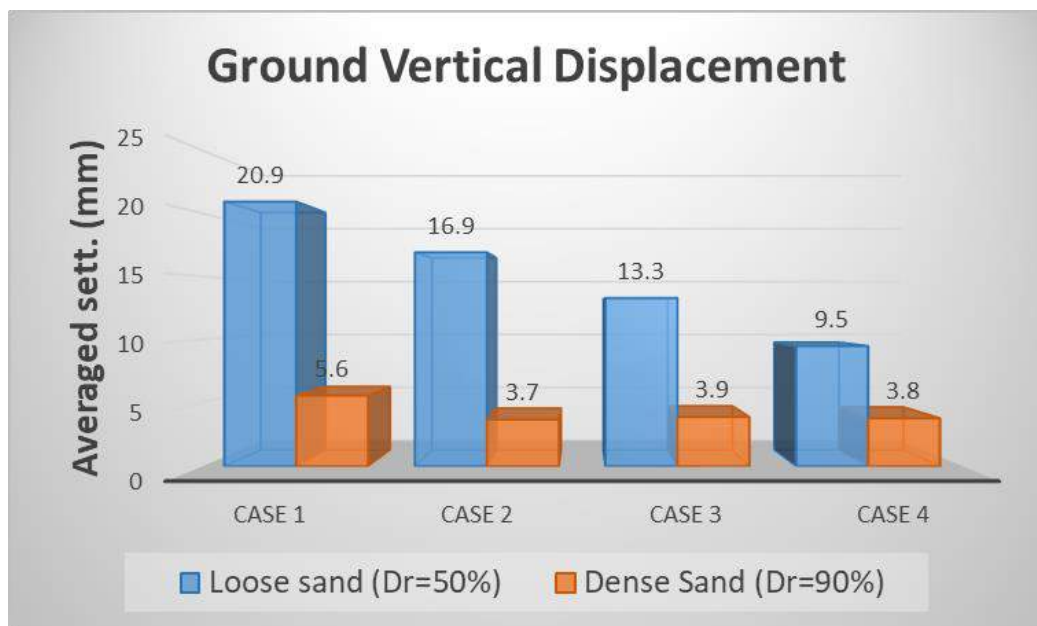
Figure 4.14 Averaged residual vertical ground displacement

The coherence of the gravel layer with its high permeability and high tensile strength provided by geosynthetics were considered as the main reason for this good result. Since the tension generated in the geosynthetics restrain the deformation of the gravel layer and integrally perform like a rigid plate with high permeability, this reinforcement could reduce the settlement that occurred on the ground surface. Since the tensile strength and the tensile stiffness of geosynthetics Type II that used in Case 4 is higher compared to type I, this type of geosynthetics could restrain the deformation of the gravel and sand better than Type I, resulting in lower ground vertical displacement compared to geosynthetics Type I that used in Case 3.
