**EXPERIMENTAL STUDY ON MITIGATION OF
LIQUEFACTION-INDUCED GROUND DEFORMATION BY
USING GRAVEL AND GEOSYNTHETICS**

Graduate School of
Natural Science and Technology
Kanazawa University

Date of Submission: June 2018

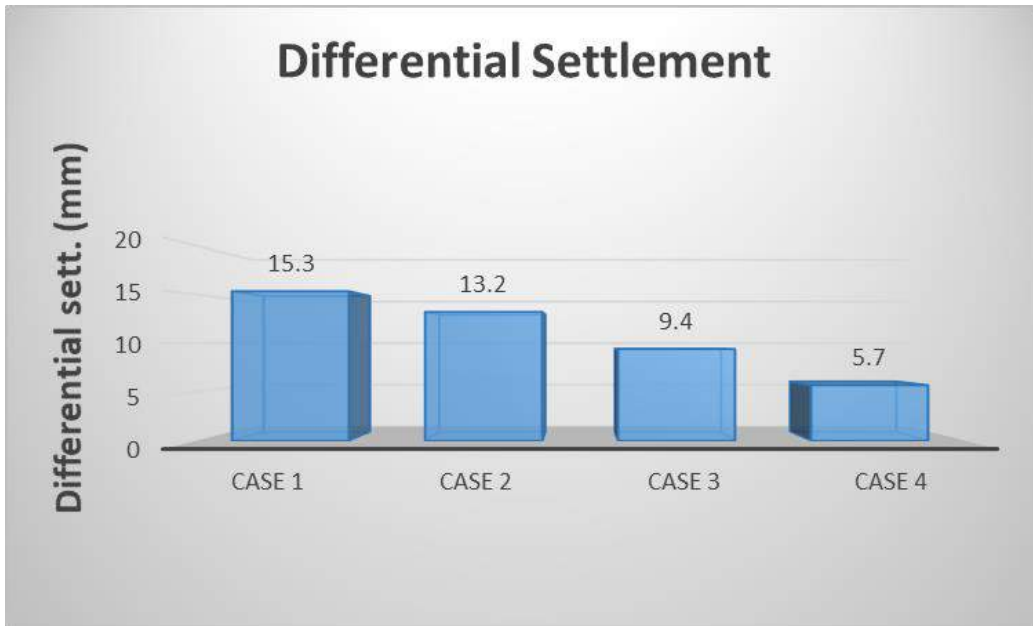
Figure 4.15 Differential settlement between the loose and dense sand zones

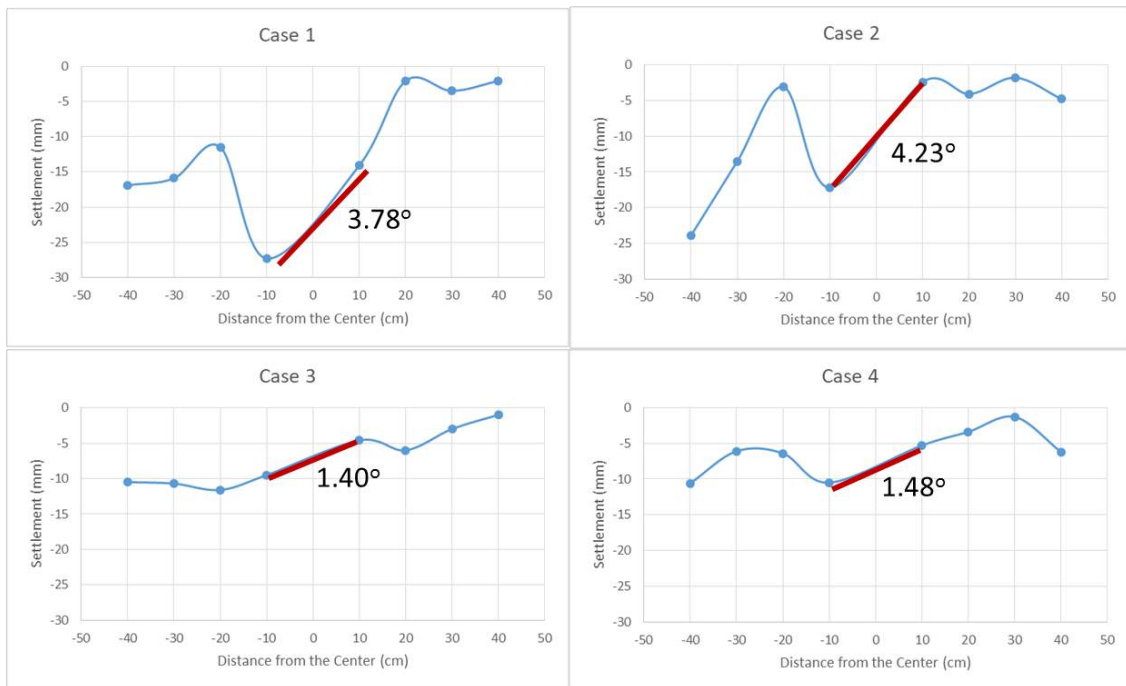
Figure 4.16 The ground surface inclination angle at the border line between loose and dense sand zones

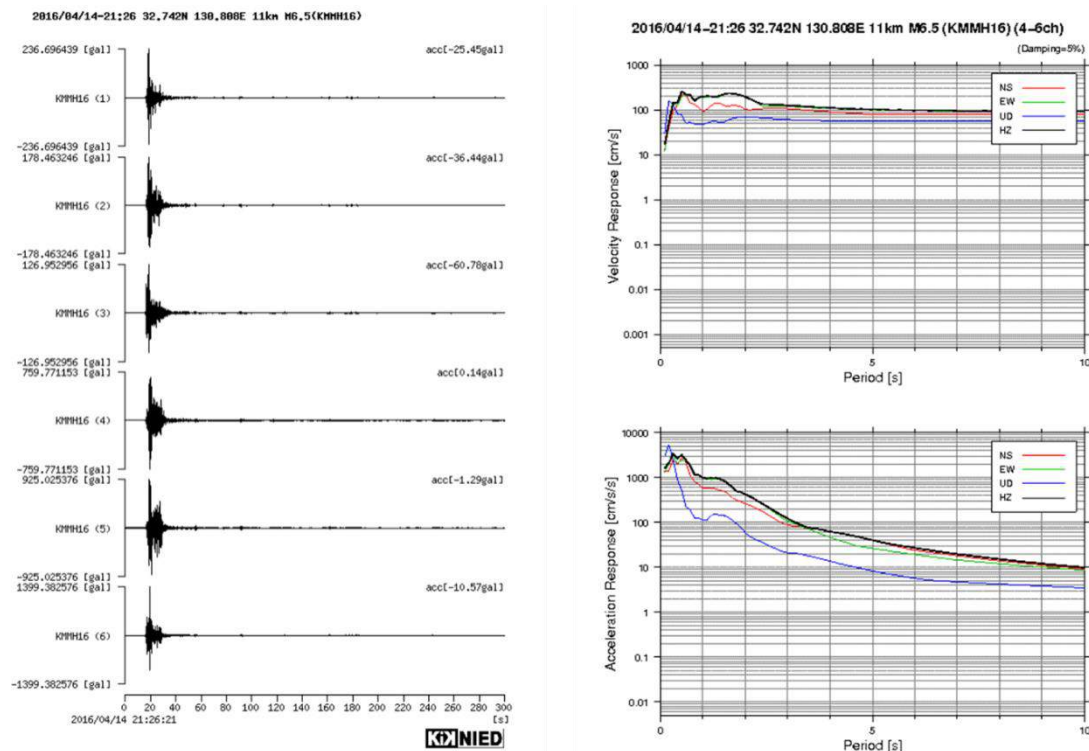
Figure A.2 The recorded acceleration, velocity response, and acceleration response of KMMH16 station at Mashiki town for the foreshock

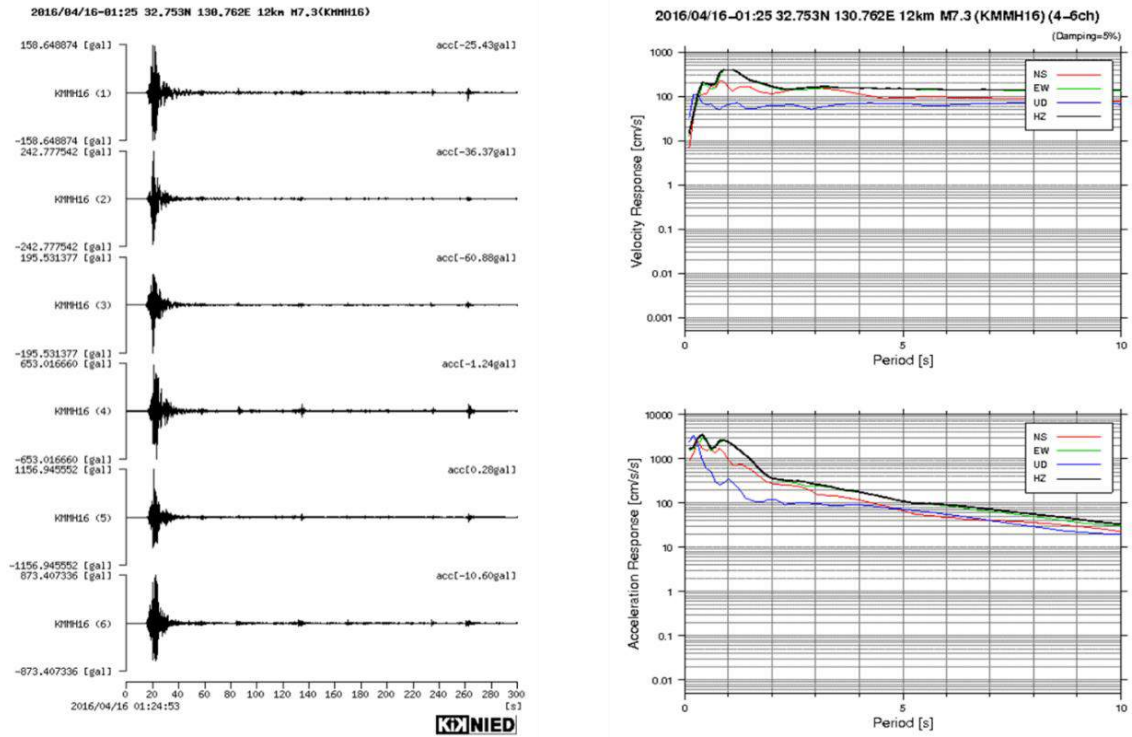
Figure A.3 The recorded acceleration, velocity response, and acceleration response of KMMH16 station at Mashiki town for the main-shock

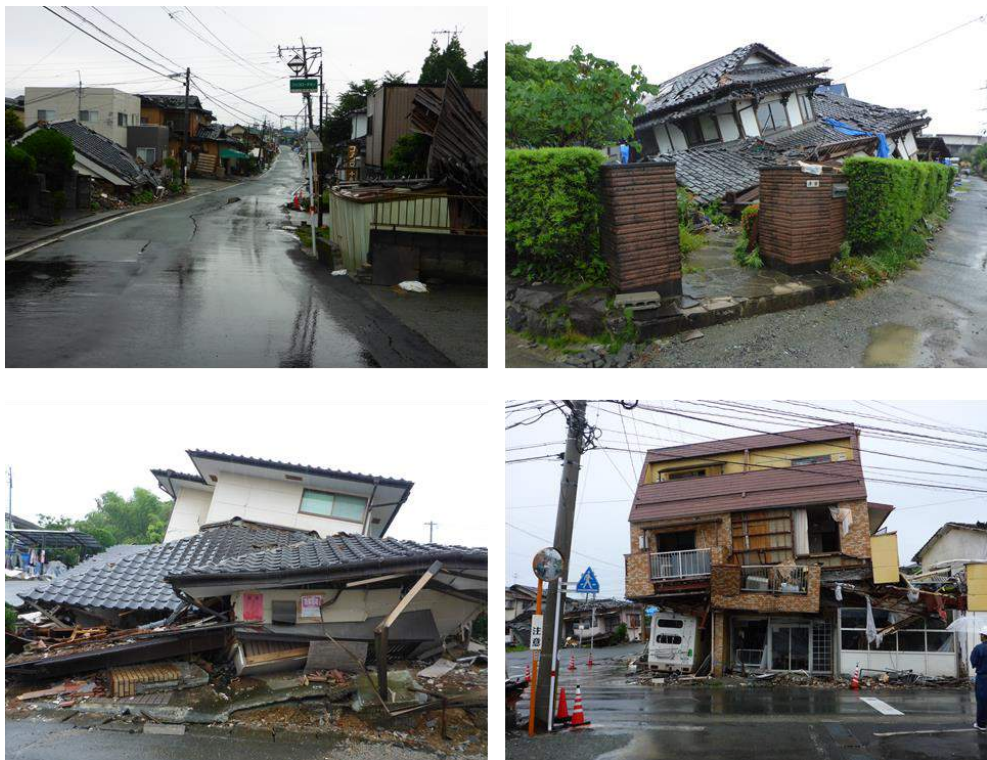
Figure A.4 The residential houses damage in Mashiki town

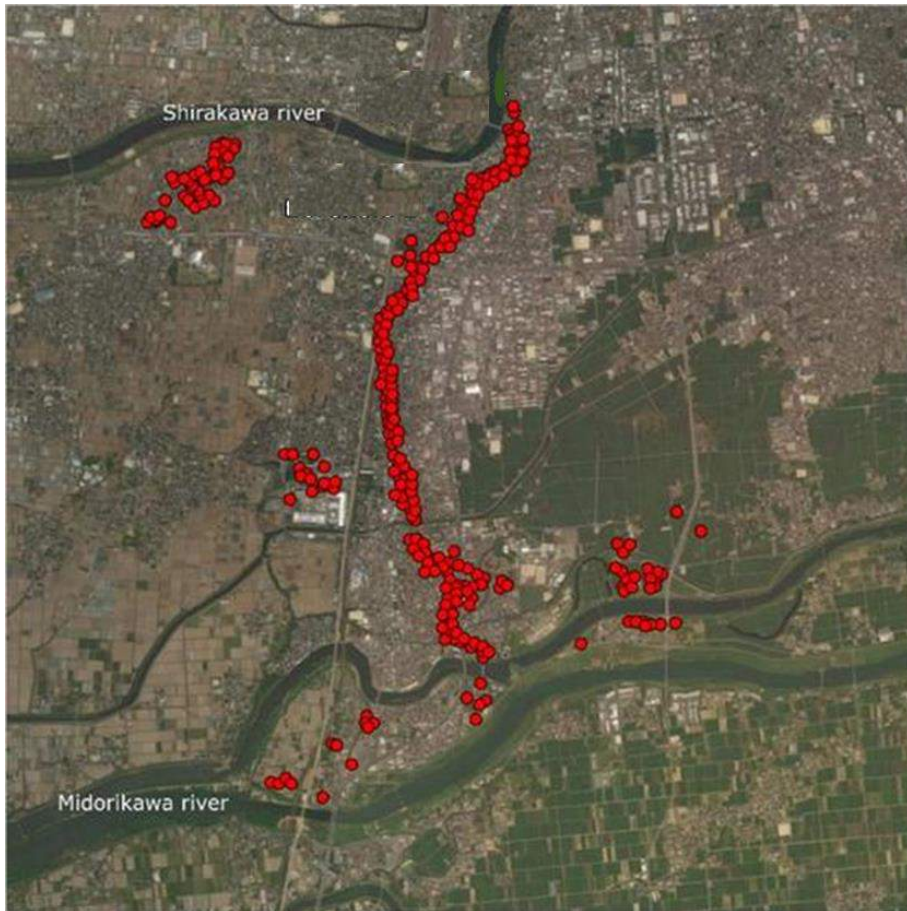
Figure A.7 Liquefaction sites during the 2016 Kumamoto earthquake

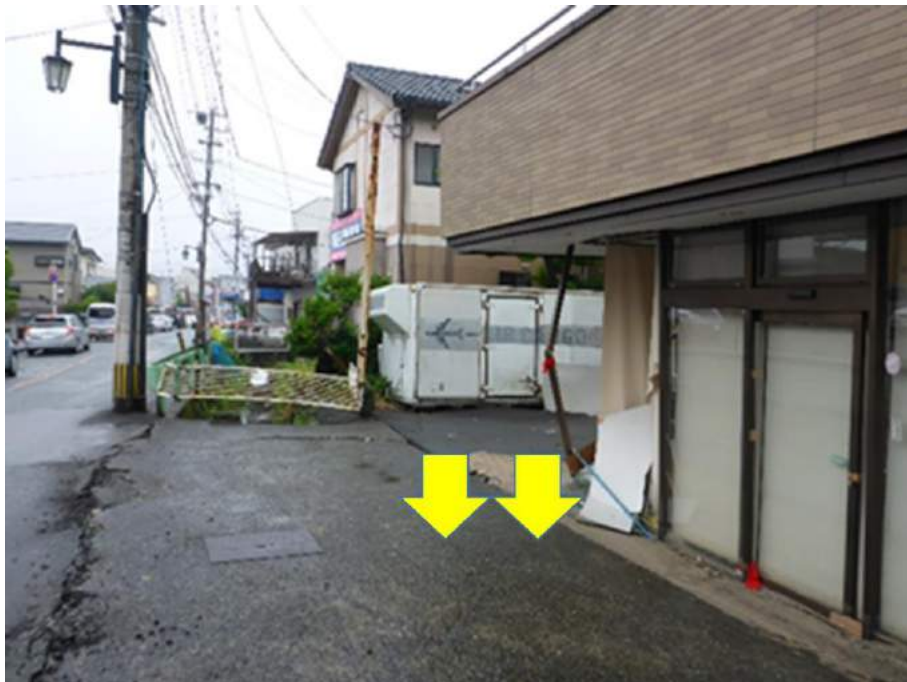
Figure A.8 Liquefaction-induced ground subsidence during the 2016 Kumamoto earthquake

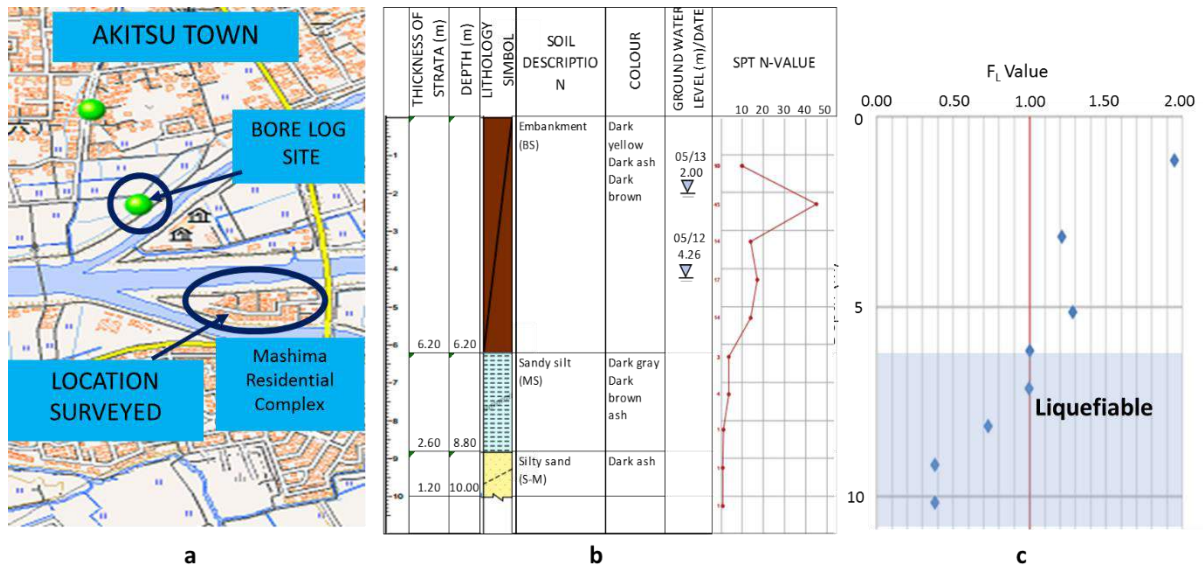
Figure A.14 (a) The location of the survey and the bore hole in Akitsu town
 (b) Boring data obtained in Akitsu town
 (c) Safety factor against liquefaction, F_L

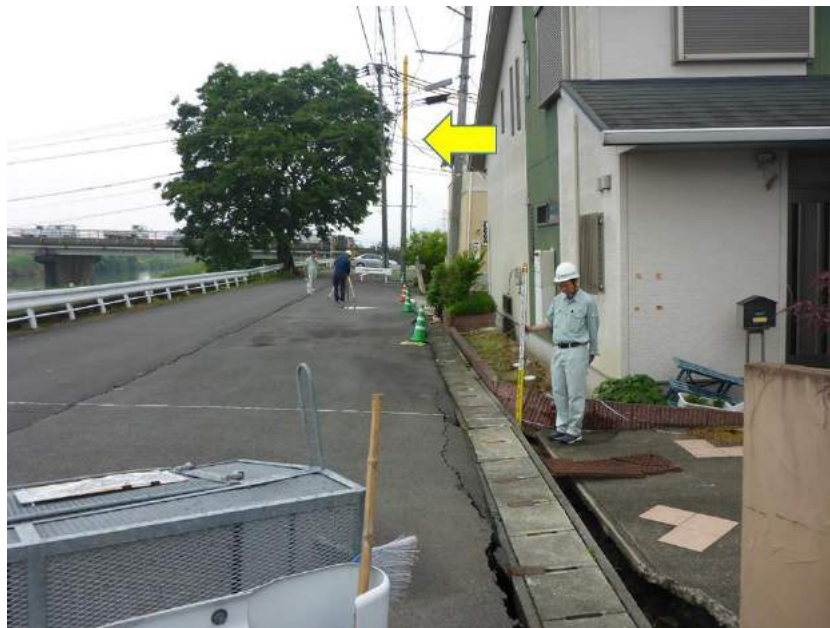
Figure A.16 One of the tilted houses in Akitsu town

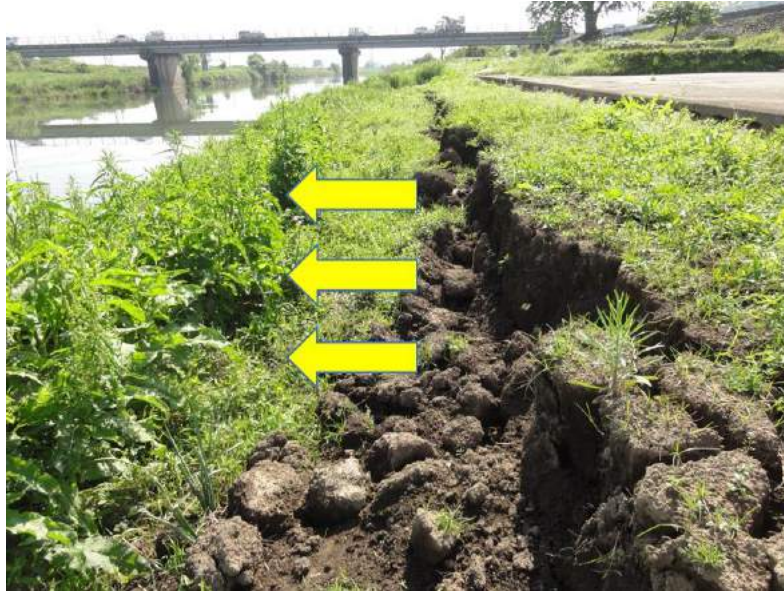
Figure A.17 The lateral spreading occurred at Kiyama Riverbank, Akitsu town

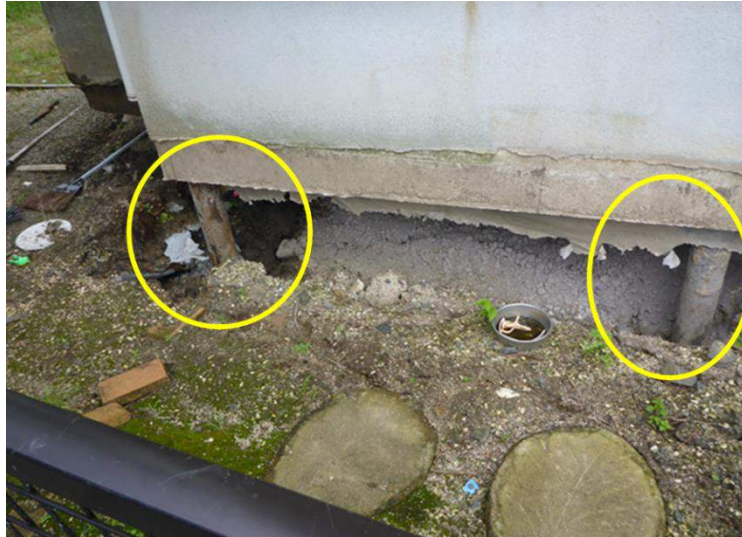
Figure A.19 The pile-supported house which experienced minor inclination in Akitsu town

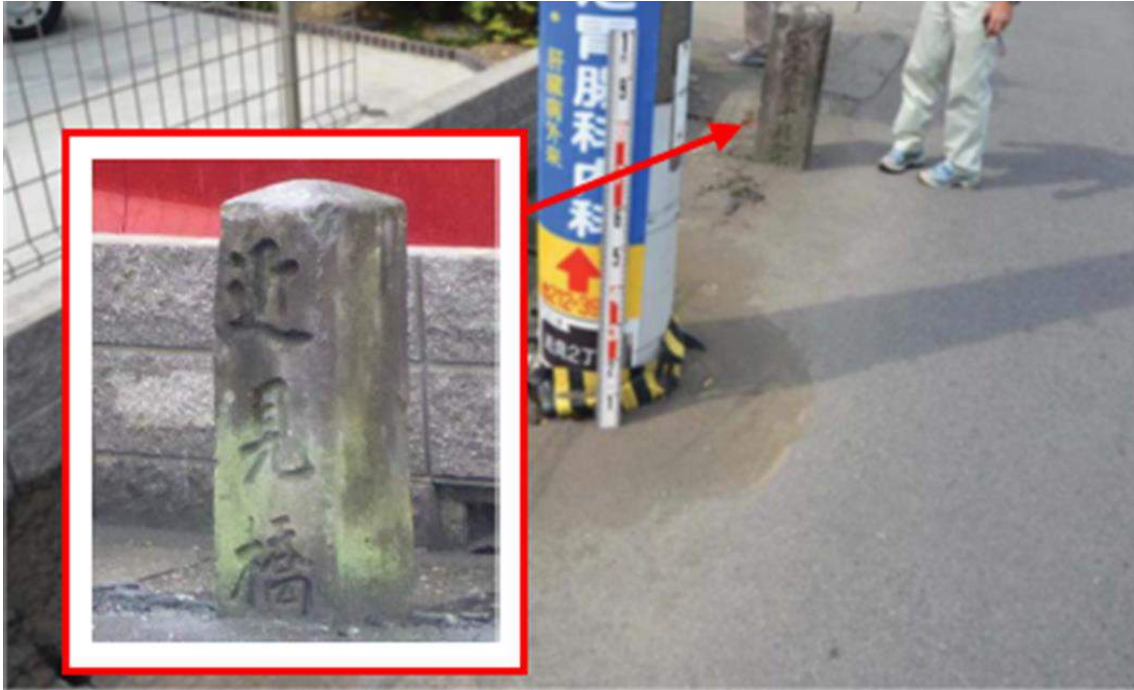
Figure A.22 The guiding pillar of former Chikami bridge

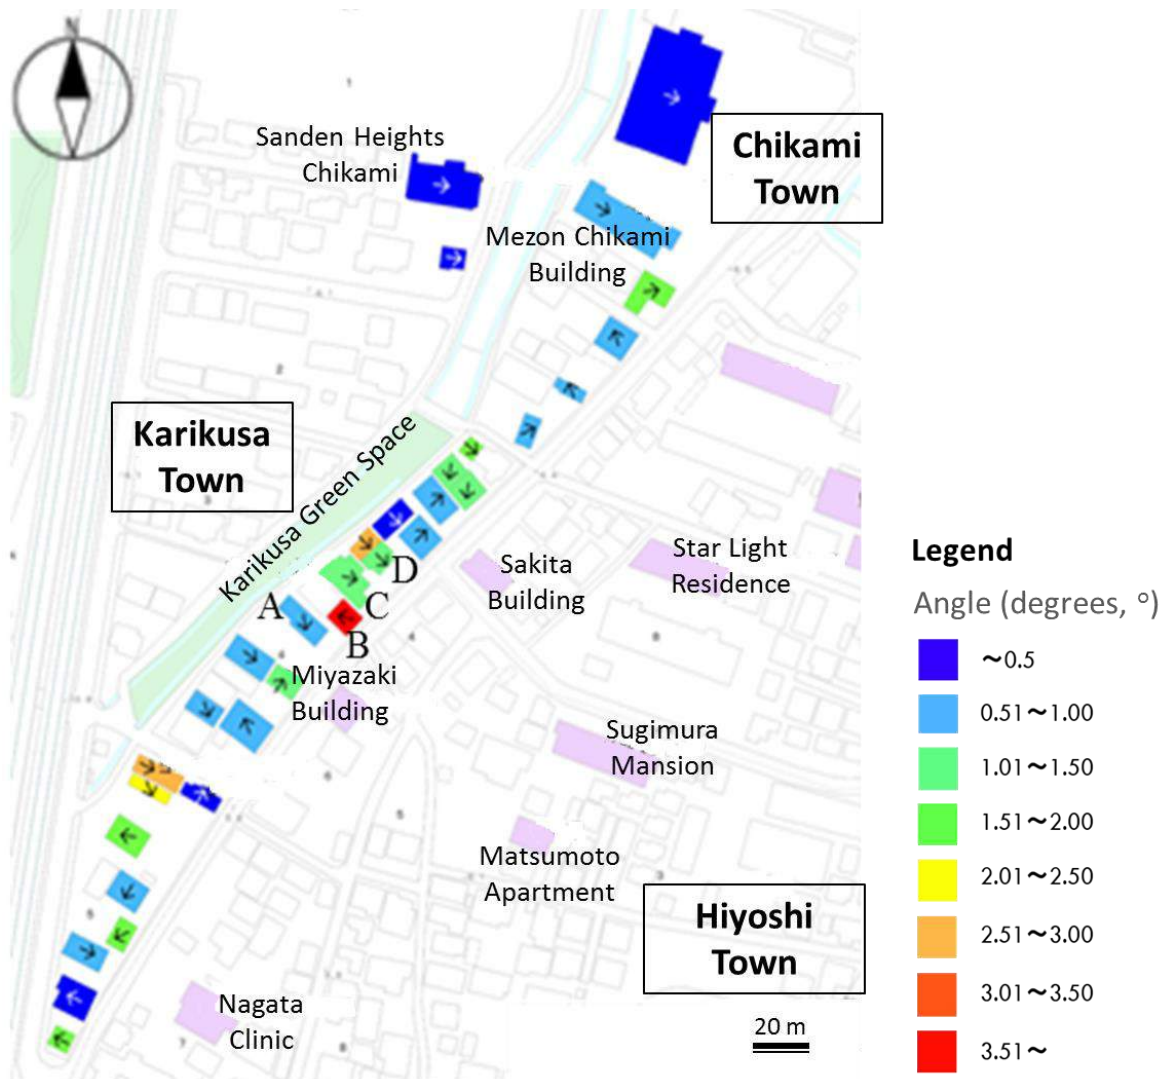
Figure A.25 The inclination angle and direction measured in Karikusa town
