Dissertation

EVALUATION AND COUNTERMEASURE
EFFECTIVENESS OF CONCRETE STRUCTURES
DETERIORATED BY ALKALI-SILICA REACTION
AND DE-ICING SALTS

Graduate School of
Natural Science & Technology
Kanazawa University

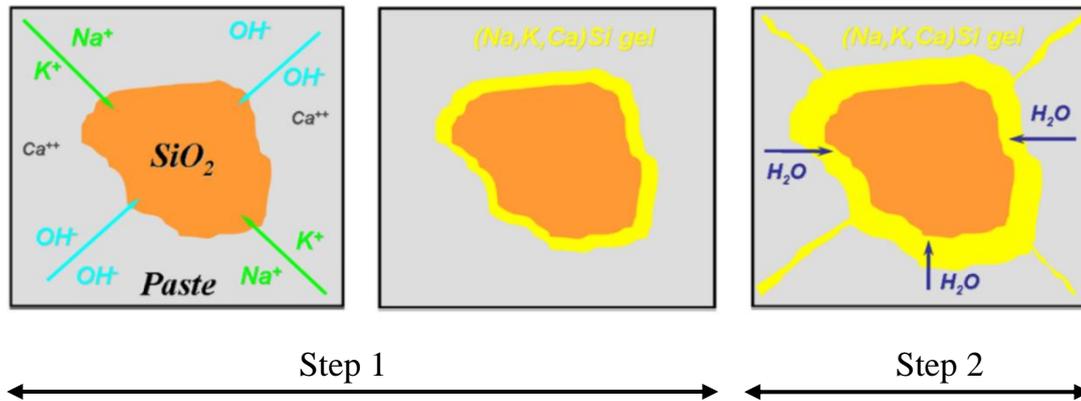
Figure 1.1 Alkali-Silica Reaction sequence (FHWA. 2013)

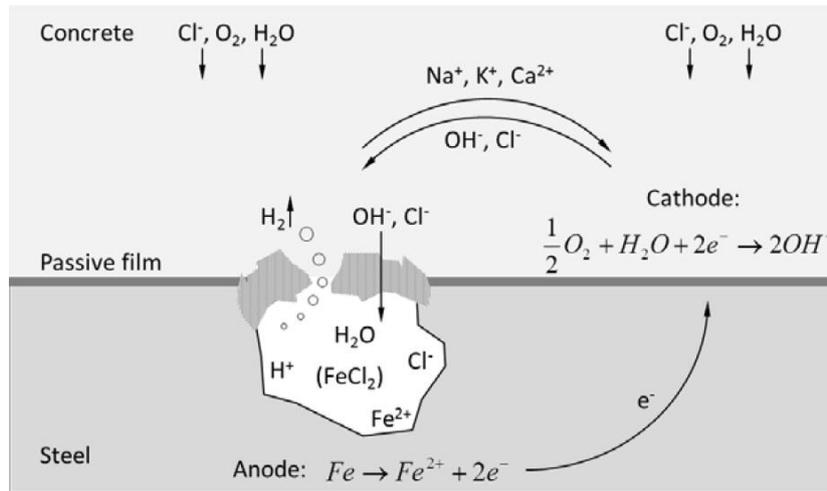
Although the role of chloride-induced corrosion is not yet fully understood, it is considered that process of corrosion in reinforced concrete structures can be schematically represented by **Figure 1.3** (Silva. 2013).

Figure 1.3 Schematic representation of chloride-induced corrosion (*Silva. 2013*)

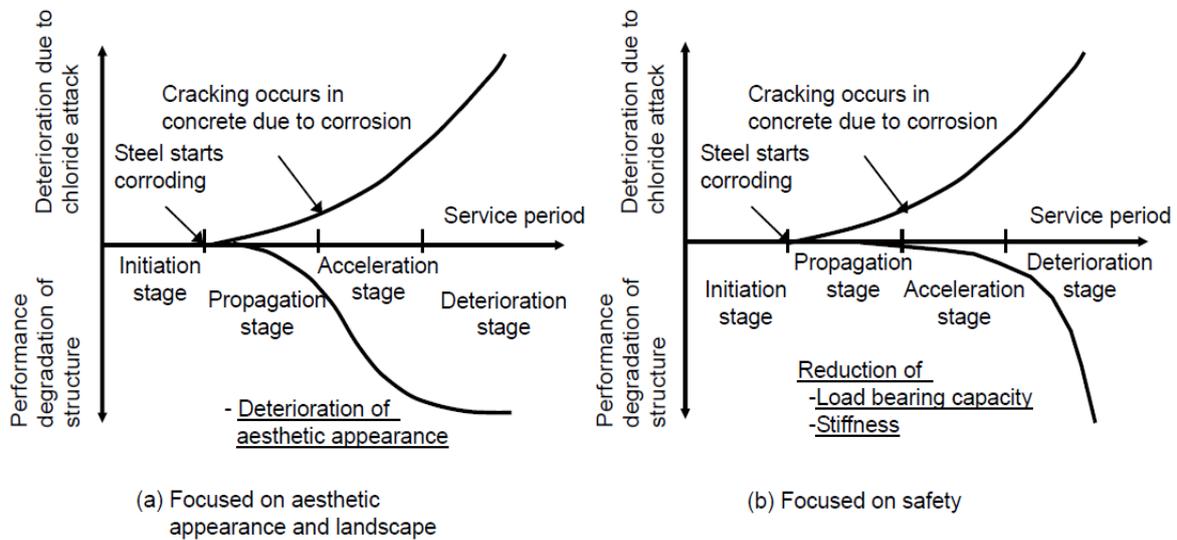
Figure 1.4 Deterioration progress due to chloride attack (JSCE.2010)

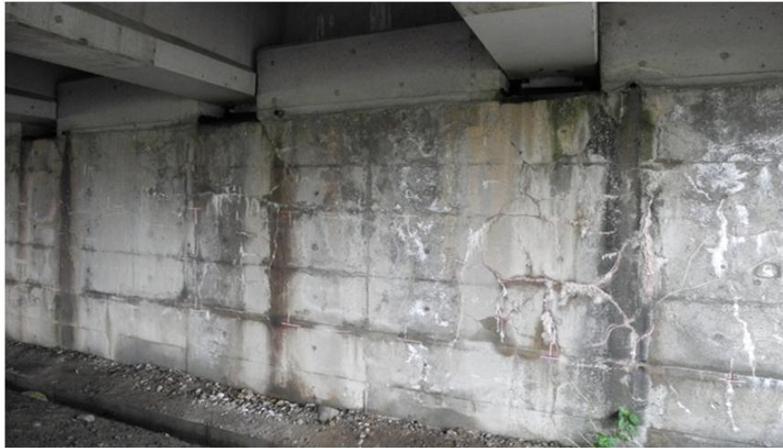
The in-situ survey was conducted on the front wall of target abutments. The occurrence of cracks due to ASR was relatively small and the crack width was almost smaller than 0.5 mm. In addition, the exudation of rust due to steel corrosion on the surface of abutments could not observe by visual inspection. The front walls of these abutments were distinguished into two parts (the up line and the down line) and ten detailed investigation points were selected to observe corrosion grade of reinforcing bars by chipping concrete cover and to analyse chloride ion penetration (chloride ion content profile). **Figure 2.1** shows the current state of abutment A as an example of ASR deteriorated concrete abutment.

Figure 2.1 Abutment A deteriorated by ASR

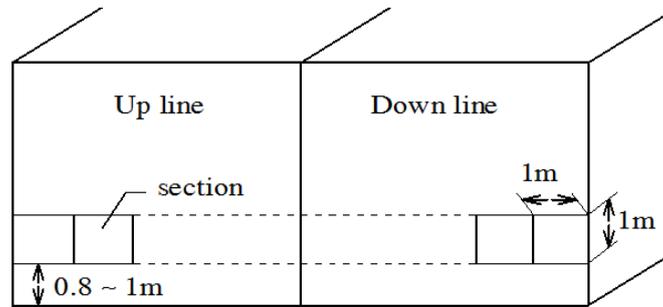
The crack density of an area on the surface of abutments was measured at the height of 0.8m to 1.8m from the ground. The measured area of each abutment was divided horizontally into many sections (1m × 1m) (shown in **Figure 2.2**).

Figure 2.2 Outline of survey sections on each abutment

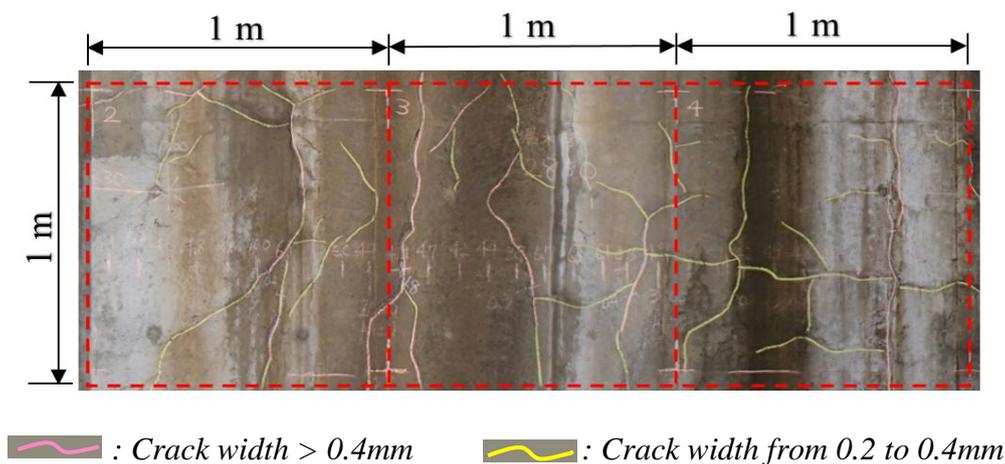
Figure 2.3 Example of crack density measurement

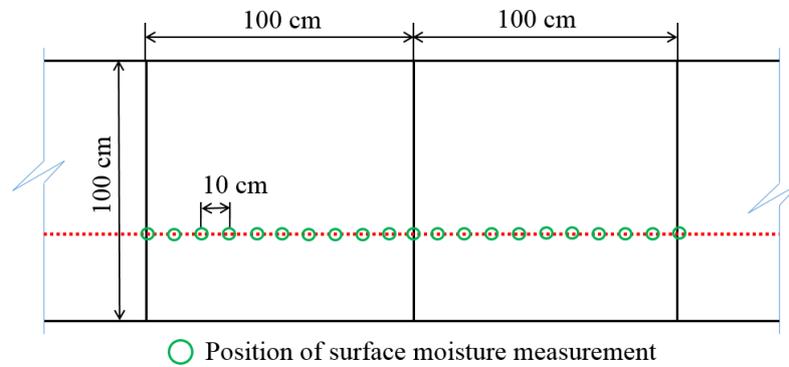
Surface moisture content of concrete was measured by using a high-frequency surface moisture meter and these values were measured horizontally at intervals of 0.1m on the surface concrete of abutments. In each section (1m × 1m), the average value of surface moisture content was calculated from ten measured points of each section. The positions of surface moisture content measurement are shown in **Figure 2.4**. Each average value of surface moisture content compared with crack density of each section on abutment surface and the relation between them are discussed later to clarify the influence of water leakage or de-icing salts on the result of crack density.

Figure 2.4 Measured positions of the surface moisture content

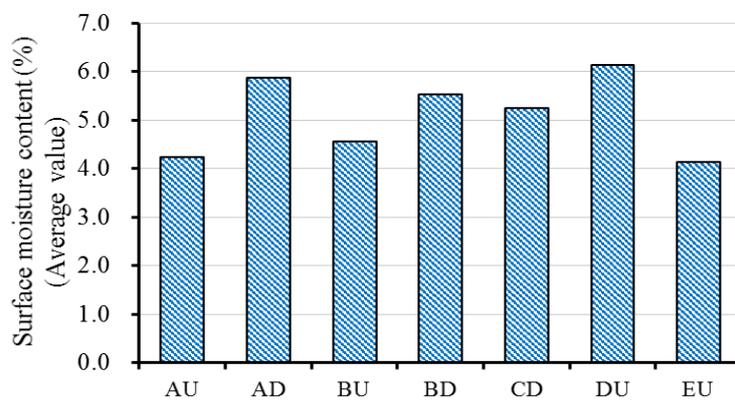
Surface moisture content of concrete for each abutment (discriminated between up line part and down line part) is shown in **Figure 2.6**. The value of surface moisture content of concrete was the average value of all measured points on each abutment.

Figure 2.6 Surface moisture content of all abutments

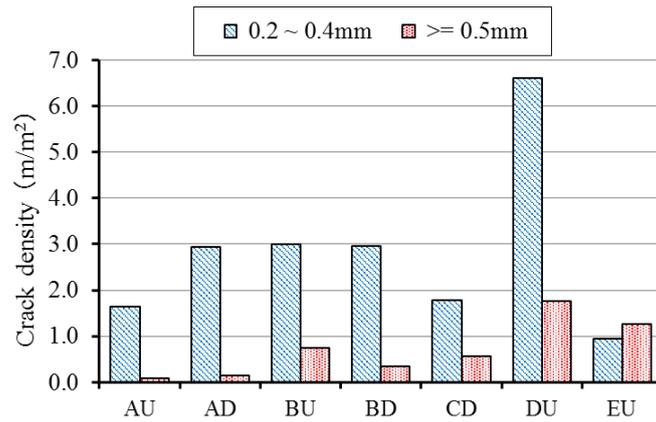
The crack density (m/m^2) of each abutment (discriminated between up line part and down line part) is shown in **Figure 2.7**. The value of crack density was the average value of all measured sections of each bridge abutment. The crack density of small grade of crack width (from 0.2mm to 0.4mm) occurs on most bridge abutments. Almost values of this grade are larger than $2m/m^2$ while those values of large grade of crack width (more than 0.4mm) on all abutments are smaller than $2 m/m^2$. Although many small cracks occurred, result showed that the ASR progress of these abutments was not significant since the crack density of large grade was small.

Figure 2.7 Crack density of abutments

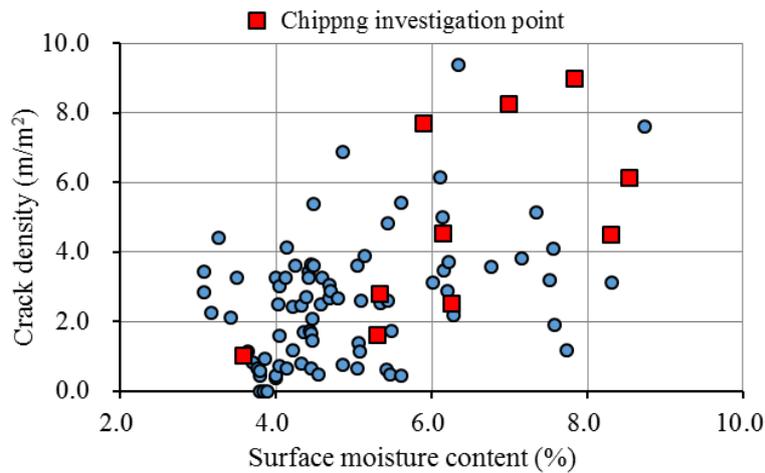
The relationship between crack density of the small grade of crack width (0.2 ~ 0.4mm) and surface moisture content of concrete of each section is shown in **Figure 2.8**. The surface moisture content of concrete in each section (1m × 1m) was averaged of all measured points of that section. In this figure, the square symbol means the value measured at ten points of chipping investigation.

Figure 2.8 Crack density and surface moisture relationship

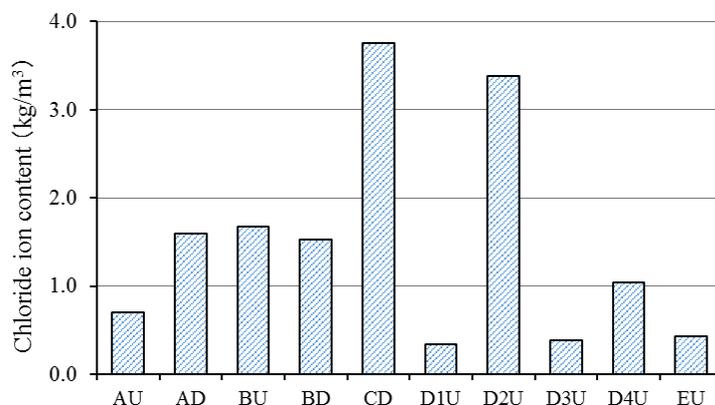
The maximum value of chloride ion content of concrete at the designed cover depth was about 4kg/m^3 and it was obtained in bridge abutment CU. However, the values of chloride ion content of most bridge abutments were lower than 2kg/m^3 . As mentioned above, the front walls of these target abutments were not repaired and crack density on concrete surface was relatively small except for bridge abutment DU. This corresponded to the visual aspect of crack propagation of these concrete abutments. Additionally, concrete cover depth of these abutments is sufficient to maintain the low chloride content at 80 mm of depth. The chloride ion penetration at concrete cover depth is relatively small although ASR deteriorated concrete abutments are affected by de-icing salts.

Figure 2.9 Chloride ion content at concrete cover depth

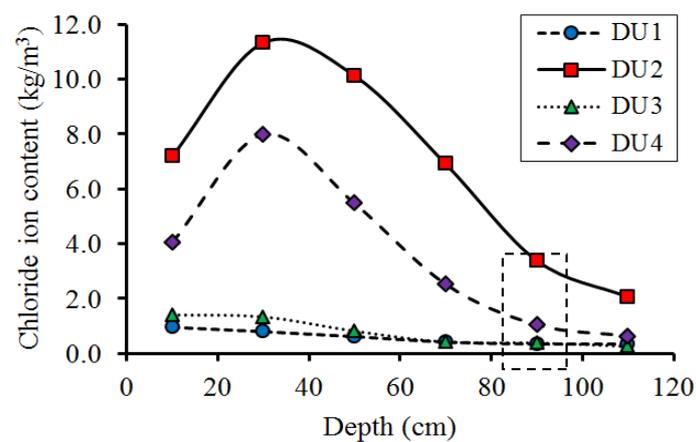
100mm) are smaller than 2.0kg/m^3 except for DU2. On the other hand, chloride ion content of concrete at 50mm of depth on bridge abutment DU2 and DU4 are larger than 4kg/m^3 . The profiles of chloride ion content in abutment DU1 and DU3 show smaller values of chloride ion penetration due to the larger of concrete depth and all values are smaller than 2.0 kg/m^3 . However, these values in abutment DU2 and DU4 are large and it shows larger content of chloride ion in depth from 20mm to 40mm in comparison with values near the surface (0 ~ 20mm). For this reason, water leakage does not contain chloride ions except for winter season. It is considered that water leakage without chloride ion washes the permeated chloride ion out of concrete surface during spring and fall seasons when de-icing salts were not sprayed (Hirano et al. 2010). Thus, chloride ion content near the surface could fluctuate seasonally. In this study, samples of concrete powder for the obtaining chloride ion content profile were carried out during September and October when de-icing salts were not sprayed in this season. Therefore, it is inferred that chloride ion content near the surface is strongly affected and is reduced by the washout action of water leakage without chloride ions for chloride ion content profiles obtained in abutments DU2 and DU4.

Figure 2.10 Chloride ion distributions in abutment D

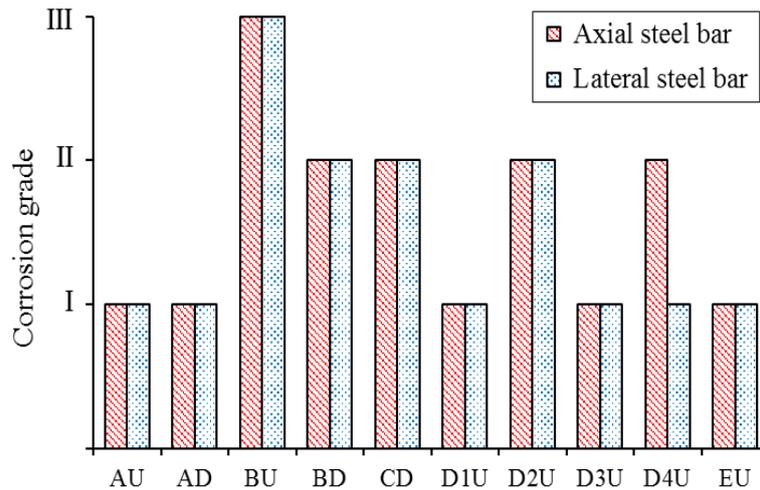
As mentioned above, almost chloride ion contents of concrete cover depth were less than 2.0kg/m^3 . It was confirmed after chipping concrete that most concrete cover depths were larger than designing cover depth. Consequently, it is considered that chloride ion content of concrete at in-situ concrete cover depth is suppressed under the relatively small content of chloride ion penetration and it results in low steel corrosion grade on most abutments.

Figure 2.11 Corrosion grades of steel bars in all abutments

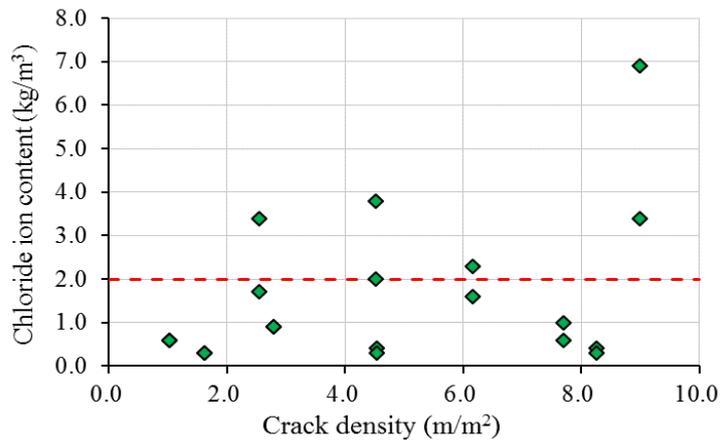
Figure 2.12. Although the variation of data was somewhat large and the relationships between them had a weak correlation, a few values showed the tendency of chloride ion content at concrete cover depth increased with the increase of the crack density of detailed investigation points. Cracks due to ASR influenced locally on chloride ion penetration near the generated crack while crack density was measured for one section (1m × 1m). Thus, it is noted that the crack density obtained in each section did not necessarily correspond to the content of chloride ion penetration of the detailed investigation point. For example, in the same section, crack density was not the same as the point of detailed investigation and crack density ranged widely. Although the relationship between the crack density and the chloride ion content shows a weak correlation, it is considered that the more penetration of chloride ion can be obtained at the position of large crack propagation.

Figure 2.12 Relationship between crack density and chloride ion content

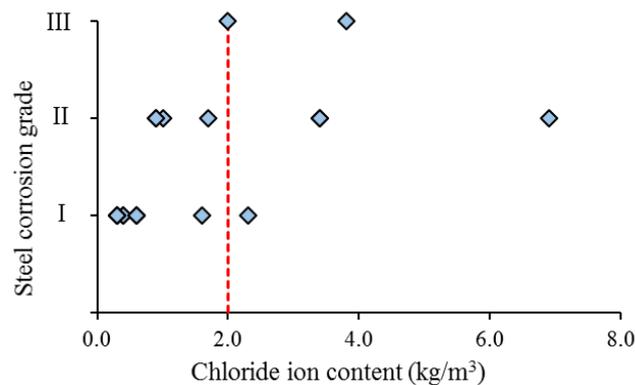
shown in **Figure 2.13**. In the case of more than 2kg/m^3 of chloride ion content of concrete, most steel corrosion grades were grade II or III. These grades indicated steel corrosion was progressed. The previous study (Higashida et al. 2010) investigated the relationship between chloride ion content of concrete at concrete cover depth and steel corrosion grade of steel bar. That study showed that steel corrosion grade III or IV occurred since chloride ion content of concrete at cover depth exceeded 2.4kg/m^3 .

Figure 2.13 Relationship between chloride ion content and steel corrosion grade

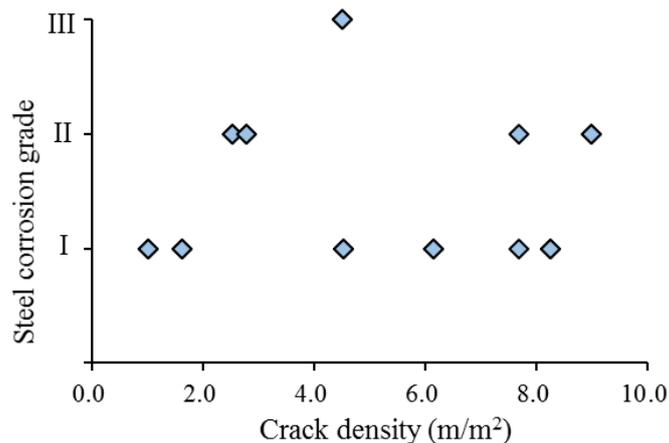
The relationship between crack density and steel corrosion grade of detailed investigation points of all abutments is shown in **Figure 2.14**. When crack density was more than 2.0m/m^2 , half values of steel corrosion grade were grade II or III. On the other hand, even in the case of more than 2.0m/m^2 of crack density, some values of steel corrosion grade were grade I. For this reason, although all abutments were influenced by de-icing salts, chloride ion content at concrete cover depth was not too large to onset the steel corrosion in this survey or the position of crack propagation did not correspond to detailed investigation points.

Figure 2.14 Relationship between crack density and steel corrosion grade

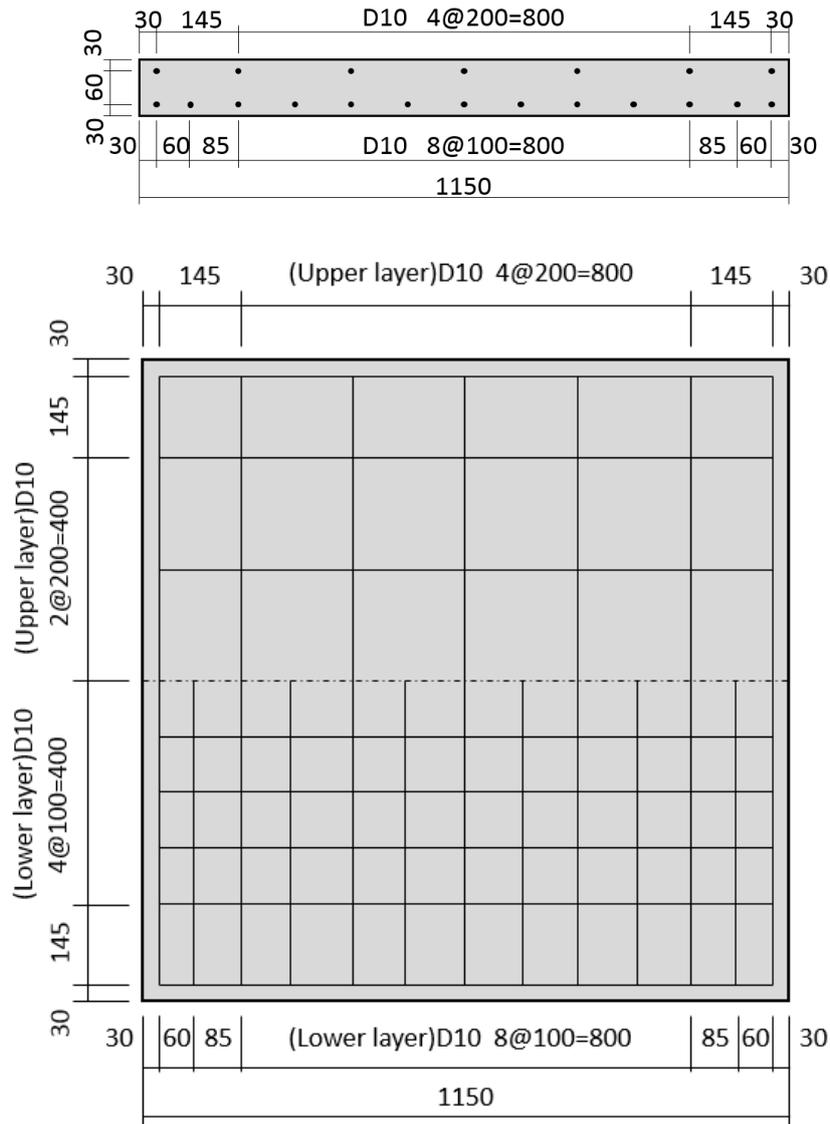
The dimensions of all specimens were 1150mm in length, 1150mm in width and 100mm in thickness. Steel bars D10 were used as reinforcing bars in these slabs and the ratio between steel and concrete was 1.07% (compressive side: 0.36% and tensile side: 0.71%). The number of main and distribution reinforcing bars in slabs was set equal and these bars were placed at 20mm, 80mm, and 30mm, 70mm from the top of concrete slabs, respectively. The positions and the number of steel bars in experimental concrete slabs were described in **Figure 3.1**.

Figure 3.1 The position of steel bars in the specimens

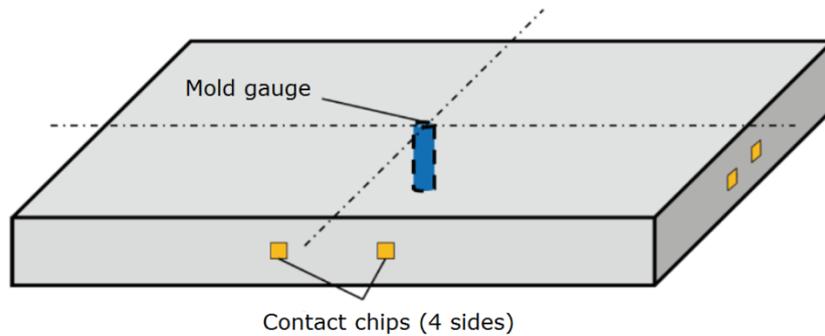
50 mm) was buried via the vertical direction (thickness direction) at the center of a specimen and the vertical expansive strain was measured. Contact gauge chips were attached to the concrete surface at four sides of each specimen and the expansive strain via horizontal direction was measured (base length: 250 mm). The measurement positions of mold gauge and contact gauge chips of each specimen are shown in **Figure 3.2**.

Figure 3.2 Positions of contact gauge chips and mold gauge

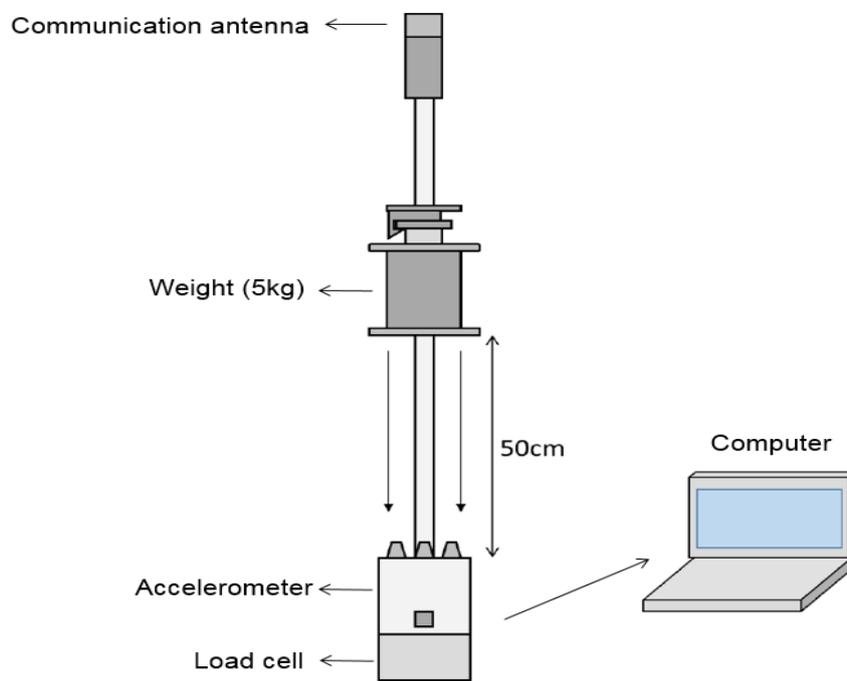
Using the compact FWD equipment (see in **Figure 3.3**), the center displacement (maximum value) and the impact load were measured with a height of 50cm and a weight of 5kg. These concrete slabs were fixed at four sides on the firm steel frame (see in **Figure 3.4**) and the weight was loaded at the center of each slab. The deflection of each slab was measured from three to five times to ensure the accuracy of the data.

Figure 3.3 FWD equipment

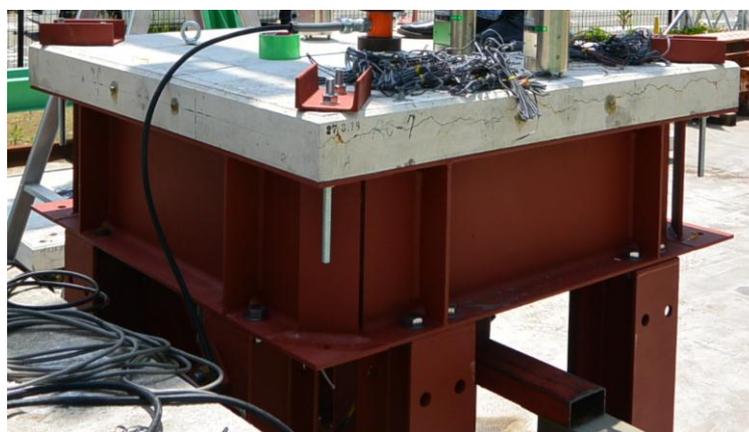
Figure 3.4 The steel frame for FWD experiment

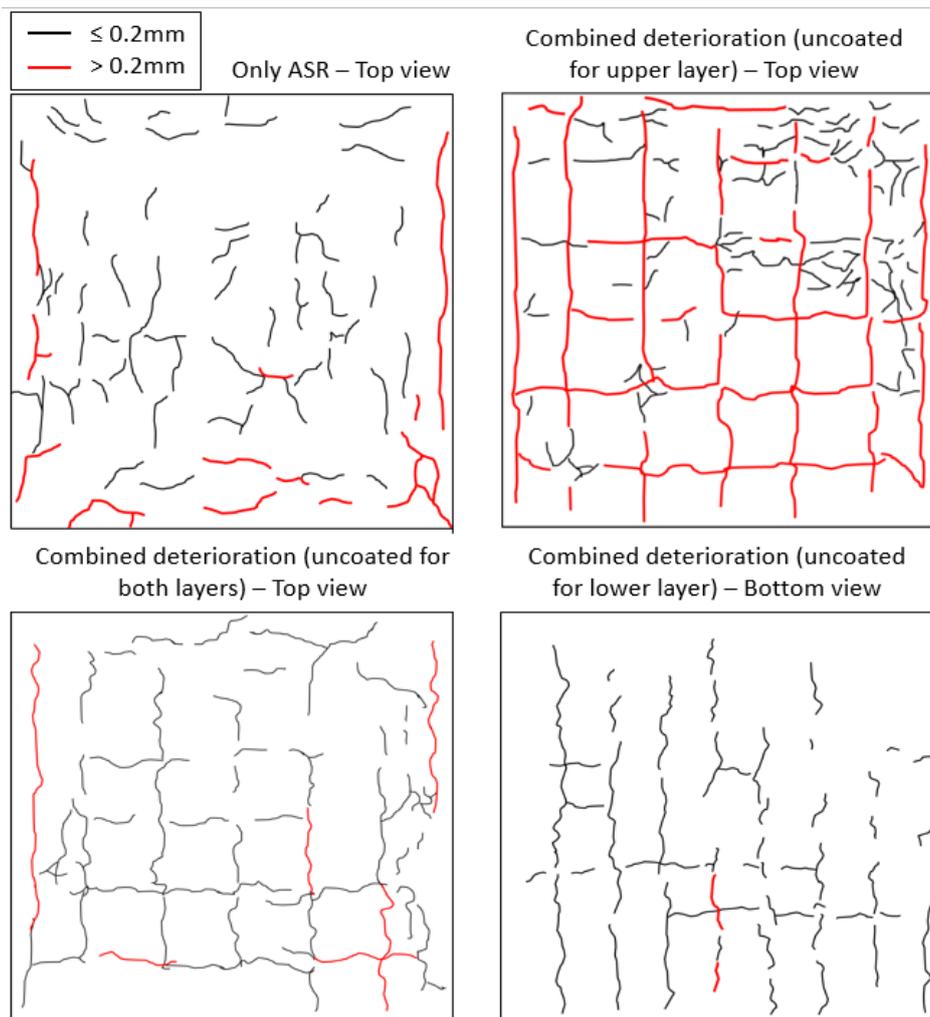
could contribute significantly to reduce the number and the width of cracks in comparison with specimen AC-U. In particular, the more steel bars of lower layer had a better effect for the tensile strength of concrete and it could result in the smaller number and width of cracks caused by ASR expansion. In the specimen AC-B that both layers of steel bars were not coated with epoxy, many cracks on upper surface occurred along steel bar positions and these cracks did not become noticeable (almost crack width of 0.2mm or less). It is considered that ASR expansion in this slab was dispersed to both upper and lower surfaces, although both steel bar layers were corroded due to chloride attack.

Figure 3.5 Sketching of cracks on the surface of some specimens

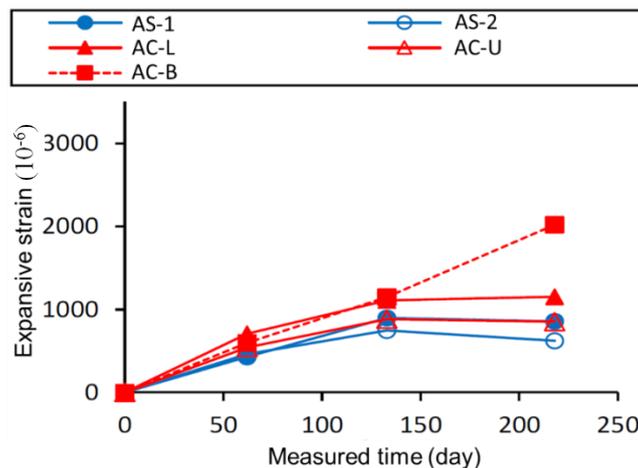
The horizontal expansive strain measured on the side surfaces of slab specimens is shown in **Figure 3.6**. Since the ratio of the main and the distribution steel bars was the same, the average value was calculated from the expansive strain at four sides and it was taken as the expansive strain of each specimen.

Figure 3.6 Expansive strains along the horizontal direction

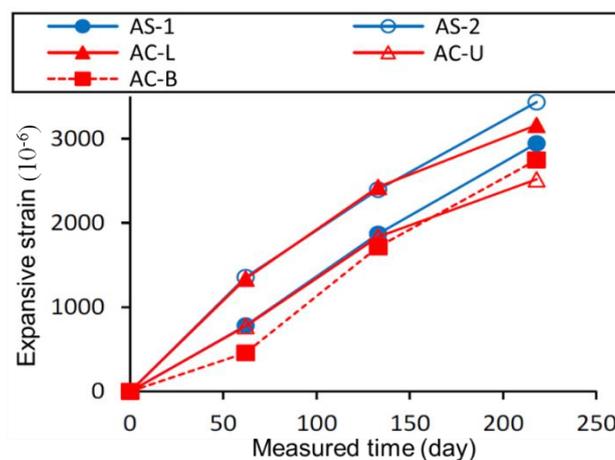
The expansive strain along the thickness direction of concrete slabs is shown in **Figure 3.7** and these values were from 2500 to 3500 x 10⁻⁶ at the end of measurement. This measurement was carried out by the mold gauge buried at the center of slabs. The values of expansion along the thickness direction of all specimens affected by ASR or combined deterioration were similar or it seems that there is no significant difference between these cases. The large expansive strain could be explained due to steel bars did not restrain the expansion along the thickness direction in both cases of specimens affected by only ASR and combined deterioration.

Figure 3.7 Expansive strains along the thickness direction

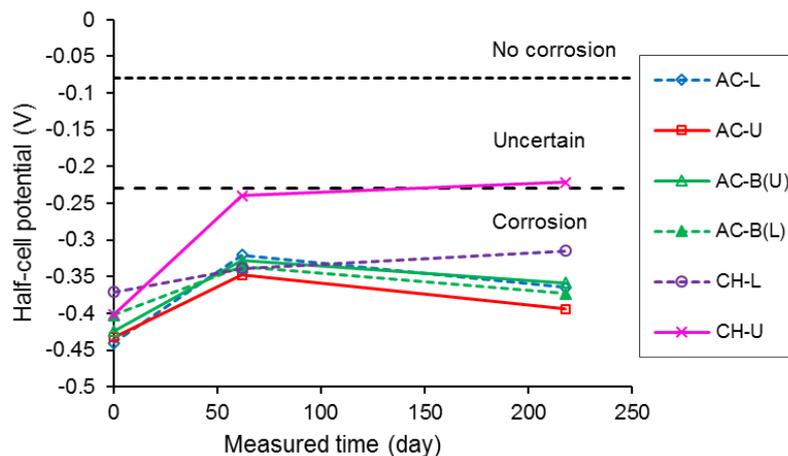
The measurement results of half-cell potential and polarization resistance of specimens affected by only ASR and combined deterioration are shown in **Figure 3.9** and **Figure 3.10**, respectively. Most of the values of half-cell potential shown in the corrosion zone indicate steel bars in all specimens could be corroded. The content of chloride ion mixed in specimens affected by combined deterioration and only chloride attack was 7.6 kg/m^3 and 5.0 kg/m^3 , respectively. The suitable content of NaCl or chloride ion added in these specimens revealed the corrosion risk of steel by half-cell potential measurement. Additionally, all specimens were kept in the environmental conditions to promote the ASR (steamed at 50°C from 10 to 12 hours per day), thus, steel corrosion could be developed faster in this environment. Before the measurement by electrochemical method (half-cell potential and polarization resistance), the steam curing was stopped and all specimens were stored in room temperature, then the measurement was carried out.

Figure 3.9 Half-cell potential of specimens affected by chloride attack

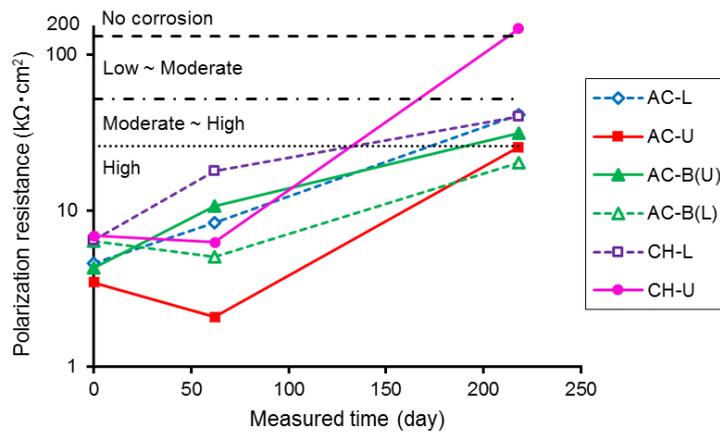
Regarding the polarization resistance values, although the result showed a tendency that these values had been increasing (decrease in corrosion rate) with the increase of promotional period, most value was shown in the high and the moderate to high corrosion zones. In the calculation of polarization resistance value, the polarization range was assumed of 10 cm. The polarization range decreased when corrosion occurred and there was a possibility that it was shifted to a smaller polarization range than the presumption. Therefore, it is necessary to conduct concrete chipping and to investigate the actual situation of steel corrosion.

Figure 3.10 Polarization resistance of specimen affected by chloride attack

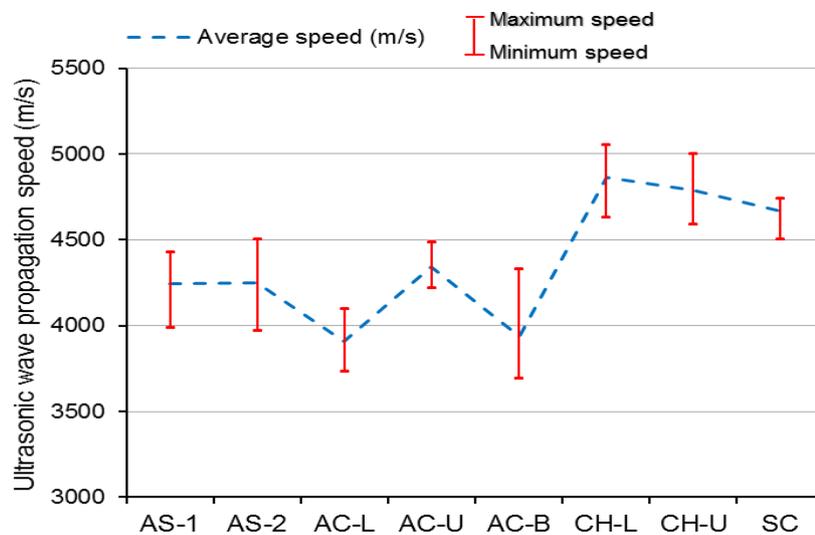
were calculated from all measured points on each specimen, the maximum and minimum values are shown in this figure. As for the average value, the ultrasonic propagation speed of sound concrete slab was about 4700 m/s while these values of slabs affected by ASR alone and combined deterioration were lower than 4300 m/s or even below 4000 m/s in the case of combined deterioration. However, in the case of specimens affected by chloride attack alone, the ultrasonic wave propagation speed is same as the case of sound concrete. The horizontal cracks and/or cracks inside specimens, which was the result of ASR expansion along the thickness direction, became a significant reason for the decrease of ultrasonic propagation speed of specimens affected by ASR alone and combined deterioration.

Figure 3.11 The ultrasonic propagation speed of all specimens

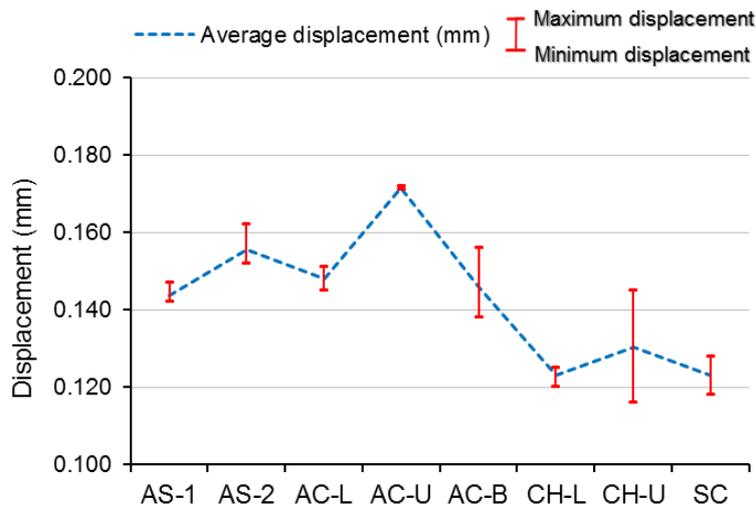
Figure 3.13 The center displacement of all specimens by FWD measurement

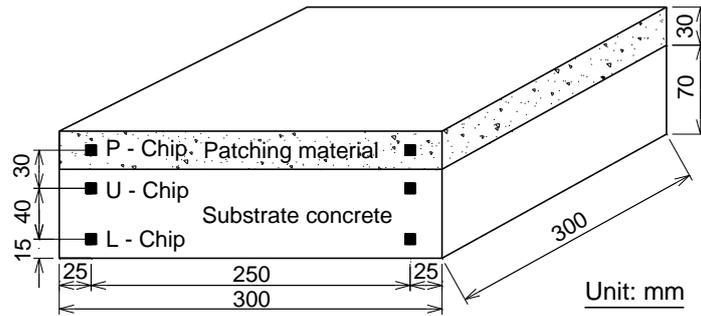
Figure 4.1 Dimension and contact chips position of specimens in series 1

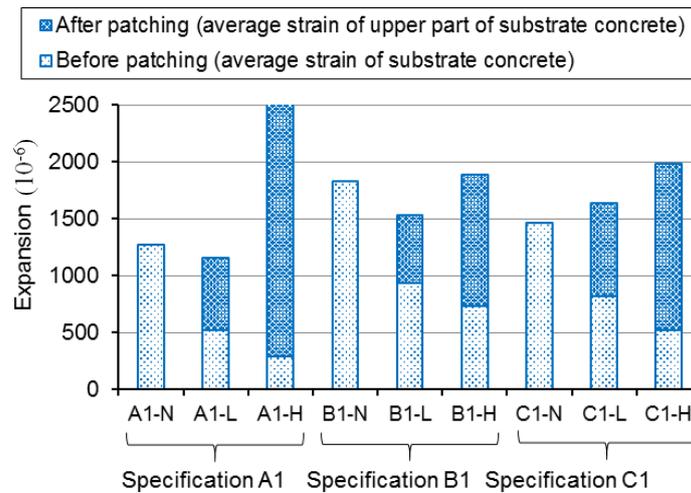
Figure 4.2 Expansive strains of substrate concrete specimen in experimental series 1

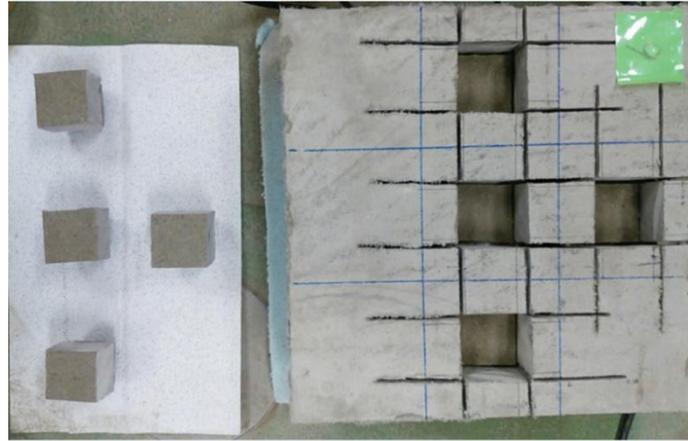
In order to investigate the influence of expansion on the interface between patching material and substrate concrete, the adhesive strength was measured by the pull-off test. On the surface of specimens, notches were formed along a square of 50mm × 50mm, and the depth of notches was 40mm. Adhesion tests were carried out in three stages of attaining expansion of low-level, high-level and no expansion. The cutting notch position and the concrete blocks obtained after adhesion test are shown in **Figure 4.3**.

Figure 4.3 The positions of adhesion test on the upper surface

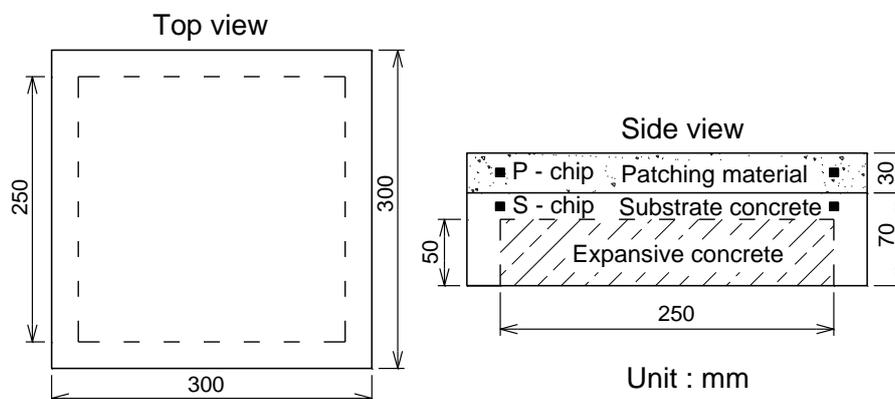
Figure 4.4 Dimension and contact chips position of specimens in series 2

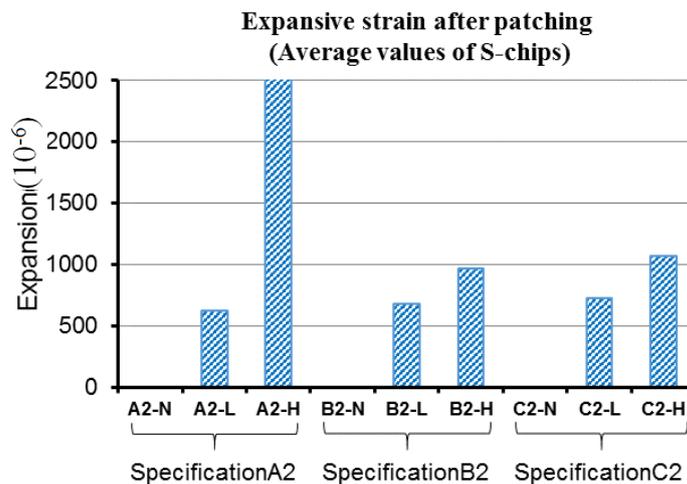
Figure 4.5 Expansive strains of substrate concrete in experimental series 2

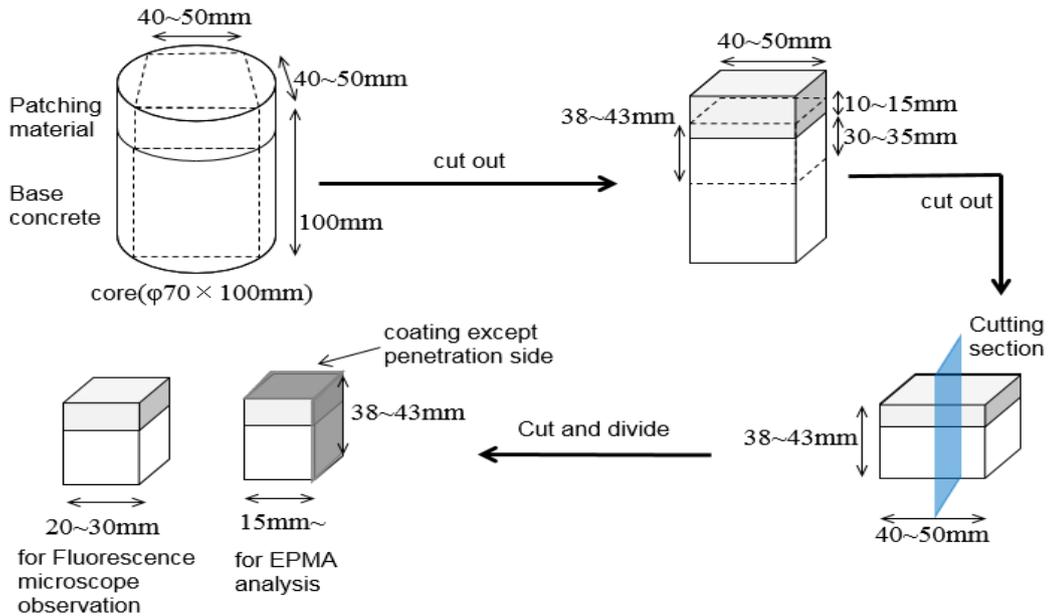
Figure 4.6 Observation sample for EPMA test and fluorescence microscope analysis

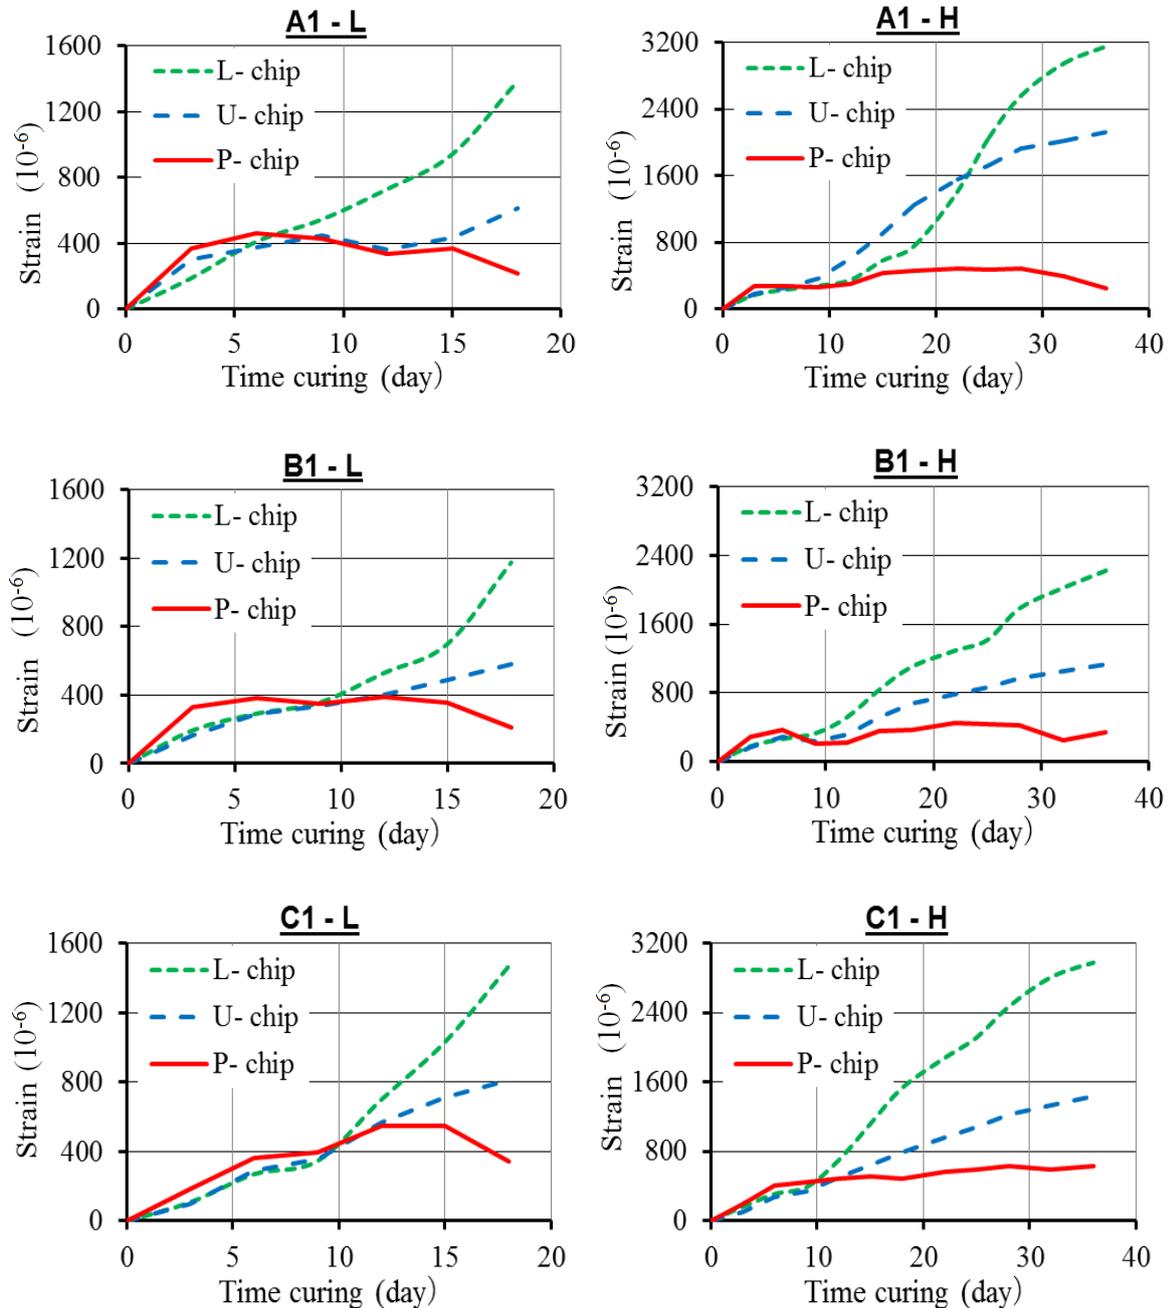
Figure 4.7 Expansion behavior of specimens in series 1

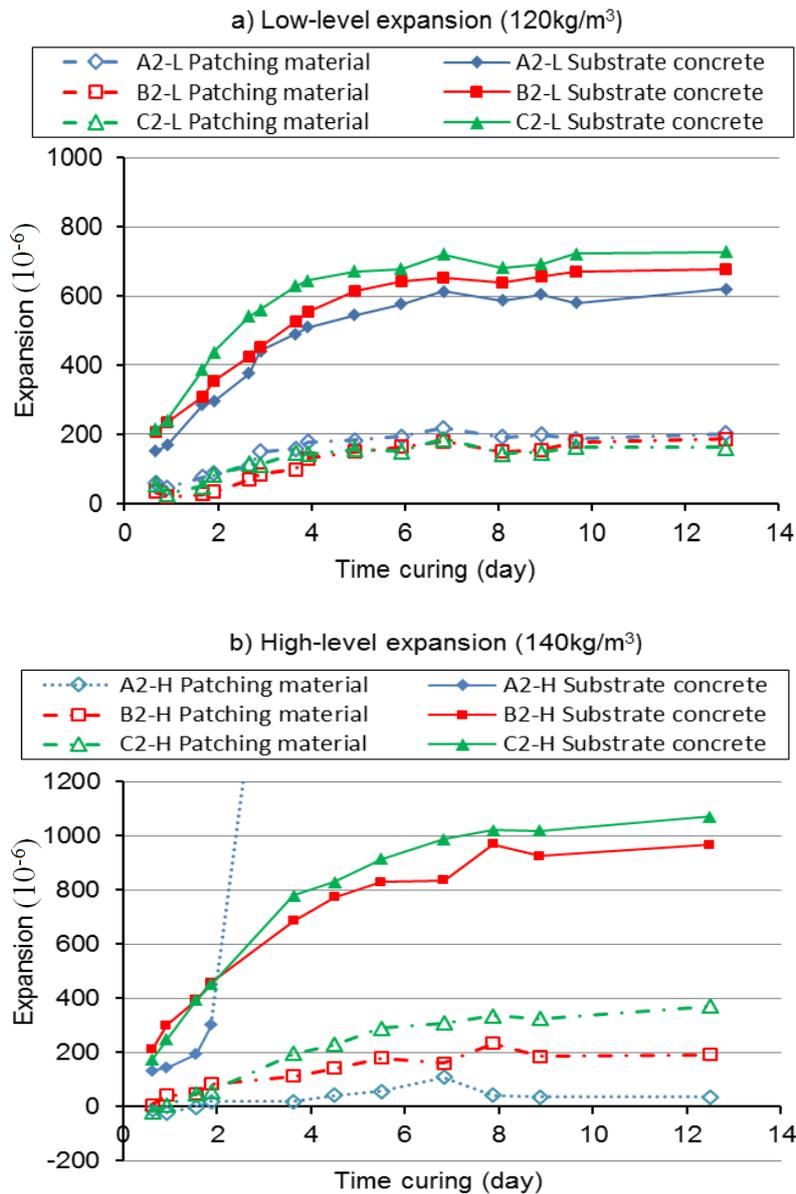
Figure 4.8 Expansion behavior of specimens in series 2

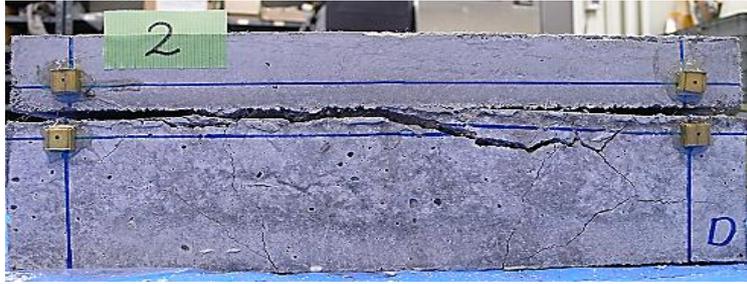
Figure 4.9 Appearance of cracks in the specimen A2-H

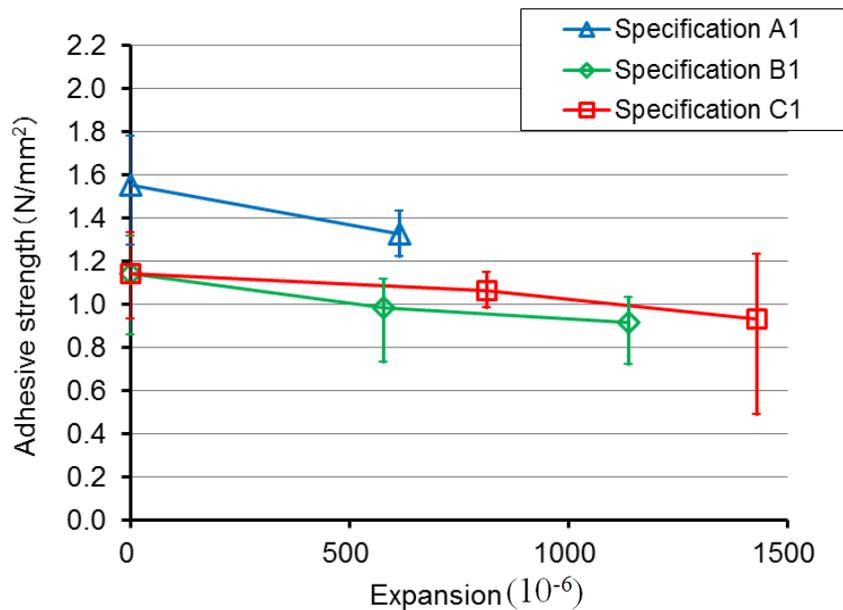
Figure 4.10 Adhesive strengths of experimental series 1

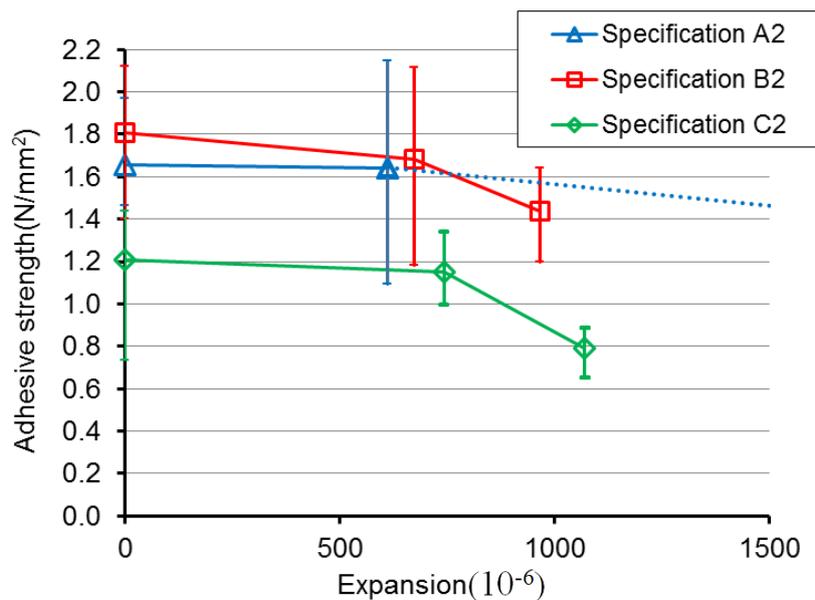
Figure 4.11 Adhesive strengths of experimental series 2

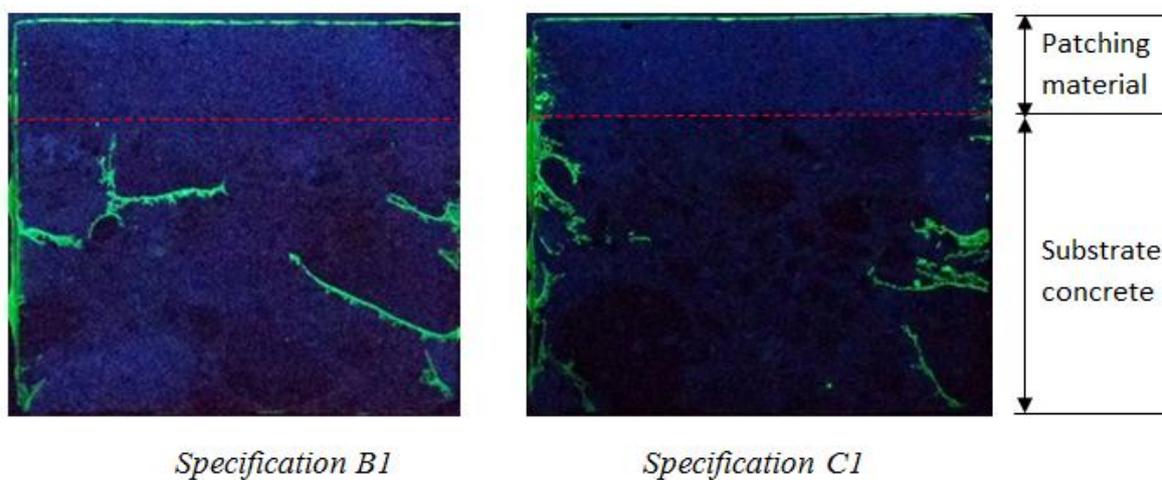
Figure 4.12 Fluorescence impregnation images in series 1

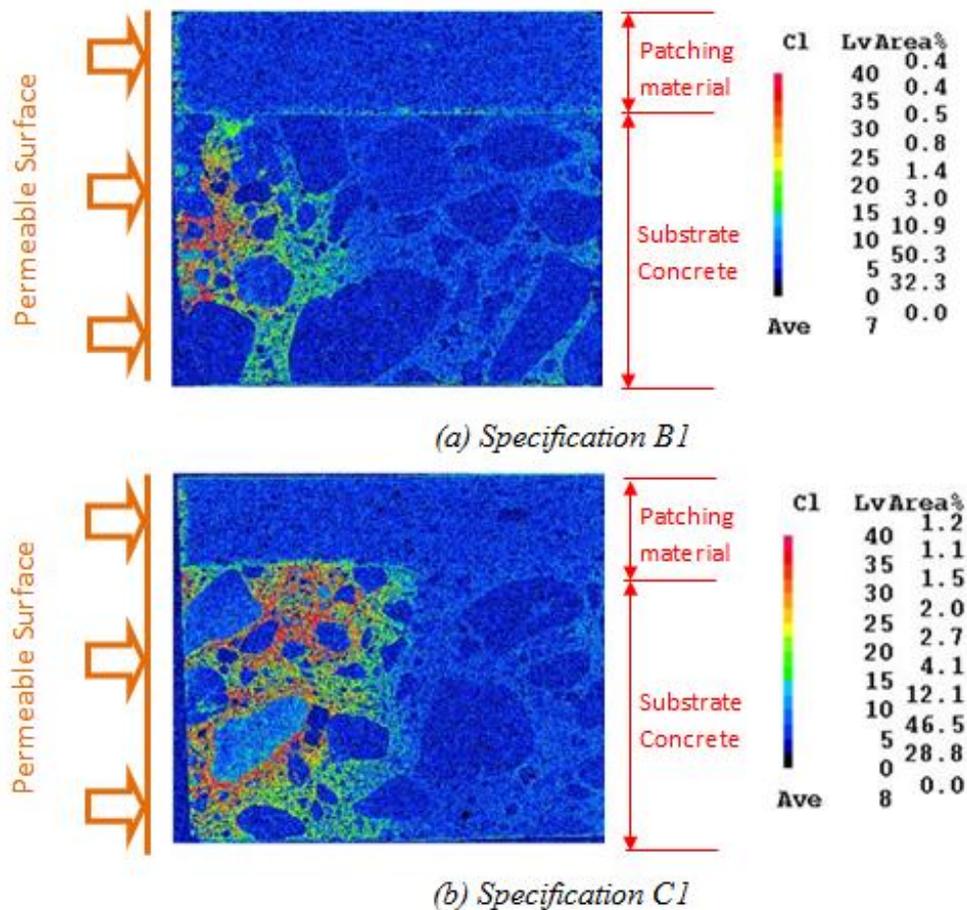
Figure 4.13 EPMA images of specimens in series 1
