Dissertation

EVALUATION AND COUNTERMEASURE
EFFECTIVENESS OF CONCRETE STRUCTURES
DETERIORATED BY ALKALI-SILICA REACTION
AND DE-ICING SALTS

Graduate School of
Natural Science & Technology
Kanazawa University

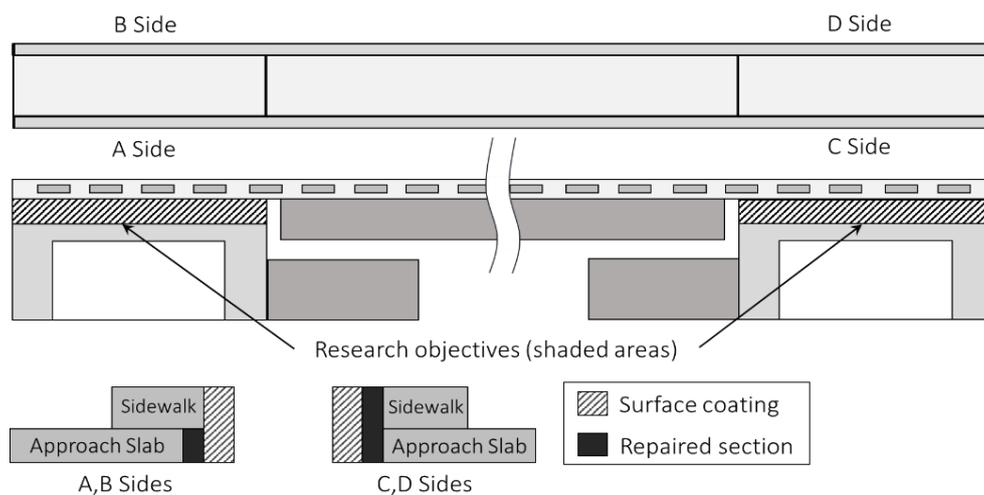
Figure 5.1 Outline of the target bridge

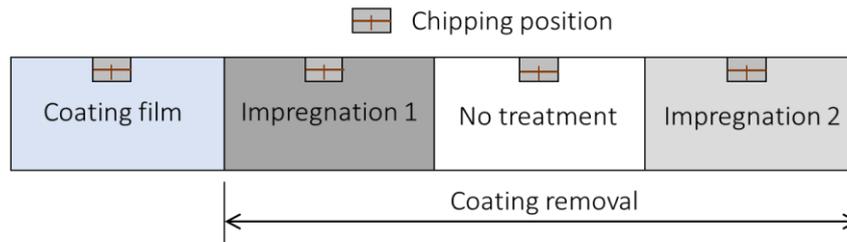
Figure 5.3 Position of surface impregnation parts

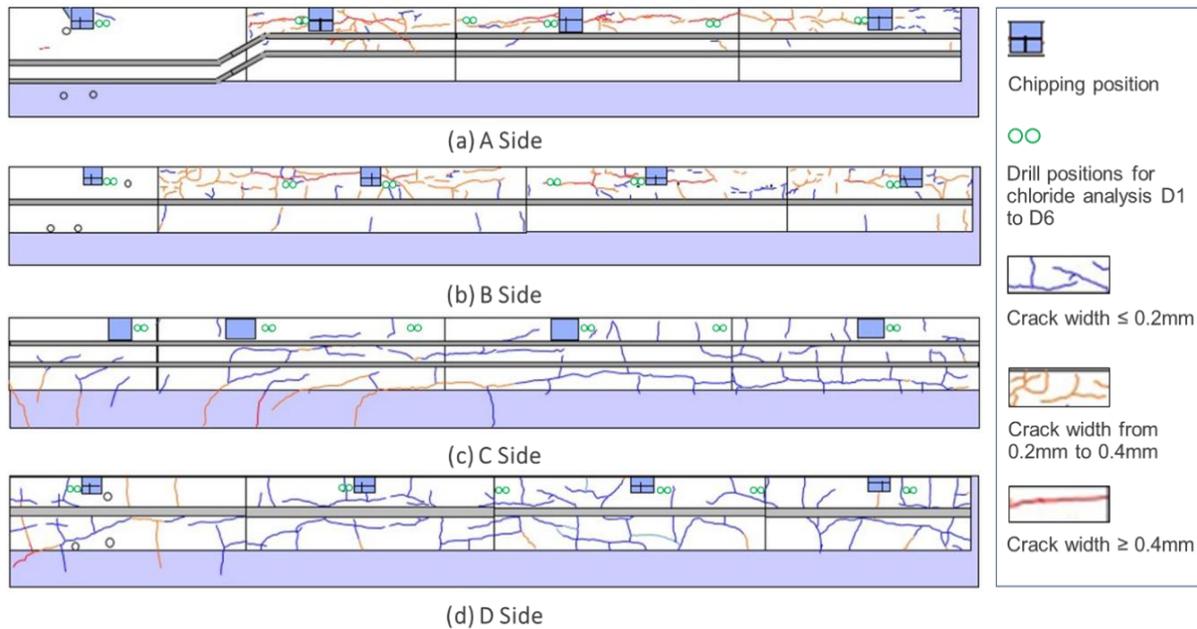
Figure 5.4 Cracks sketching on four sides of wheel guard structure

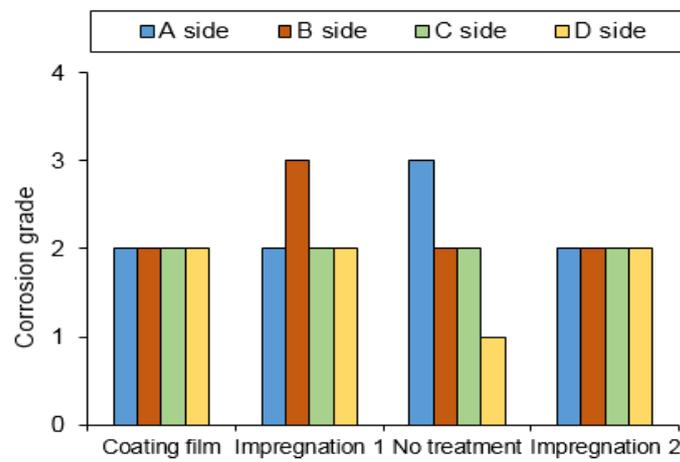
Figure 5.5 Corrosion grade of axial steel bars

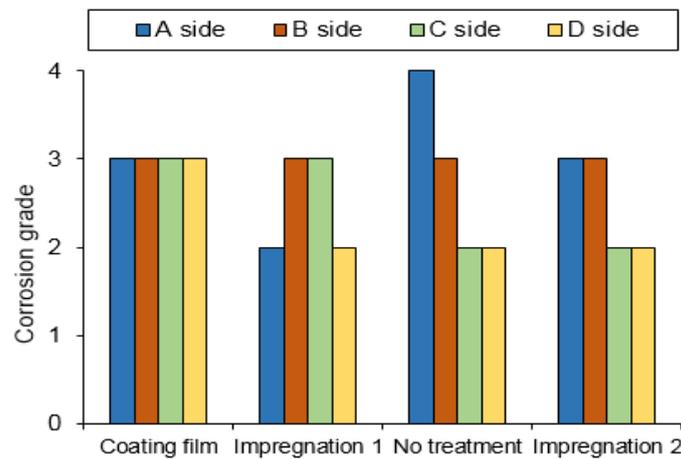
Figure 5.6 Corrosion grade of lateral steel bars

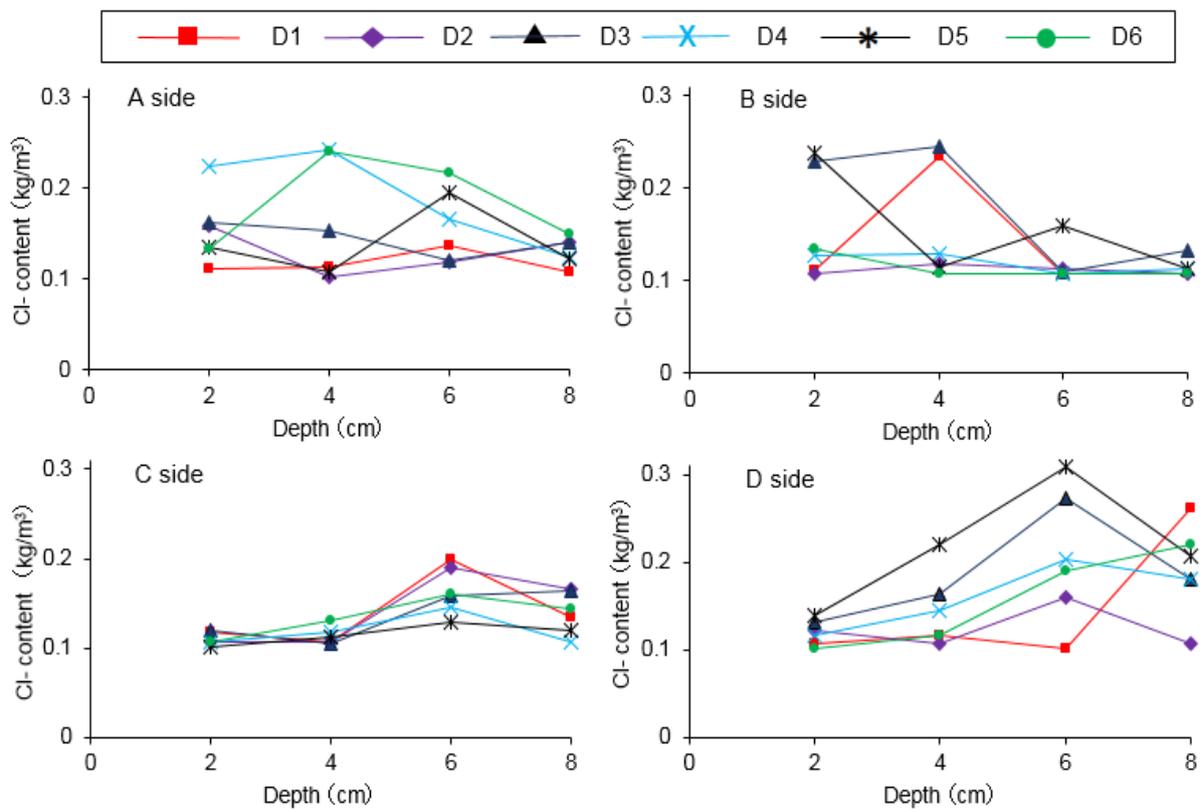
Figure 5.7 Chloride ions content distribution

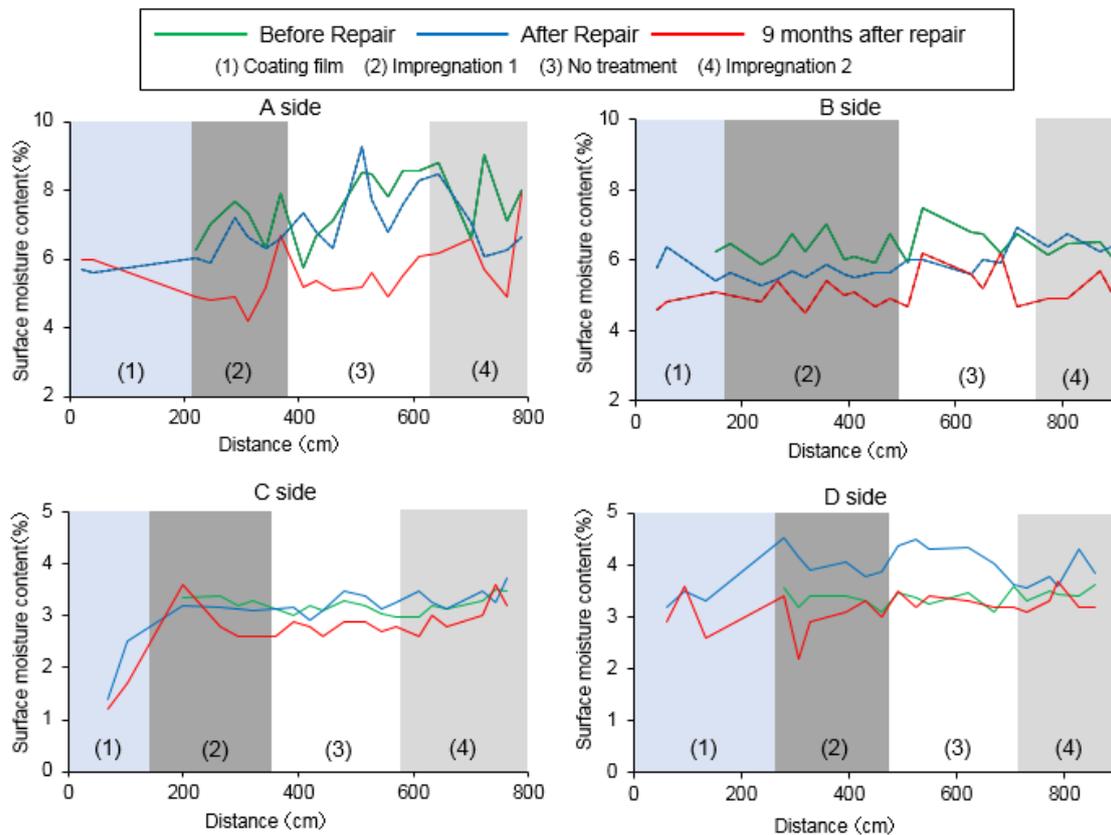
Figure 5.8 Surface moisture content of concrete

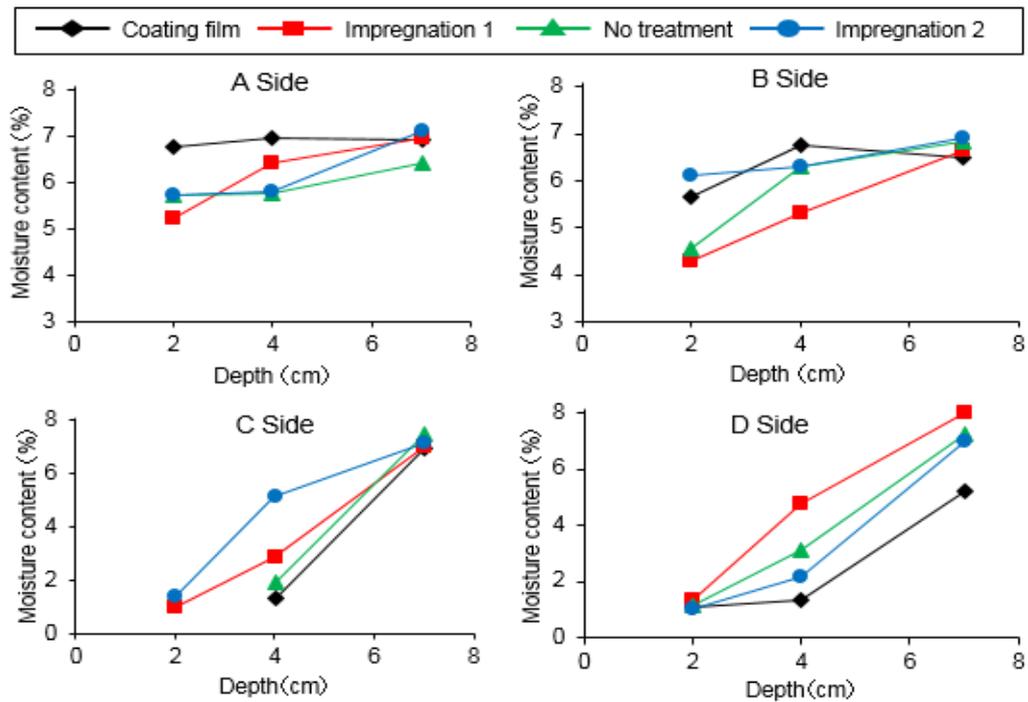
Figure 5.9 Internal moisture content of concrete

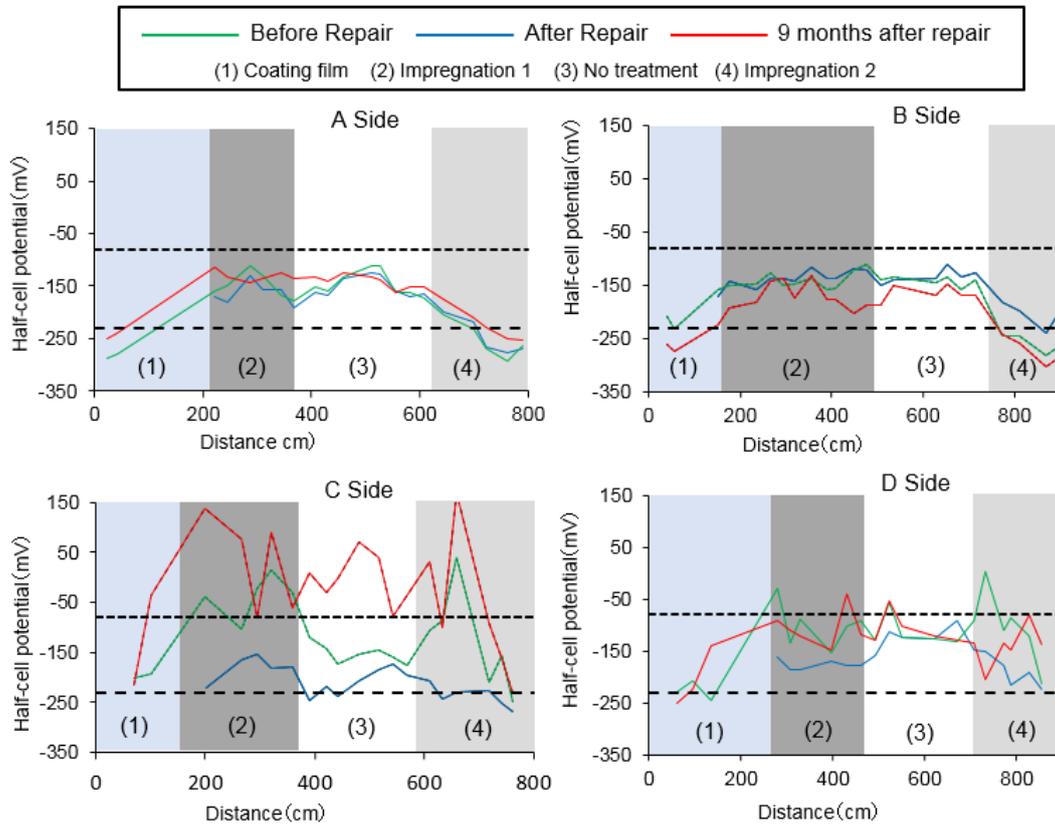
Figure 5.10 Measurement of half-cell potential

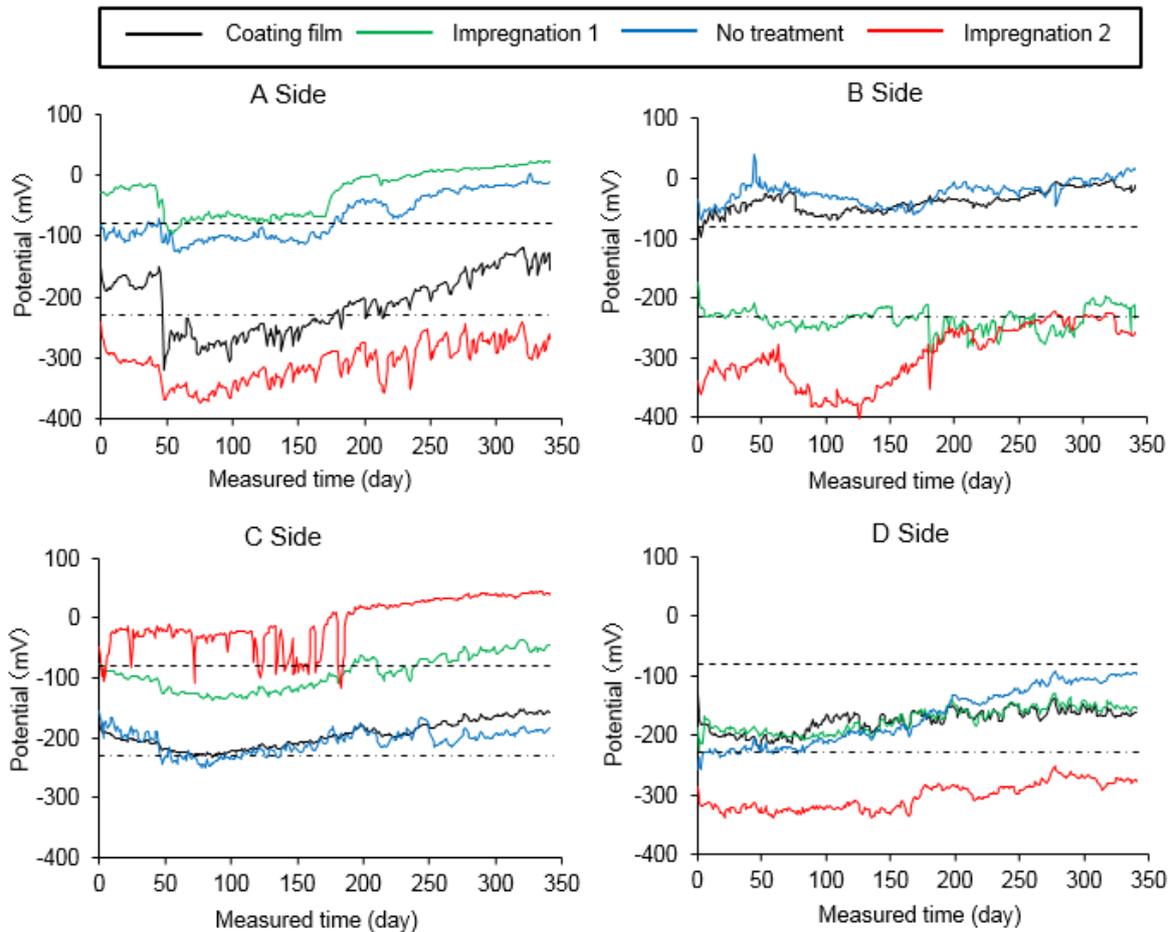
Figure 5.11 Half-cell potential monitoring

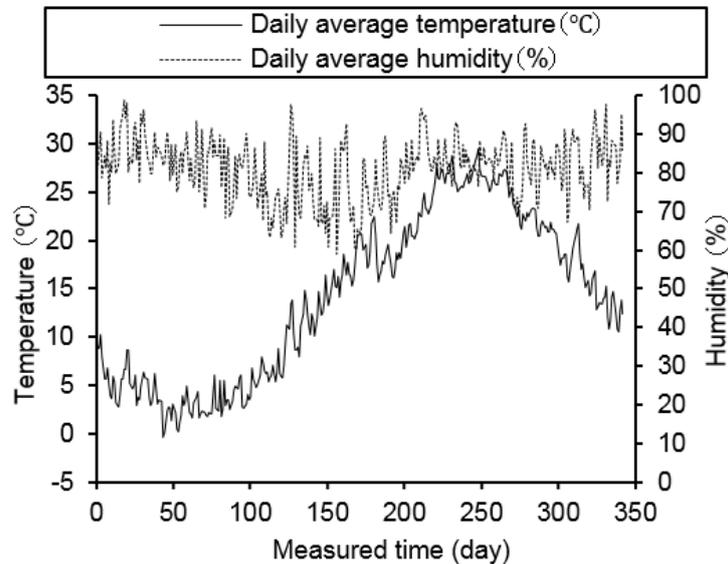
Figure 5.12 Temperature and humidity monitoring

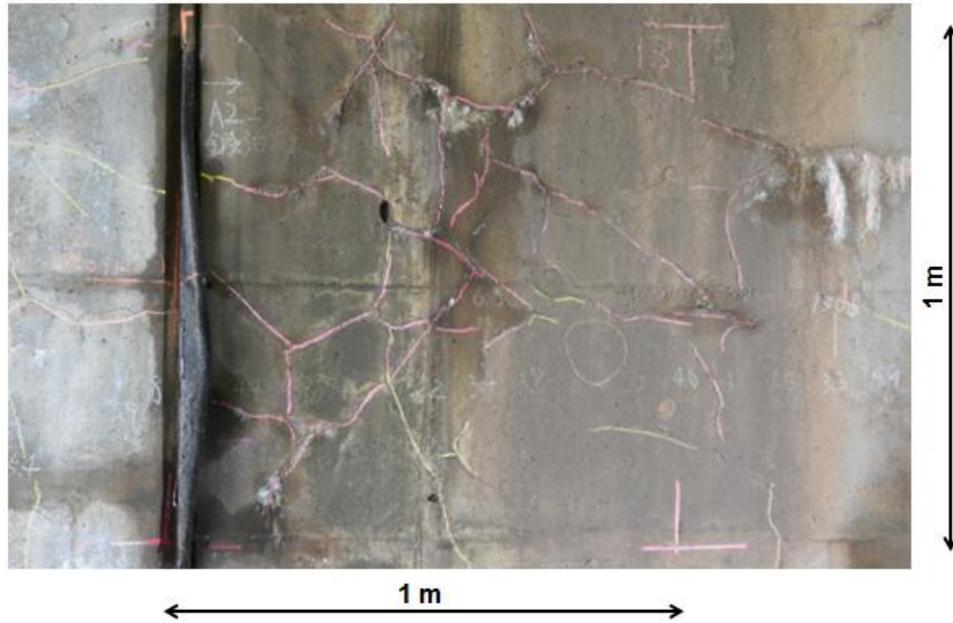
Figure 6.1 An example of abutment affected by combined deterioration

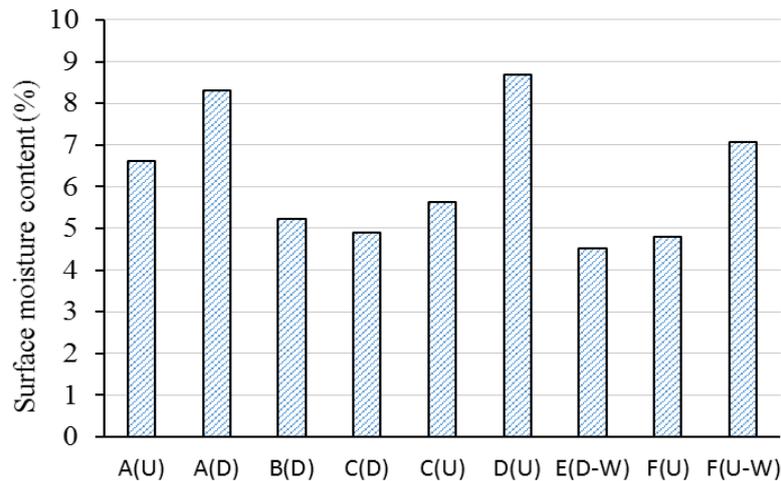
Figure 6.2 Surface moisture content of all abutments

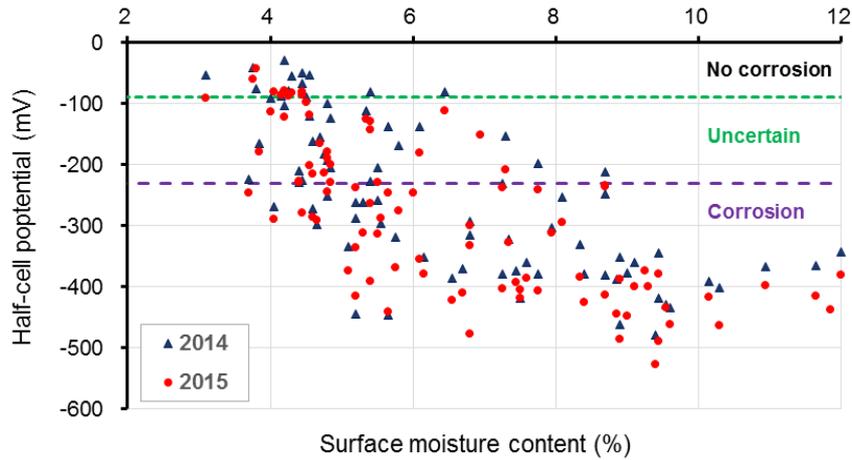
(a) Surface moisture content of concrete and half-cell potential relationship

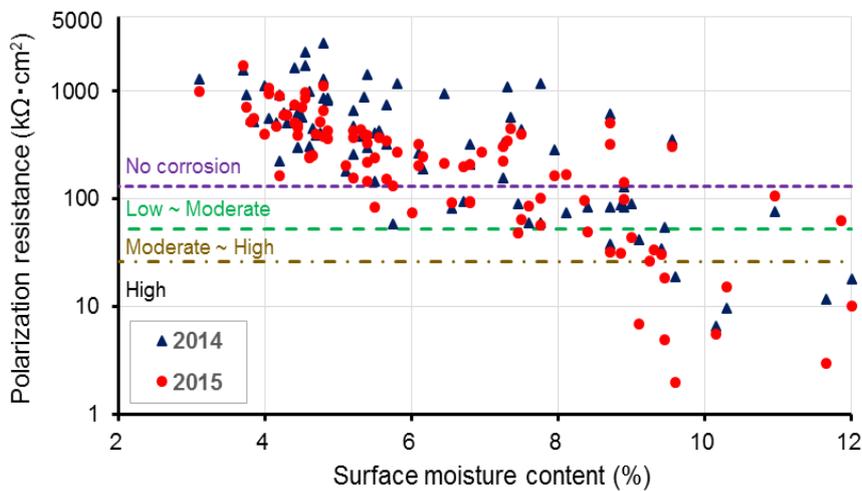
(b) Surface moisture content of concrete and polarization resistance relationship

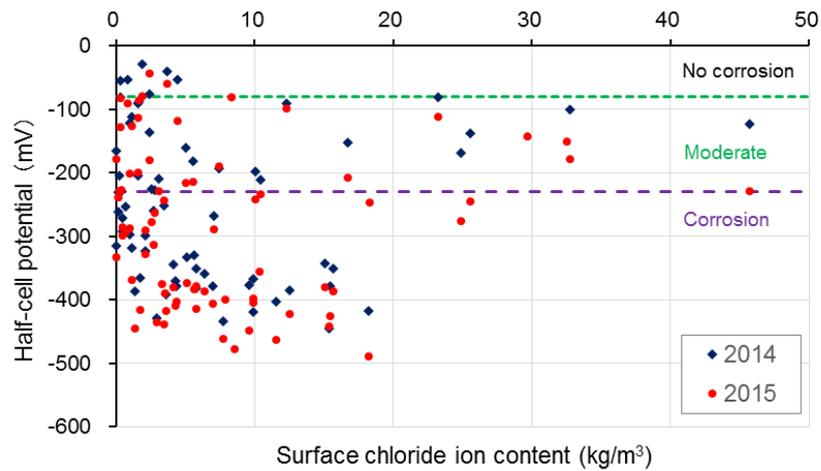
(a) Half-cell potential and surface chloride relationship

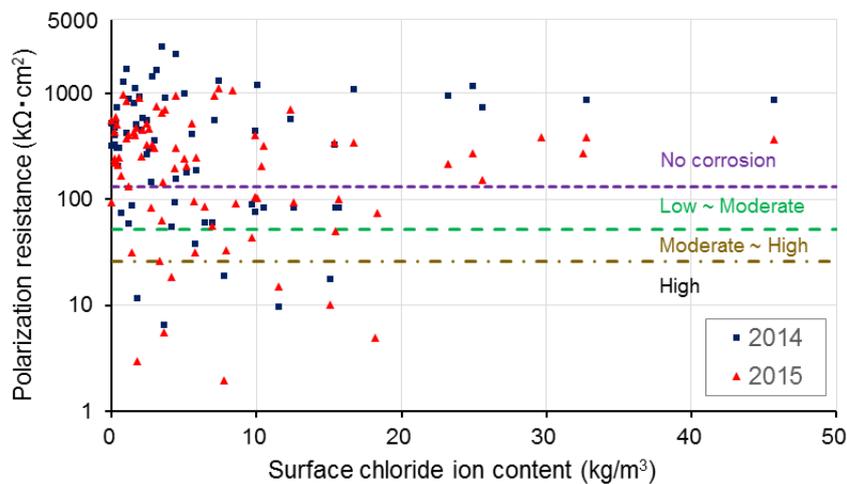
(b) Polarization resistance and surface chloride relationship

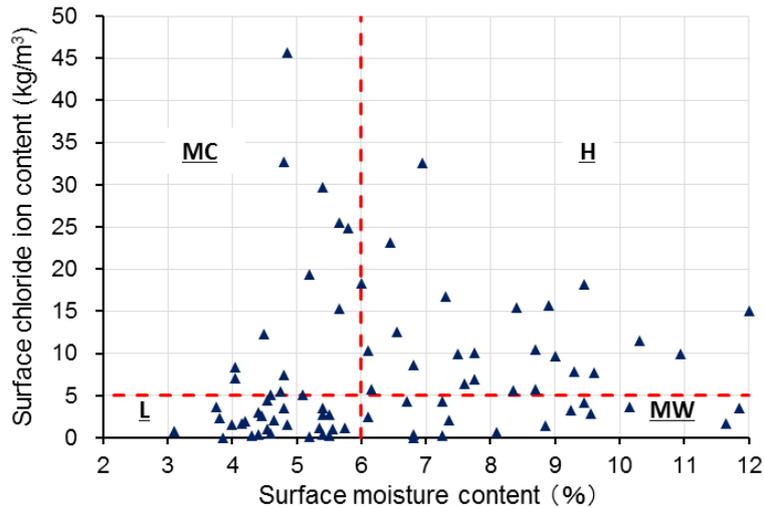
Figure 6.5 Corrosion risk classification based on surface moisture and surface chloride ion contents

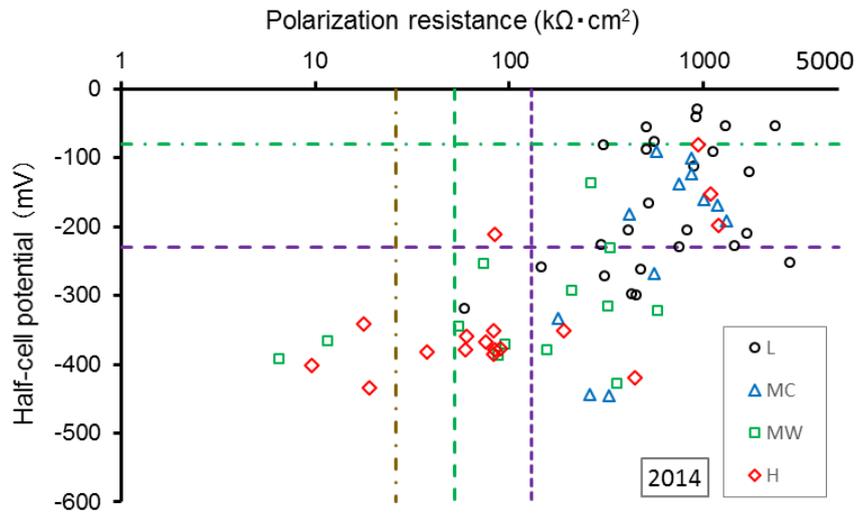
(a) Corrosion measurements in 2014

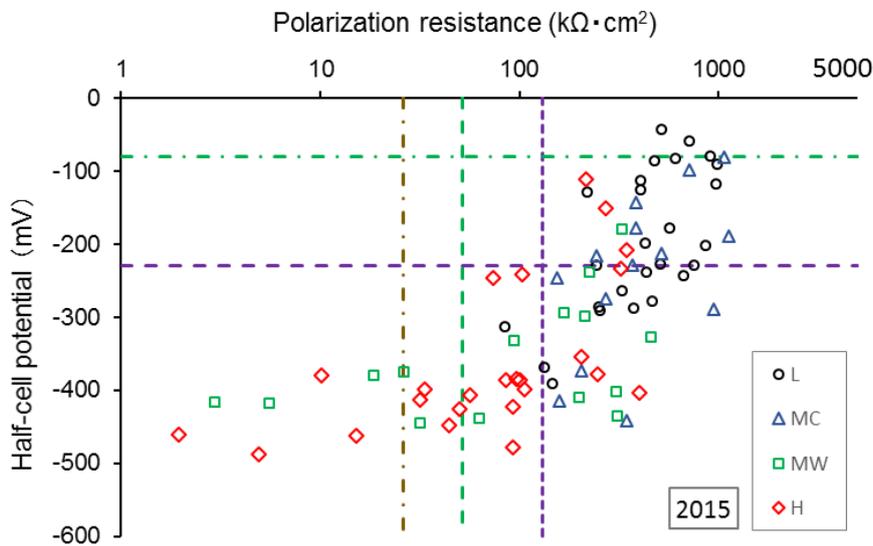
(b) Corrosion measurements in 2015

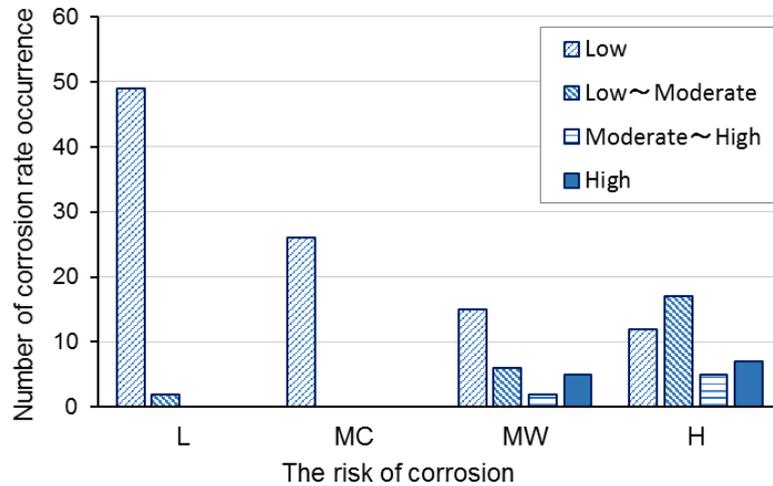
(a) Corrosion risk classification based on the number of corrosion rate occurrence

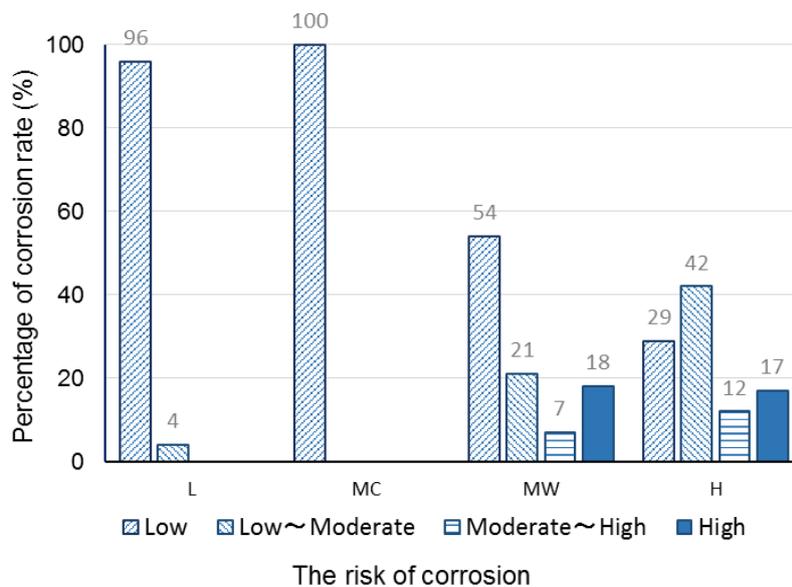
(b) Corrosion risk classification based on the percentage of corrosion rate occurrence
