Inclination of houses induced by liquefaction in the 2018 Hokkaido Iburi-tobu earthquake, Japan

Abstract

Keywords: The 2018 Hokkaido Iburi-tobu earthquake, Liquefaction, Damage to houses, Inclination of house

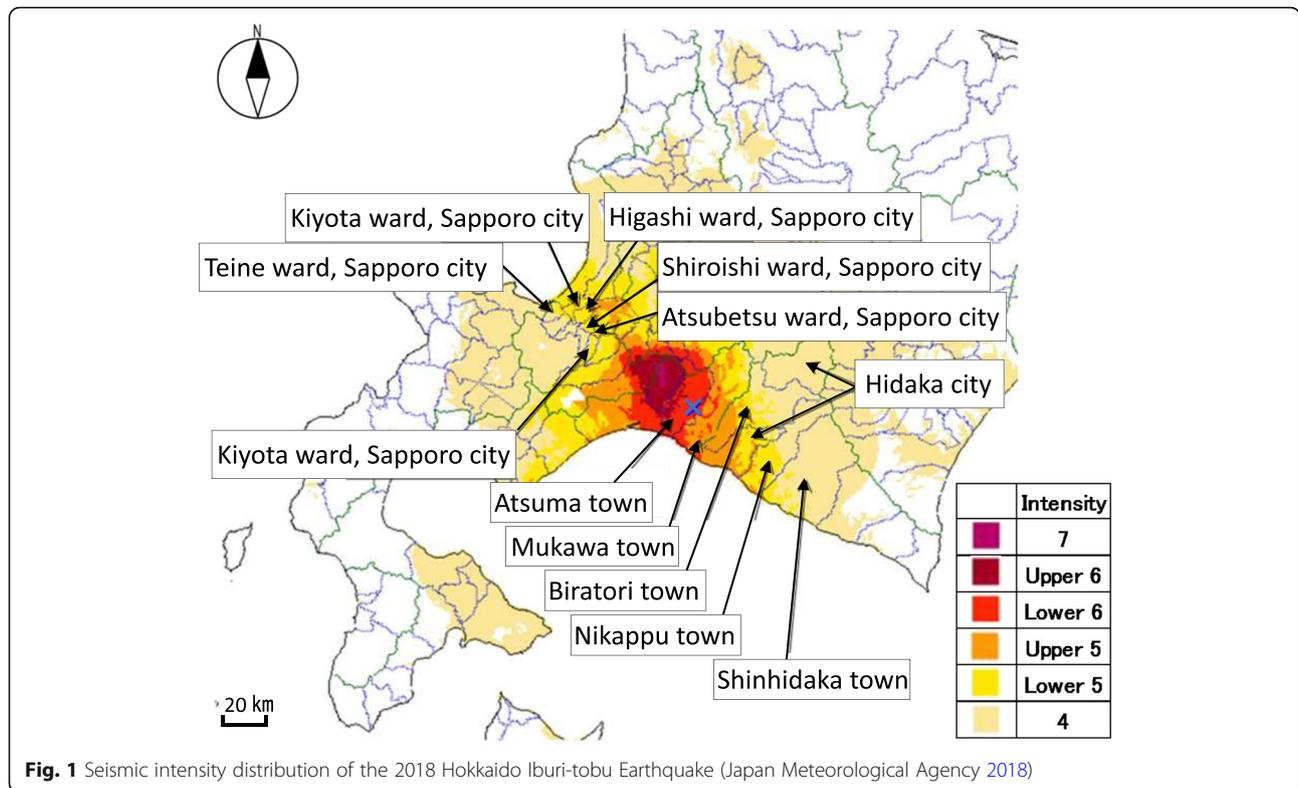
An earthquake of about 35 km depth and Magnitude 6.7 occurred middle east of Hokkaido-iburi region at AM 3:07 local time on September 6th, 2018. Figure 1 shows a distribution of JMA (Japan Meteorological Agency 2018) seismic intensity. A maximum JMA seismic intensity of 7 was observed at Atsuma town. The human damage of this earthquake was 42 deaths, 31 seriously injured and 731 minor injuries. Table 1 lists an outline of the damage caused by this earthquake (Cabinet Office 2018). The damage to houses and buildings were 462 completely destroyed

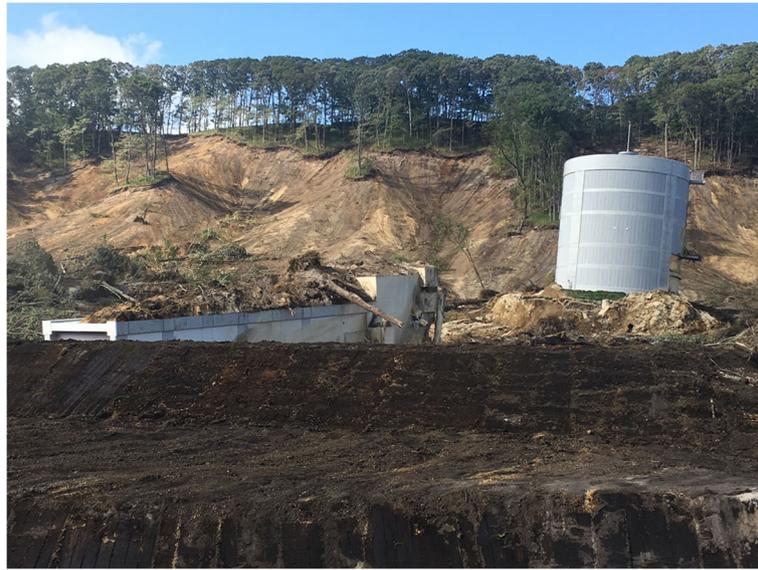
Fig. 2 Landslide at Atsuma town

houses, 1570 partially destroyed and 12,600 slightly damaged houses. Two thousand four hundred fifty-six non-residential buildings were also damaged. The main cause of these damages were landslides at Atsuma near the epicenter. Fig. 2 shows the landslide that occurred at Atsuma. The total area of landslides was about 13.4 km² according to the Ministry of Land, Infrastructure and Transport, Japan. This scale is the biggest in Japan since 1968. One of causes of the landslides seems to be a large amount of water contained in soil because of heavy rain caused by a strong typhoon the previous day. It is considered that the descent pumice layer deposited in this area is highly permeable, and clay is formed by chemical weathering, therefore, landslides are likely to occur.

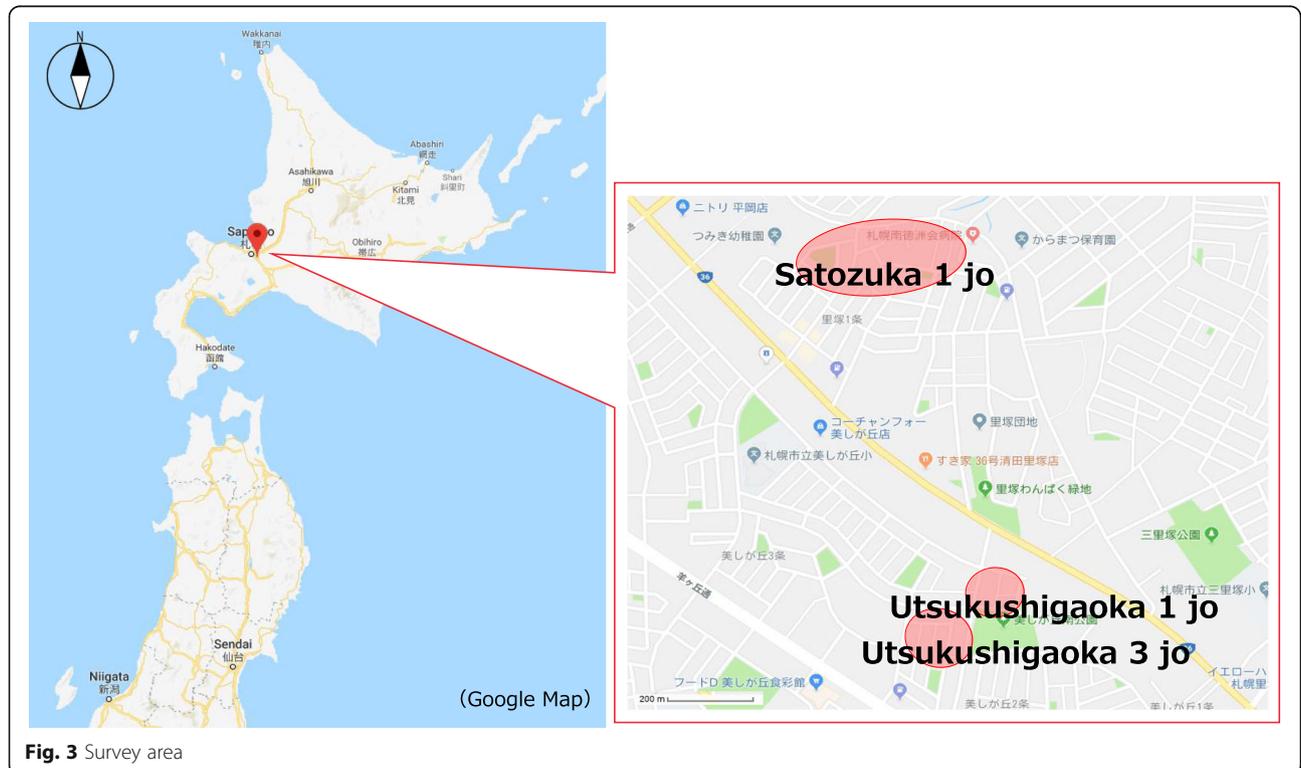
Fig. 3 Survey area

Uplift and sinking of road and inclination of houses were caused by liquefaction in the part of southeastern Sapporo city, where hilly land consisting of pyroclastic flow sediment of Shikotsu volcano. Enormous liquefaction damage occurred in a wide area of Satozuka and Utsukushigaoka, Kiyota ward, Sapporo city. Fig. 3 shows the location of Satozuka and Utsukushigaoka. Some photographs of the damage at each site are shown in Fig. 3. The ground deformation due to liquefaction was the largest and the ground was settled down about 2.0 m at Satozuka 1 jo (Wakamatsu and Onoue 2018) shown as yellow portion in Fig. 4. Figure 4-① shows settlement of the ground and

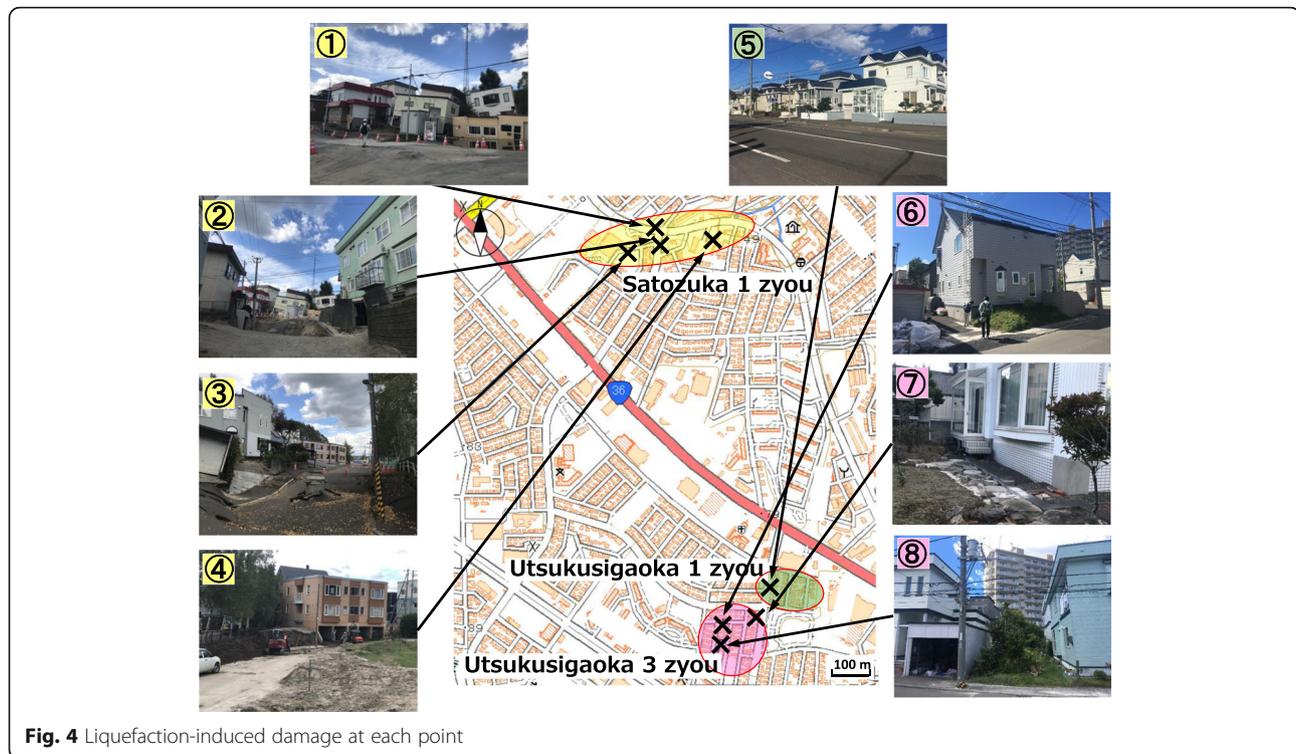
Fig. 4 Liquefaction-induced damage at each point

inclination of the houses are remarkable and water puddles formed in front of the house. The road shown in Fig. 4-② collapsed, and traffic using vehicles was difficult. Since the ground level before the earthquake was at the top of this utility hole in Fig. 4-③, it is considered that this road subsided about 1.2 m.

The inclination of the surrounding houses was large. Figure 4-④ shows accumulated sand in height of about 1.3 m. It is thought that a large amount of liquefied sand ejected at the sites of Fig. 4-① to ③ was accumulated at the location of Fig. 4-④ because the location of Fig. 4-④ is lower than the sites of Fig.

4-① to ③. In this area, tension cracking was not seen so much, so it can be inferred that the lateral spreading is not large.

The green portion in Fig. 4 indicates Utsukushigaoka 1 jo. There were many inclined houses due to liquefaction. The houses shown in Fig. 4-⑤ seems to suffer no damage at first glance, but inclination of houses occurred. Most of the residents continued to live at the inclined houses just after the earthquake, but many residents moved without being able to withstand the inclination of houses after around 1 month.

The red portion in Fig. 4 indicates Utsukushigaoka 3 jo. Many houses suffered inclination by liquefaction. The inclination of the house shown in Fig. 4-⑥ was the second largest inclination in Utsukushigaoka. The residents of this house moved soon after the earthquake. The surrounding ground of the house shown in Fig. 4-⑦ subsided, and there was a gap between the stairs and the ground. The inclined houses shown in Fig. 4-⑧ were inclined to the direction of each house. The right house was with the largest inclination in the Utsukushigaoka. The utility pole shown in this photo has settled about 1.8 m (Wakamatsu and Onoue 2018).

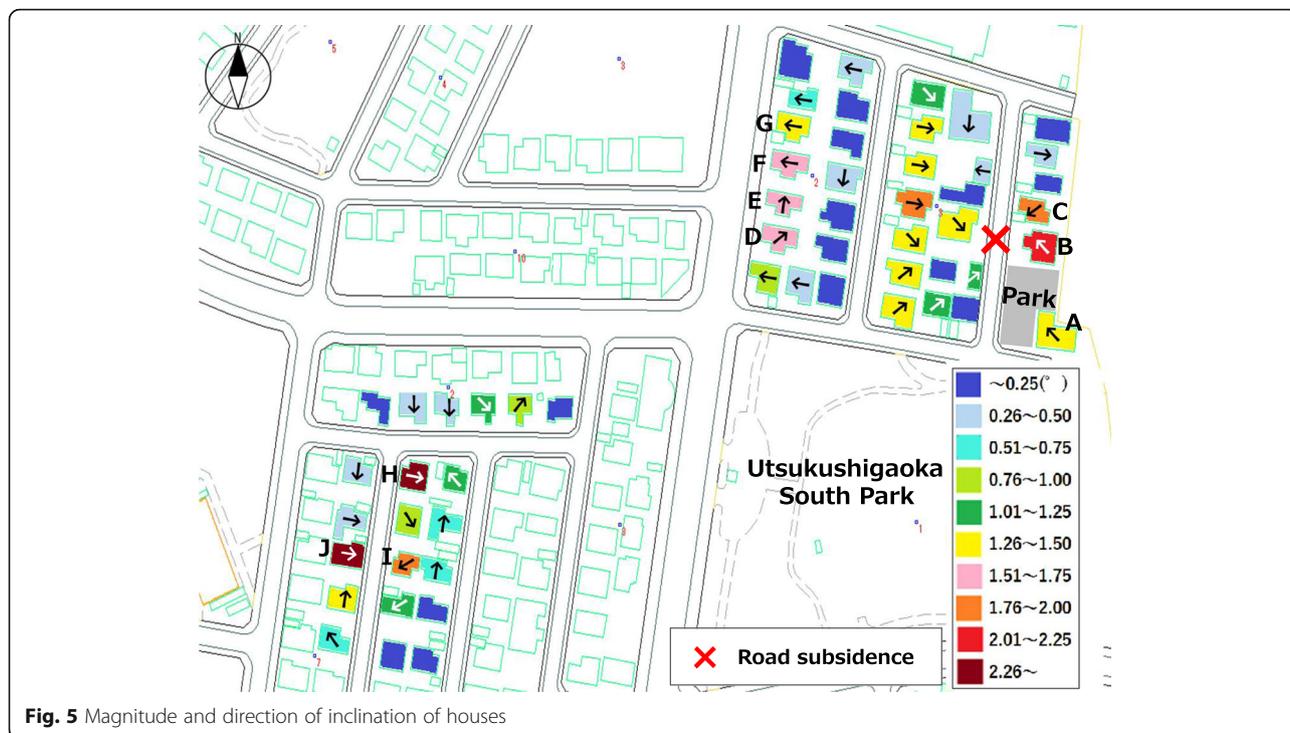
Fig. 5 Magnitude and direction of inclination of houses

Figure 5 shows inclination of the outer wall of the houses in Utsukushigaoka 1 jo and 3 jo. The inclination is shown in color-coded of every 0.25 degree on the map. Vector synthesis was performed in two orthogonal directions and the direction of inclination with larger inclination is indicated by an arrow in this figure. If the maximum inclination and the synthesized inclination are less than 0.25 degree, vector synthesis is not performed and only the direction of the maximum inclination is shown. The location of largest subsidence of road is also indicated by red cross in this figure. It is found that the houses that were greatly inclined were adjacent and that

such houses are inclined in the same direction according to Fig. 5. The houses were also inclined in the direction of the largest subsided road. These houses have almost the same wooden structure and were constructed 29 years ago.

The houses in the vicinity of the subsided road, houses A to C are listed in Table 2. These houses with large inclination are located near the park (Utsukushigaoka Sumire Park) where many sand volcanoes appeared by liquefaction. The houses B and C were greatly inclined in the direction of the subsided road. The inclined houses located along the main street are listed in Table 3. Houses D and E were inclined in the north direction, Houses F and G were inclined to the west direction. The houses where the inclination were great in Utsukushigaoka 3 jo are listed in Table 4. The inclination of the

outer wall of the house J was 2.58 degree, which was the largest inclination among the surveyed houses. The second largest inclination house H was inclined 2.40 degree. Houses H and J were inclined to the southeast direction, and house I was inclined in the southwest direction. The houses J and I were inclined to the front road. These results revealed that most of the large inclined houses inclined to the same direction.

Figure 8 shows an old topographical map of Kiyota ward, Sapporo city in 1961(Geographical Survey Institute 2018). According to this map, Utsukushigaoka was valley. Figure 9 is superimposed the past terrain on Fig. 5. According to this figure, the houses built in the former valley were inclined. It can be seen that houses A, B and C with large inclination and largely settled road were located at the former valley. Houses D and E were inclined in the direction of north and houses F and G in the west direction. These areas were formerly flood or valley plain. Houses H, I and J are also located at the former valley. It is clear that the direction of inclination of the houses coincides with the direction of former valley or flood plain.

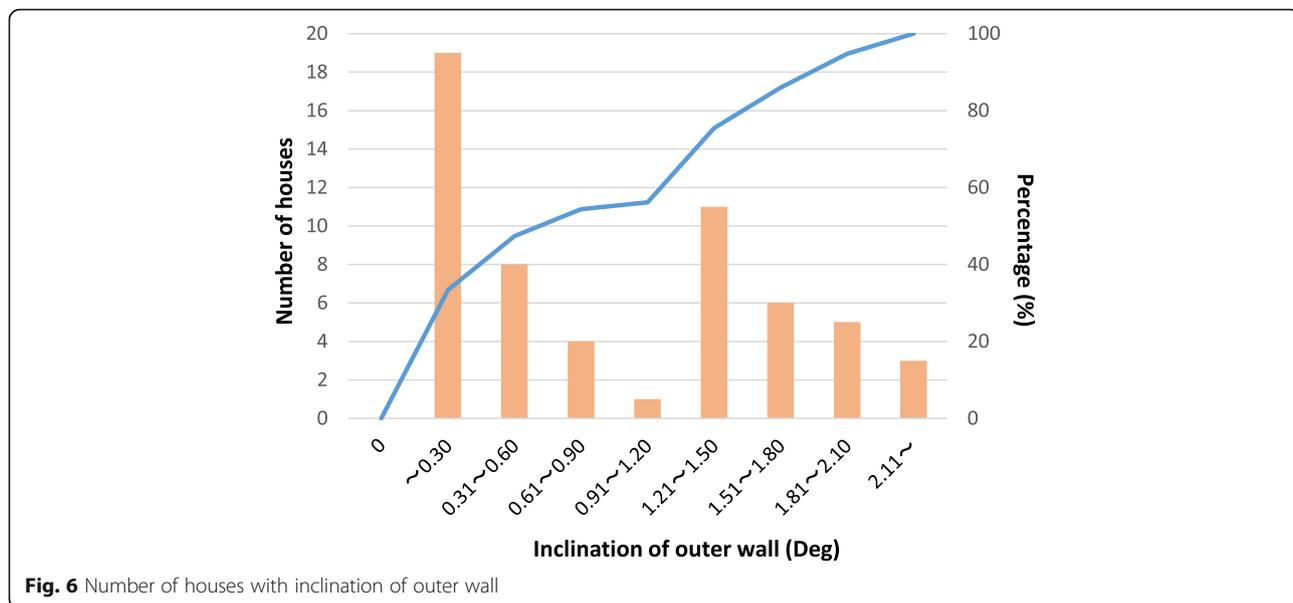
Fig. 6 Number of houses with inclination of outer wall

The number of houses in each inclination angle is shown in Fig. 6. Kohiyama and others conducted a hearing survey on health problems for residents who suffered liquefaction damage during The 2011 Tohoku earthquake, and dizziness gradually occurred when the inclination angle exceeded 1/100 (0.6 degree), revealed that health problems occur. Health problems may occurred at the houses with an inclination of 0.6 degree or more

(Kohiyama et al. 2012), and about 53% of the surveyed houses exceeded it. Survey of inclination of houses was conducted again 1 month after the earthquake. Inclination of houses increased more than 1.8 degrees in some cases by the aftershocks. There were two aftershocks that exceeded JMA seismic intensity 5 between our first and second field survey, and there were houses with large inclinations due to this aftershock. It was difficult for the residents to live there and most of decided to move. Since there are many residents who have difficulties in living, it is thought that the impact of inclination of houses caused by liquefaction on resident’s quality of life very serious.

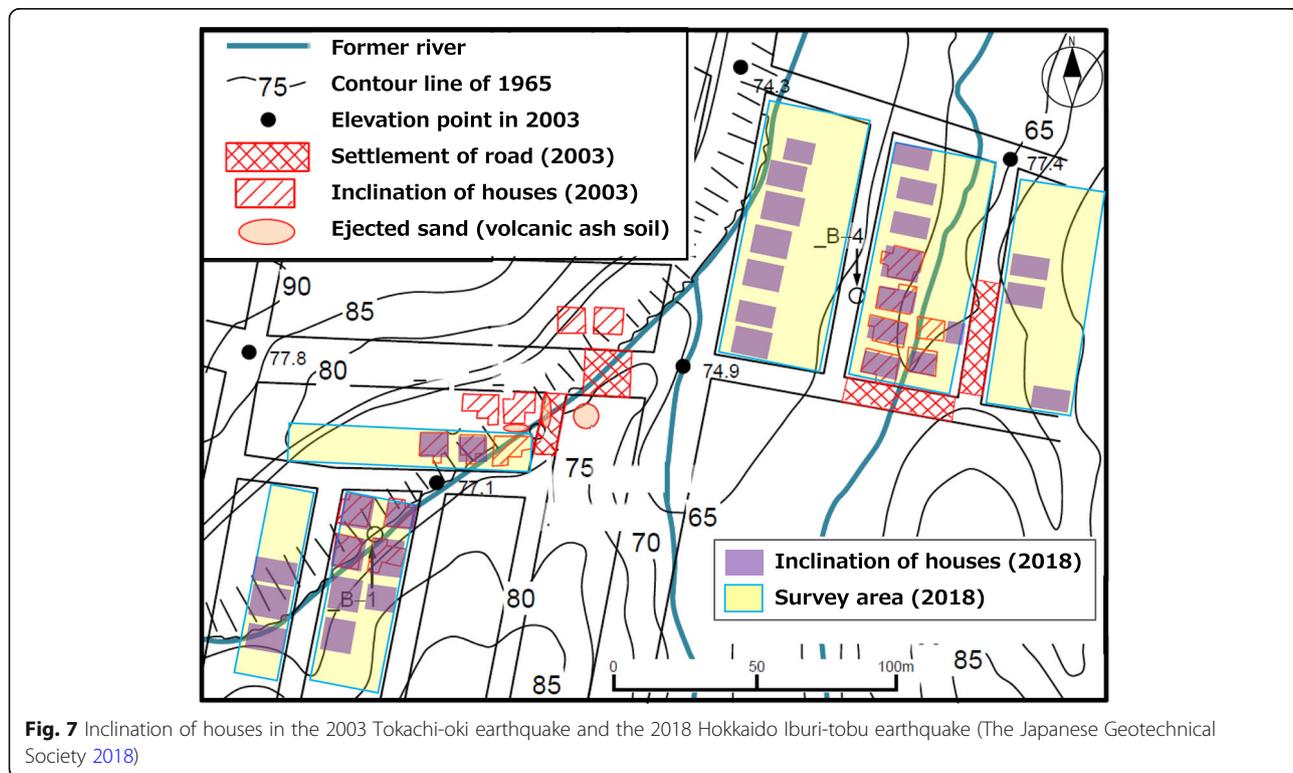
Fig. 7 Inclination of houses in the 2003 Tokachi-oki earthquake and the 2018 Hokkaido Iburi-tobu earthquake (The Japanese Geotechnical Society 2018)

Figure 7 shows areas of ground deformation and inclination of houses in the 2003 Tokachi-oki earthquake according to reconnaissance report of the Japanese Geotechnical Society (The Japanese Geotechnical Society

2018). The surveyed area and the houses with an inclination of 0.51 degree or more in the present study are also indicated in this figure. This figure reveals that liquefaction-induced damages in both earthquakes occurred in the vicinity of the former river, and the damage area in the 2018 Hokkaido Iburi-tobu earthquake is considered to be more extensive than that in the 2003 Tokachi-oki earthquake.

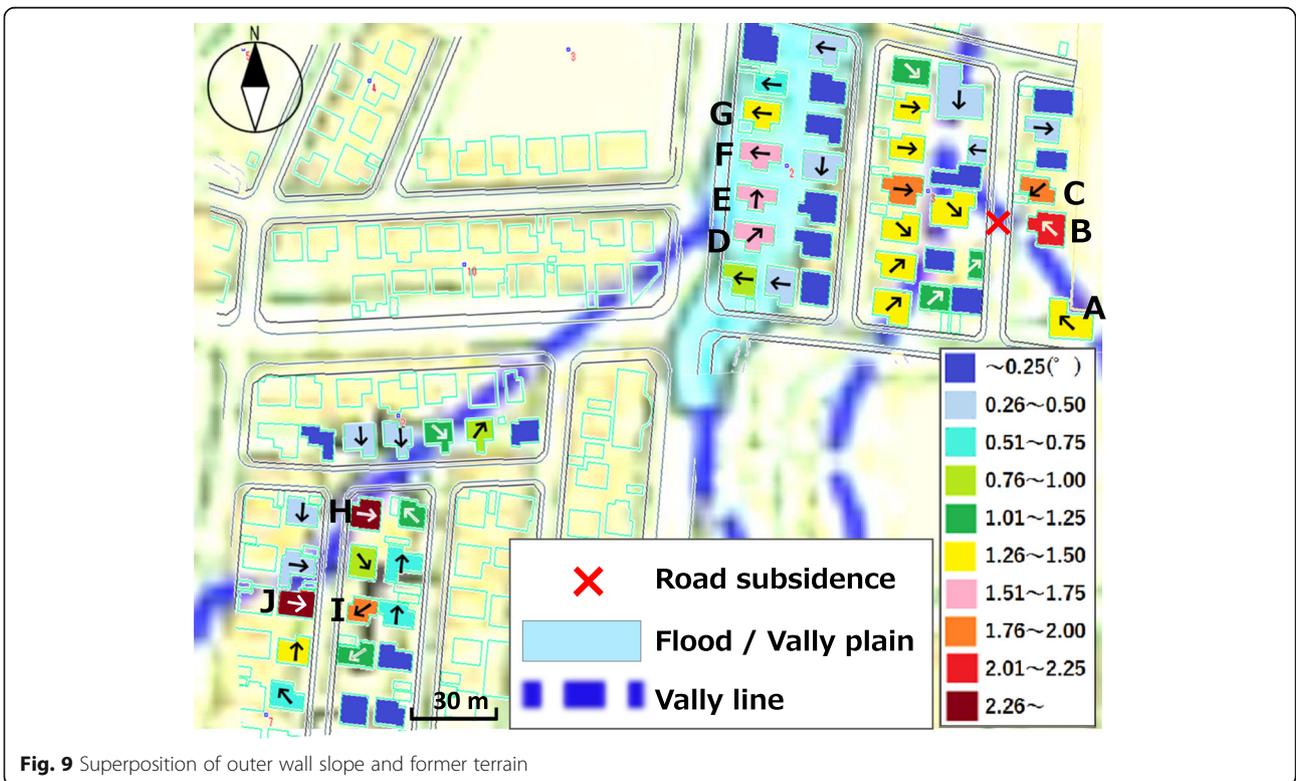
The surveyed areas of this study was originally recessed areas that erodes mountains, plateaus and terrace, then the area was reclaimed for residential houses in 1965. Houses D to F and G were located at the former flood and valley plains, houses A to C and H to J

were located at the former bottom of valley plains. It was revealed that the inclination damage of houses due to liquefaction is greatly affected by the old topography. According to a survey of the Civil Engineering Research Institute for Cold Region, it is known that the survey target site is about 3 m of filled volcanic ash and the groundwater level is about 1 m. The groundwater is very
