Investigation of shallow landslides triggered by heavy rainfall during typhoon Wipha (2013), Izu Oshima Island, Japan

RESEARCH ARTICLE

Hufeng Yang^{1*}, Fawu Wang¹ and Masakatsu Miyajima²

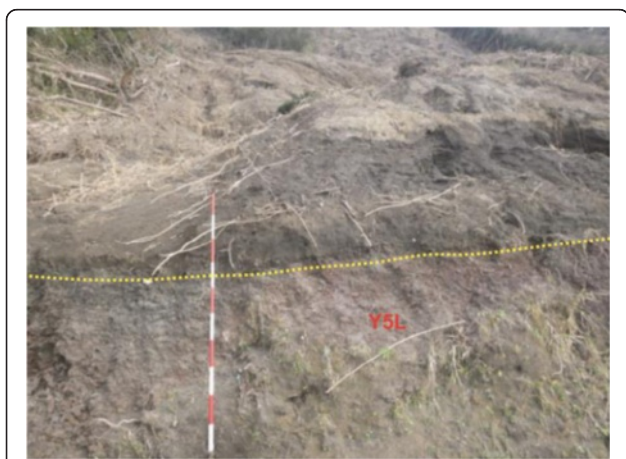
Fig. 4 Basalt (Y5L) overlain by pyroclastic-fall deposits (at red spot in Figure 3)

Izu Oshima Island is a volcanic island. This active volcano consists of pre-caldera, syn-caldera and post-caldera volcanoes (Kawanabe 1998). Many hazardous eruptions have occurred in the past. The ejecta in each stage were mostly coarse-grained pyroclastic materials, with basaltic lava flows and pyroclastic-fall deposits. Younger deposits and lava flows covered the deposits and lava flows from the older volcano stage. This type of volcanic activity led to the formation of resistant lava flows interbedded with poorly consolidated pyroclastic-fall deposits. Fig. 3 shows the geological map of the main landslide area, which is outlined in Fig. 2 (right) with a yellow frame. Most of the shallow landslides which were the source of the debris flows occurred within the distribution of basalt (Y5L). Pyroclastic-fall deposits overlie the basalt (Y5L) in the section which is exposed in the upper slope along the road (Fig. 4). This type of structure with interbedded resistant basalt and weak pyroclastic deposits can easily cause landslides. Moreover, the interface between these two layers tends to be a confining boundary for groundwater passing through the upper soft and porous pyroclastic-fall deposits.

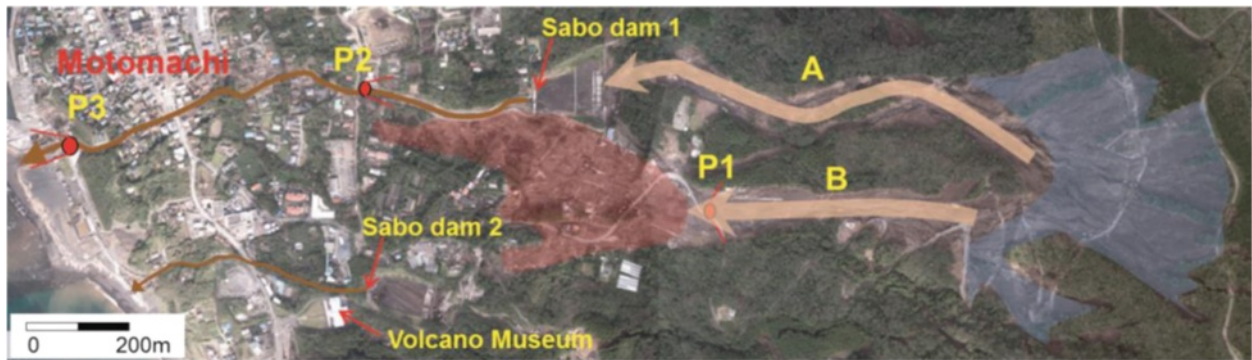
Fig. 7 shows a plan view of the areas that were impacted by debris flows. According to the information from local residents and seismic data, shallow landslides (light blue

area) occurred on the upper slopes in the early morning (Ikeya 2014). Pyroclastic-fall deposits mixed with branches and trunks flowed downslope along the gullies (beige arrows). Debris flow flushed away the surface soil and vegetation along the gullies (gullies A and B in Fig. 7). Because no drainage channels were present, the debris flow flooded the houses situated on the down slopes area (light red area), and caused serious loss of lives and properties. The sabo dam 1, which is located at the mouth of gully A, played an important role in protecting this area. It effectively reduced the speed of the debris flow, and captured branches and trunks. Furthermore, fine-grained particles were easily

Fig. 7 Plan view of the main landslide area (photograph from the Geospatial Information Authority of Japan)

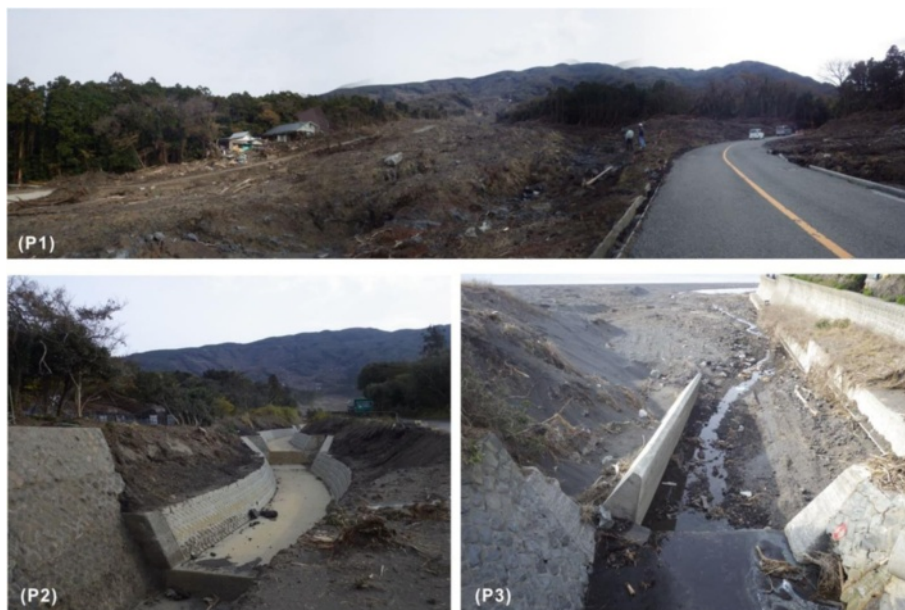
drained out through the drainage channel (brown arrow) (P2 in Fig. 8). Finally, this fine material flowed into the ocean and was deposited at the coast (P3 in Fig. 8). Sabo dam 2, situated just behind the Volcano Museum, stopped the debris from damaging the museum and nearby residential houses.

Fig. 8 Photograph locations are marked on Figure 7

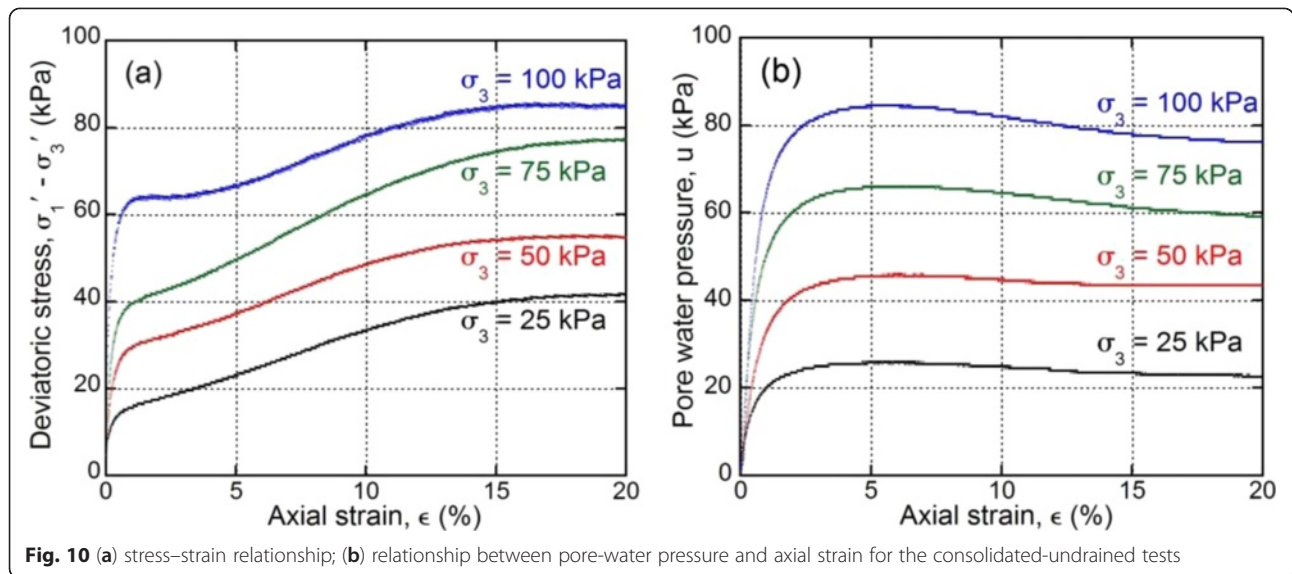
The stress–strain relationship of the consolidated-undrained tests on the saturated specimens (Fig. 10a) shows that the deviatoric stress increases with the axial strain. The stress–strain curves indicate the evidence of strain hardening. When the shear strain is over about 15 %, the deviatoric stress begins to flatten. Critical state was reached in all four tests with a high axial strain. The relationship between the excess pore-water pressure and the axial strain of the consolidated-undrained tests on the

saturated specimens is shown in Figure 10b. Positive excess pore-water pressure was recorded in all four tests. In all tests, the positive excess pore-water pressure increases to a peak at low strain (about 5 %), reduces from its maximum value as the strain increases continuously, and finally reaches a steady state at the end of the tests. The initial buildup of the positive excess pore-water pressure suggests that the specimens exhibit contractive behavior. The reduction in the excess pore-water pressure after the peak indicates that the specimens change from contractive to dilative behavior during shear, as illustrated by the effective stress paths shown in Fig. 11. Ng and Chiu (2001) described the similar shear behavior of loosely compacted saturated volcanic soil under undrained conditions in their paper. All the effective stress paths show a similar trend. Each path moves toward the right-hand side initially, and then moves toward the left-hand until reaching a turning point, after which they turn right, before reaching the critical state line CSL at the end of the test. The critical states of saturated specimens can be represented by the CSL in the stress plane, as shown in Fig. 11. The gradient of the critical state line is 0.625. This corresponds to a critical state angle of internal friction angle of 38.7 degrees.

Fig. 10 (a) stress–strain relationship; (b) relationship between pore-water pressure and axial strain for the consolidated-undrained tests

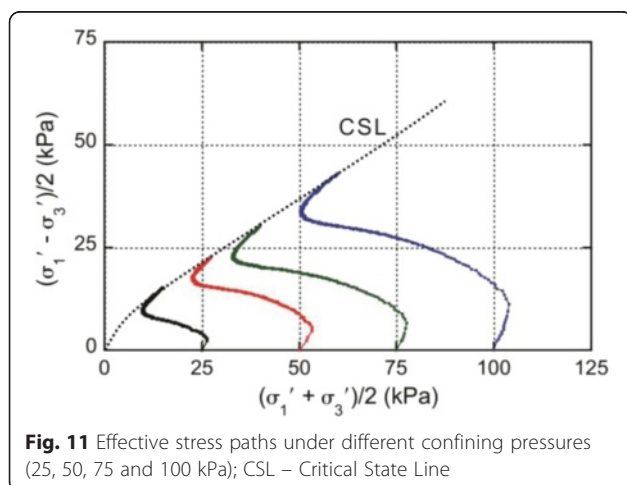
Fig. 11 Effective stress paths under different confining pressures (25, 50, 75 and 100 kPa); CSL – Critical State Line
