DOCTORAL THESIS

**ESTIMATION OF MALFUNCTION
OF A HEALTHCARE FACILITY IN
CASE OF EARTHQUAKE**

KANAZAWA UNIVERSITY

Nebil Achour

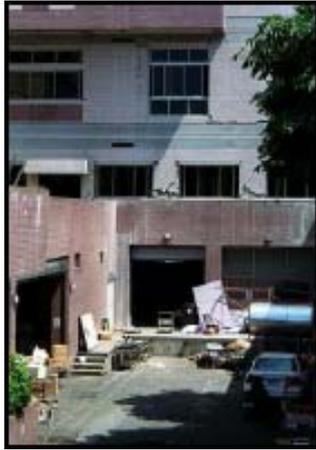
The hospital is composed of two main reinforced concrete structure sections. The oldest was built in 1979 and the newest was built in 1995. The main shock did not cause any structural damage, slight non-structural and lifeline damage occurred and equipment moved, see Photo 3.1. However following one of the aftershocks the facility suffered significant damage to its non-structural elements and lifelines which resulted in its evacuation, one week after the main shock; some of patients were moved to prefabricated buildings and some others to different facilities. The severity of damage was the cause of reducing the capacity of the hospital by 50 beds (which represents 8% of its real capacity). The first floor remained open and it was used for emergency treatment, patient registration and so forth, see Photo 3.2. The following are the most important results of that damage:

Photo 3.1- Exterior damage, Christian Hospital (Source: Lee et al, 2000)

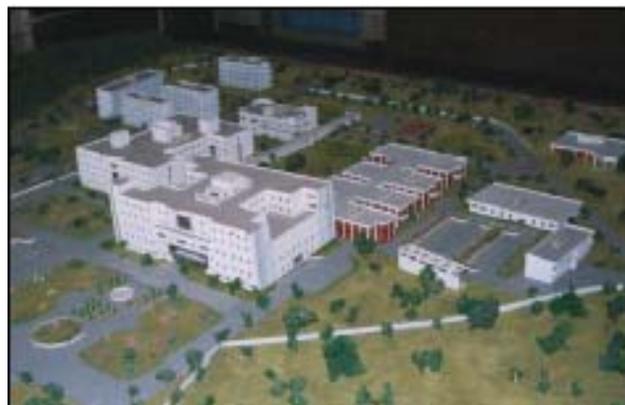
The Veteran Hospital is a multi-buildings facility as Photo 3.3 illustrates. The oldest buildings were built in 1974 and the others three years before the event. Some buildings suffered very severe damage, causing their complete closure, see Photo 3.4 and Photo 3.5. Some of the patients were moved to the other buildings while others to different facilities. The capacity of the hospital was dramatically reduced to 50% (220beds). The Medical Centre suffered considerable structural damage, lost its water supply and lost its electrical power. Emergency power did not work, since it was situated on the second floor of a separate building and as result of the amplified acceleration the majority of the components broke and caused their damage. Later on, the Medical Centre building had to be demolished and rebuilt, and the Administration Centre had to be repaired.

Photo 3.3- Veteran Hospital, Puli (Source: Lee et al, 2000)

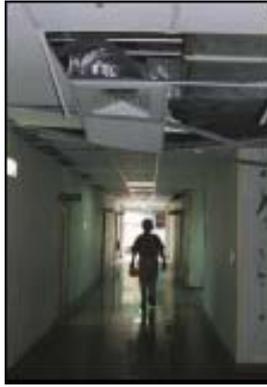
Photo 3.4-Interior damage, Veteran Hospital

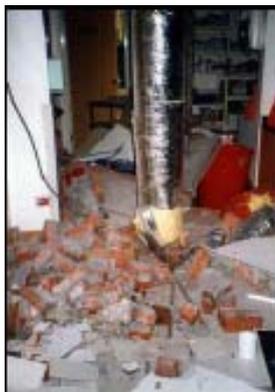
This facility represents a special case as it is a private hospital, the largest in Nantou County and was only built two years before the earthquake. It was composed of 9 stories with a reinforced concrete structure. Given that the facility was very close to the Chelungpu fault (about 120m); it suffered sizable damage to its non-structural elements, see photos 3.6 and 3.7. The second and the third stories suffered the most damage, see Photo 3.8, and since the most important facilities operation rooms, recovery rooms were located there, the 400-beds facility had to be totally evacuated to other hospitals. Finally the hospital was closed. Resembling the previous two hospitals, many patients suffered trauma during their transfer. “Seven patients died due to the stoppage of life-support systems” (Lee et al, 2000).

Photo 3.6-Interior damage, Shiu-Tuan Hospital

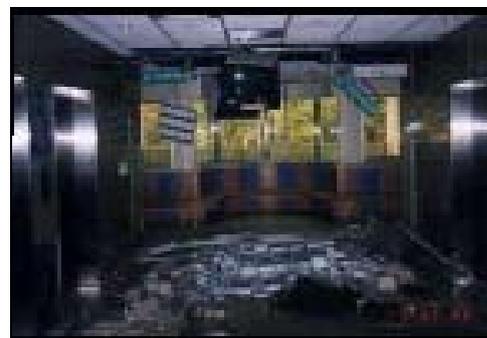
Photo 3.7- Interior damage, Shiu-Tuan Hospital

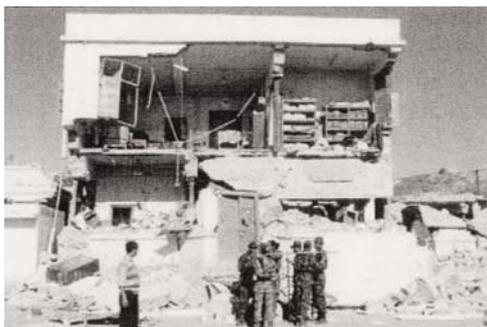
The majority of the hospitals in the area that were supposed to receive injuries failed to do so and in many cases this caused the death of many people. Aside from patients, doctors, nurses and other support staff were killed in this earthquake. In Bhuj General Hospital more than 172 were killed after it collapsed, see Photo 3.9. Since the latter facility collapsed, the Military Hospital provided medical treatment to 12,254 patients through its Out-Patient Department. However, the Military Hospital became over crowded in a very short time. The Jubilee Hospital completely collapsed too as shown in Photo 3.10. The fairgrounds and Jubilee Grounds, were opened to receive patients, many doctors volunteered to give the injureds initial treatment. Within the two first days hundreds of patients were transferred to other hospitals.

Photo 3.9- Collapsed Bhuj Central Hospital

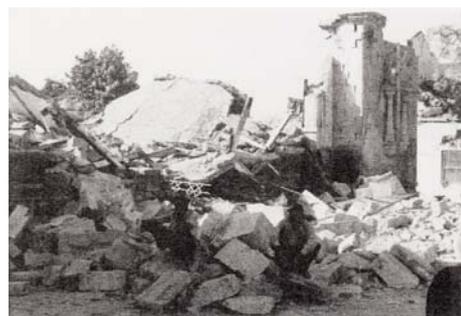
Photo 3.10- Collapsed Jubilee Hospital

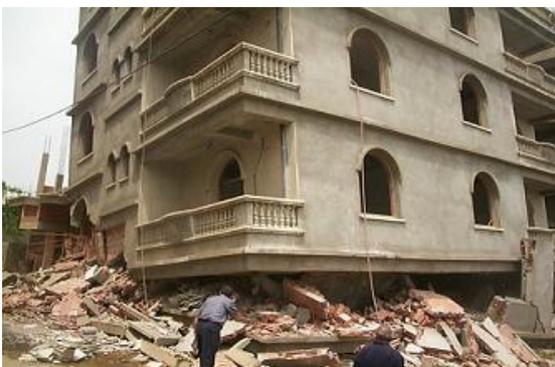
Photo 3.11- Damage to new buildings

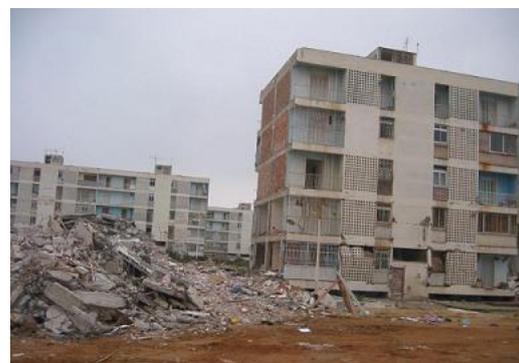
Photo 3.12- Collapse of residential building

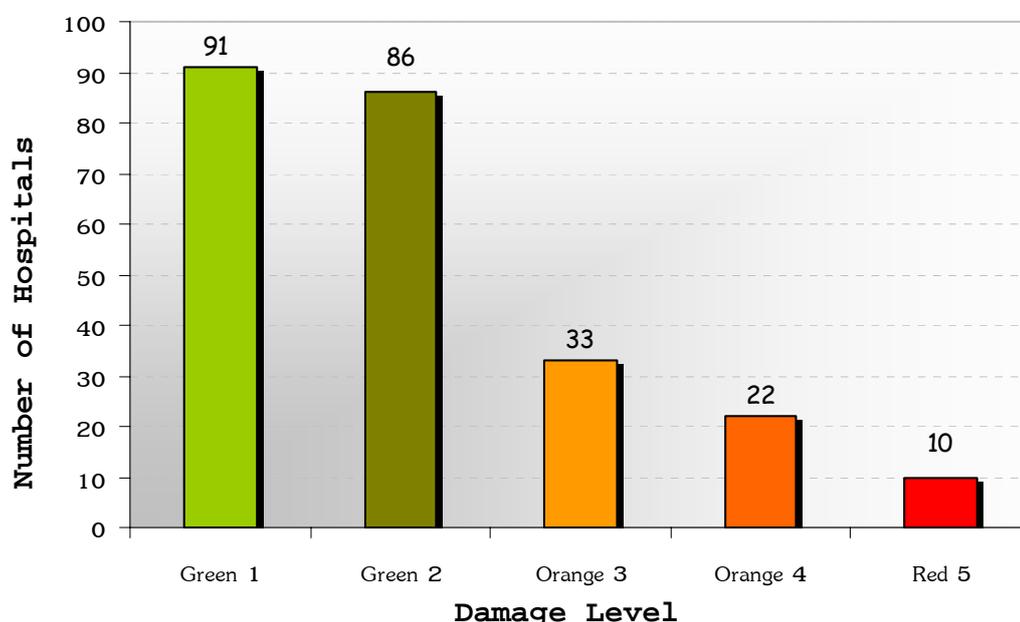
Figure 3.9- Distribution of structural damage

More than 73% of the health care facilities suffered damage to their furniture and non-structural elements; the remaining approximately 27%, suffered slight to severe damage to their structures. The main materials that were used for the construction of health care facility structures were RC, masonry and bricks. The age of the facilities were also variable, some facilities were built in the era of French colonization and were still in use. This issue made many facilities very vulnerable and weak to resist against any earthquake of such magnitude and perhaps of an even weaker magnitude.

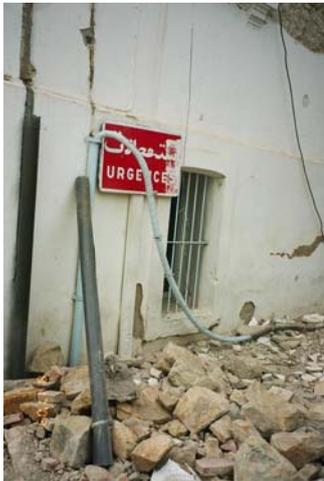
Photo 3.15- Damage to the
emergency wing

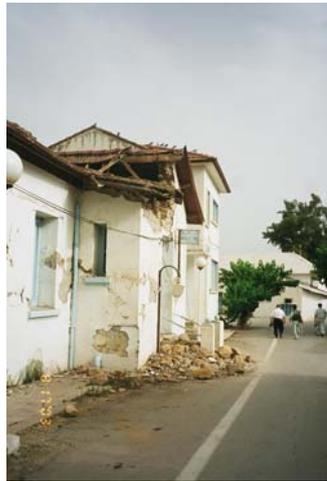
Photo 3.16- Collapsed roof
of another wing

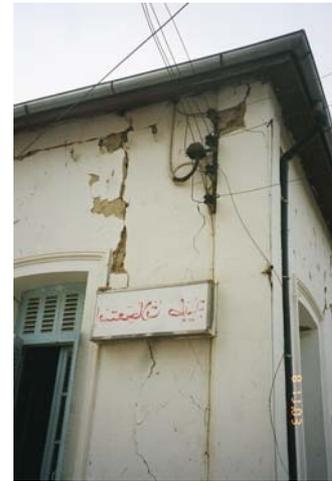
Photo 3.17- Cracks in the
walls of the emergency wing

The building had itself suffered severe damage. A lot of damage to its structural and non-structural elements was observed which affected the duties of personnel. The structural

elements were totally collapsed throughout the majority of the facility. Non-structural elements had fallen, became broken and made the area inaccessible from all wings. The damage obliged the government to supply prefabricated buildings that were used instead of the actual facility, as is shown in Photo 3.18. The prefabricated buildings were used as the actual facility in which patients were being treated. Those prefabs were equipped with electricity and air conditioners to make life easier for the medical staff as well as the patients. The structural damage had a clear impact on the patients since they had difficulty being treated. The staff could not access or move the inpatients and many patients had to be transferred to other hospitals because their treatment became impossible in that hospital.

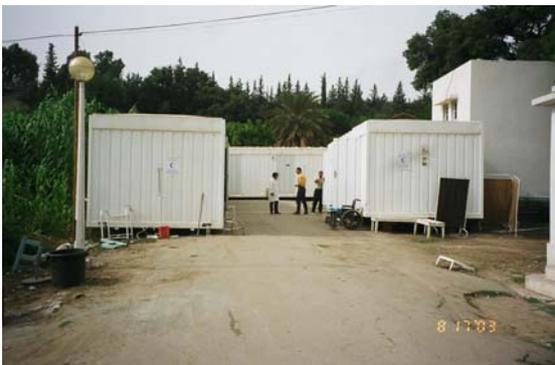
Photo 3.18- Prefabricated buildings used instead of the actual building

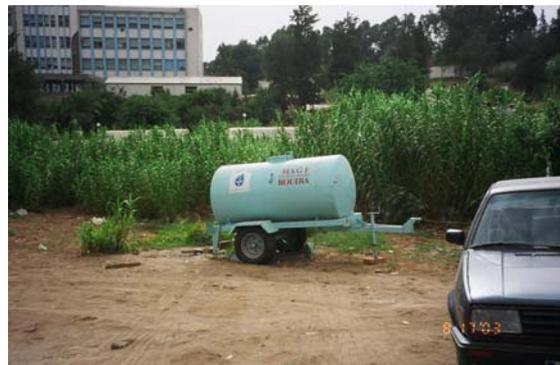
The situation in the hospital was dreadful; at least until July 2003. Many facilities were unavailable. Electrical power was cut for approximately 12 hours. During the first hours, candles were used until the back up emergency power began to operate. The gas and water supplies were cut off for more than 2 days; however alternative sources were used such as water tanks shown in Photo 3.19. Telecommunications were also cut, and there were no other options that could be used as alternative sources. Telecommunications were still not restored at least until July 2007, two months after the event. The lifeline damage made treatment difficult or even impossible; personnel stated that they could not work in the hospital under such difficult conditions. Damage to lifelines in particular affected life-saving by delaying treatment, delaying the movement of patients and hindering the transfer of casualties to other hospitals, as equipment was strewn everywhere.

Photo 3.19- Reservoir of water used as alternative source

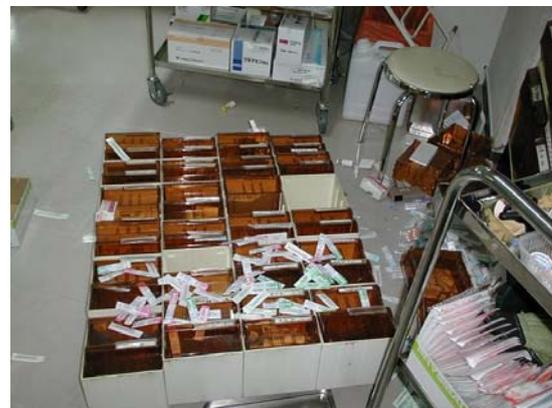
Photo 3.22- Turning over of medicine shelves, Kushiro Urinary Clinics

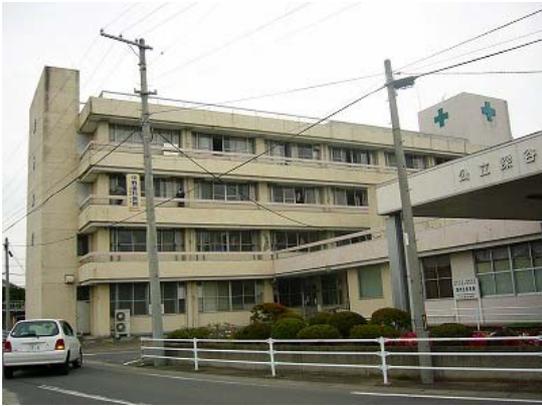
Photo 3.23- Fukaya Hospital

The facility was built in 1968 and it suffered very severe damage to its columns, see Photos 3.23 and Photo 3.24. One building collapsed, which obliged the staff to transfer patients. One member of the personnel was injured and some others couldn't reach the hospital. As well as structural damage the facility suffered damage to its lifeline. The electric power was cut for about two hours but the emergency electric generators were sufficient. The water pipelines were damaged and caused the outage of water for about four days. A mobile water supply was used instead of the local water system. All forms of telecommunication; landlines, mobiles and PHS were cut for about one hour.

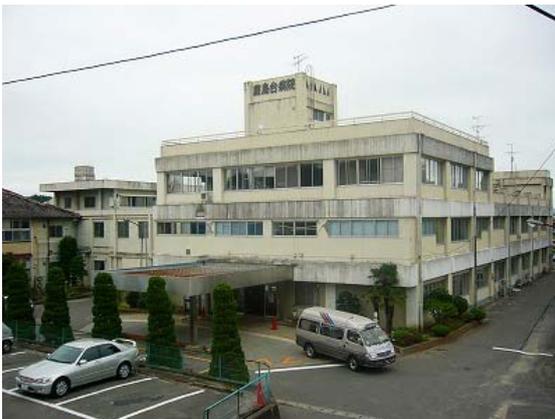
Photo 3.25- Kashimadai Hospital

The Kashimadai hospital, shown in Photo 3.25, was built in 1969 and just like the previous institute it suffered very severe damage to its structure. Columns suffered severe cracks as seen in Photo 3.26. As a result of the structural damage some patients were transferred to other hospitals. The 113 bed facility lost its electric power and when the engines stopped, a company representative went and did all the necessary repairs. There was a shortage in the water supply since a water pipe was broken; this too was later repaired.

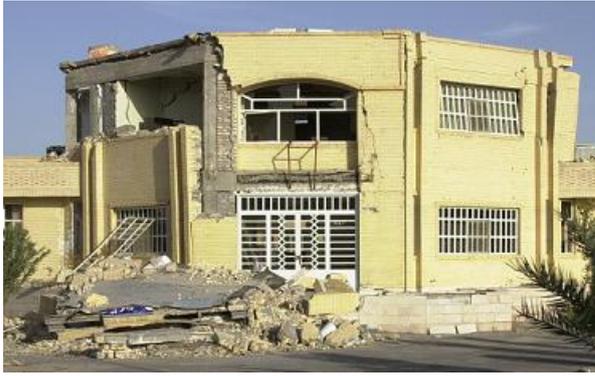
Photo 3.30- Aflatoonian Hospital, February 2004

The hospital suffered severe structural damage; some columns tilted, some others cracked and some parts collapsed, see Photo 3.30. According to one member of the hospital, the structural damage cost 5 billion IRR, *Iranian Rials* (65 Million JPY, *Japanese Yen*) of the cost of the entire building which is about 12 billion IRR (155.6 Million JPY). It should be noted that the cost of construction has become more expensive than a few years ago, in other words the damage to the facility is less than 41.6% of repair cost of entire building. The facility suffered malfunction to its lifelines; electric power was cut for about two days, there was no landline telecommunication until February 2004, there was no mobile telecommunication for at least 12 days following the quake. With regard to concerning the water supply the facility was provided with two reservoirs that were used as alternative sources. The tanks are able to store 13m³ of water which can be used for about two days, see Photo 3.36 and Photo 3.37. The damage to lifelines caused malfunction of medical equipment which caused delay in treatment. International aid teams provided the facility with some equipment which helped it to re-open and provide necessary care. Nevertheless, some medical equipment has not been used since it fell or was displaced causing its damage, see Photo 3.38 and Photo 3.39. At the time of the earthquake the facility did not have any alternative source except the water tanks shown in photos 3.36 and 3.37. Later, a 32KW electric power generator was brought to be used in case of emergency, as Photo 3.40 illustrates. The generator is used only for the operation room. However, the engine is able to make the majority of the equipment function; it can produce 768KWh/day, thus it produces 23,808KWh in 31 days which is 80% of the consumption of August 2005.

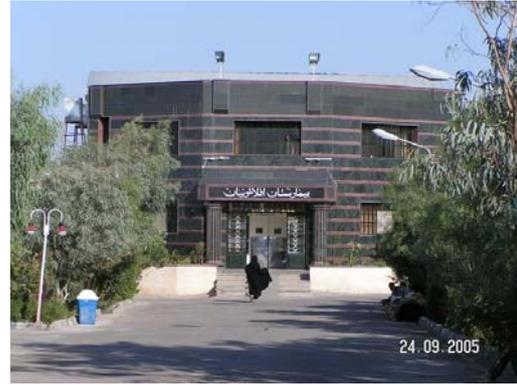
Photo 3.31- Aflatoonian Hospital, September 2005

The Aflatoonian hospital is a private hospital; the 2-story building was built about six years before the earthquake 5km from the centre of Bam. The facility has a capacity of 70 beds which can be extended to 120 beds in case of emergency. Between 25 and 30 patients are treated every day in the hospital in addition to 70 inpatients which makes the facility full without being in emergency mode. The medical service is composed of 57 people; 17 of them are doctors, 40 nurses. A problem with the facility's insurance forced it to close on January 5th 2004; after that the facility partially opened to provide treatment in its garden and parking lot, where the international teams setup their tents, the personnel stated. The actual building was totally closed until July 2004, then opened again and started treating patients. The government of Kerman helped in repairing the facility, which was exempted from paying water supply fees until October 2005. Photo 3.30 and Photo 3.31 show the front of the facility before and after being repaired, respectively.

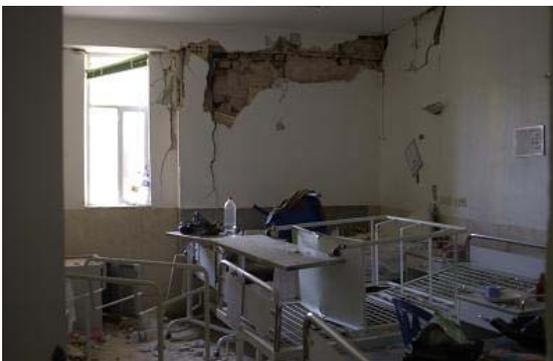
Photo 3.38- Topple of equipment
Aflatoonian Hospital

As a result of the shaking many pieces of equipment got damaged which may be the result of displacement, topple, rocking or displacement-rocking. The personnel of the Aflatoonian Hospital stated that almost all the equipment was damaged with various degrees of severity; the cost of repairing the damage was between 10-100% of the price of the equipment itself. For instance, Table 3.13 shows some of the equipment and the severity of its damage. Some of them were fixed and some others were disposed, such as the radiology unit shown in Photo 3.41. As a result of the displacement the pipelines to the water supply attached to the Central Sterilization Room (CSR), shown in Photo 3.42, were damaged rendering the equipment useless.

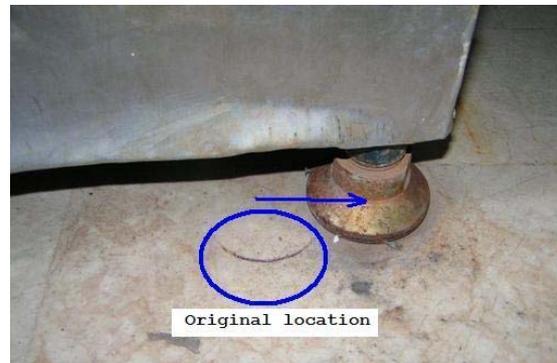
Photo 3.39- Displacement of a sterilizer
Aflatoonian Hospital

Unit	Severity of damage	Remarks
X-Ray	10%	
Sterilizer (CSR)	10%	Damage to the water pipes because of the displacement, Photo 3.42 and Photo 3.39
Radiology	100%	Photo 3.41

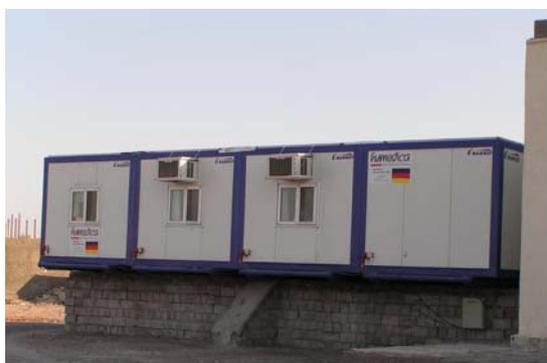
Some services are still operating in prefabricated buildings, such as the operation room and women’s ward. The prefabs are located on small masonry walls without being attached to any support which may make them unstable in case of strong shaking, see Photo 3.43 and Photo 3.44. The masonry is not capable of resisting horizontal loads, which is the case of earthquakes; this may result in their damage during an earthquake. The damage to walls leads to the total malfunction of the service provided in the prefabricated building.

Photo 3.43- Operation room, Women’s ward

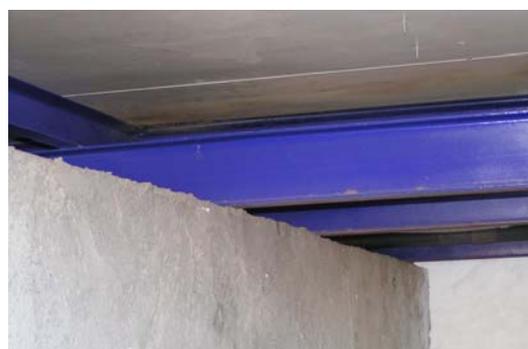
Photo 3.44- Operation room, base view

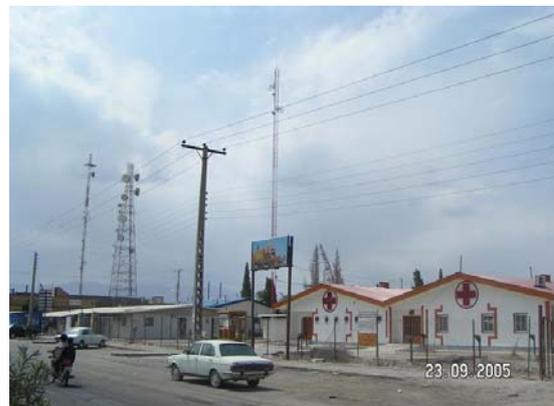
The facility is a public hospital located in the centre of Bam City. Its capacity is 100 beds, and it hosts 290 staff members; 24 doctors, 146 nurses and 120 administrative personnel. The facility had many problems that hampered its normal functioning; mainly the severe structural damage that it experienced, see Photo 3.47. The international aid teams installed prefabricated hospitals beside the actual building, as Photo 3.28 and Photo 3.29 show. They lent Iranian personnel some of their equipment, which was used for treatment. Later the rubble was cleared and the rest of the original building was demolished. Some prefabricated buildings were installed by international companies and societies and are being used as small clinics, Photo 3.48, Photo 3.49 and Photo 3.50.

Photo 3.48- Prefabricated buildings installed instead of the Imam Khomeini Hospital September 2005

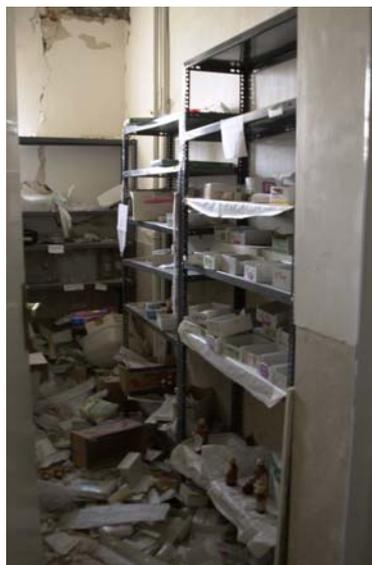
Photo II. 3- Topple of medical equipment
