Geotechnical damage in the 2018 Sulawesi earthquake, Indonesia

SHORT REPORT

Masakatsu Miyajima^{1*}, Hendra Setiawan², Masaho Yoshida³, Yusuke Ono⁴, Kenji Kosa⁵, Ida Sri Oktaviana², Martini² and Irdhiani²

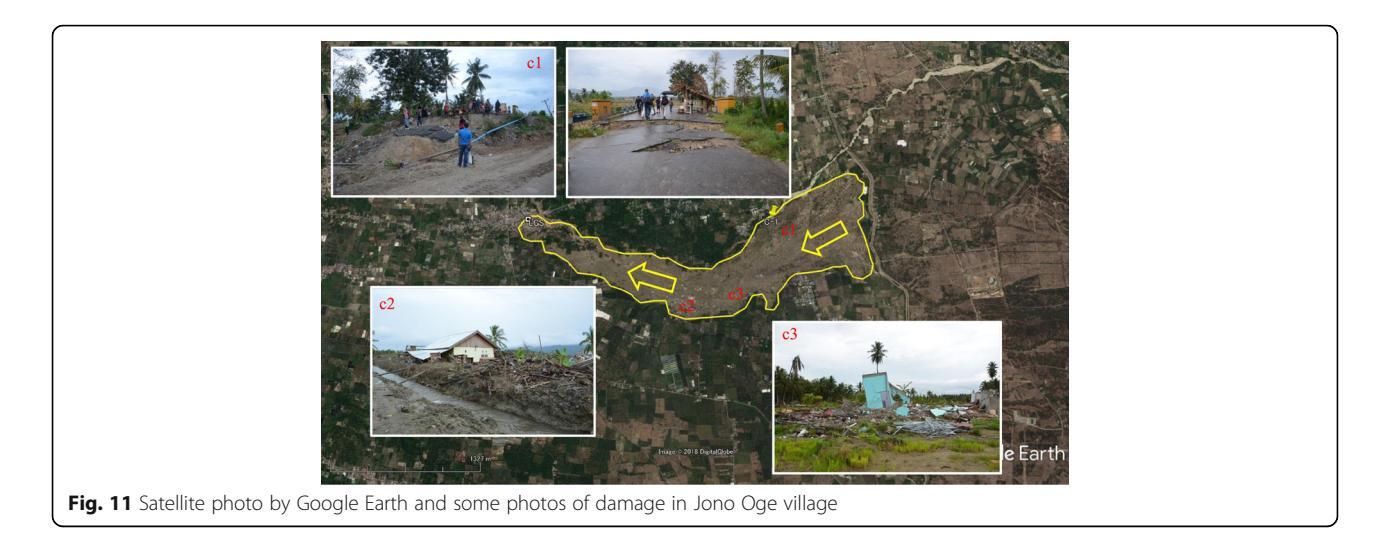
Figure 11 shows a satellite photograph by Google Earth and some photographs of damage in Jono Oge village. The direction of the large scale ground flow is also shown by a yellow arrow in this figure. The ground flow occurred from east to west. Lateral ground flow occurred as well with the affected area around 180,000m² in Jono Oge village. Most of this area was used for rice field before the event. In this area, at least 34 high school students who joined a bible camp were killed, but it is suspected that many others are dead.

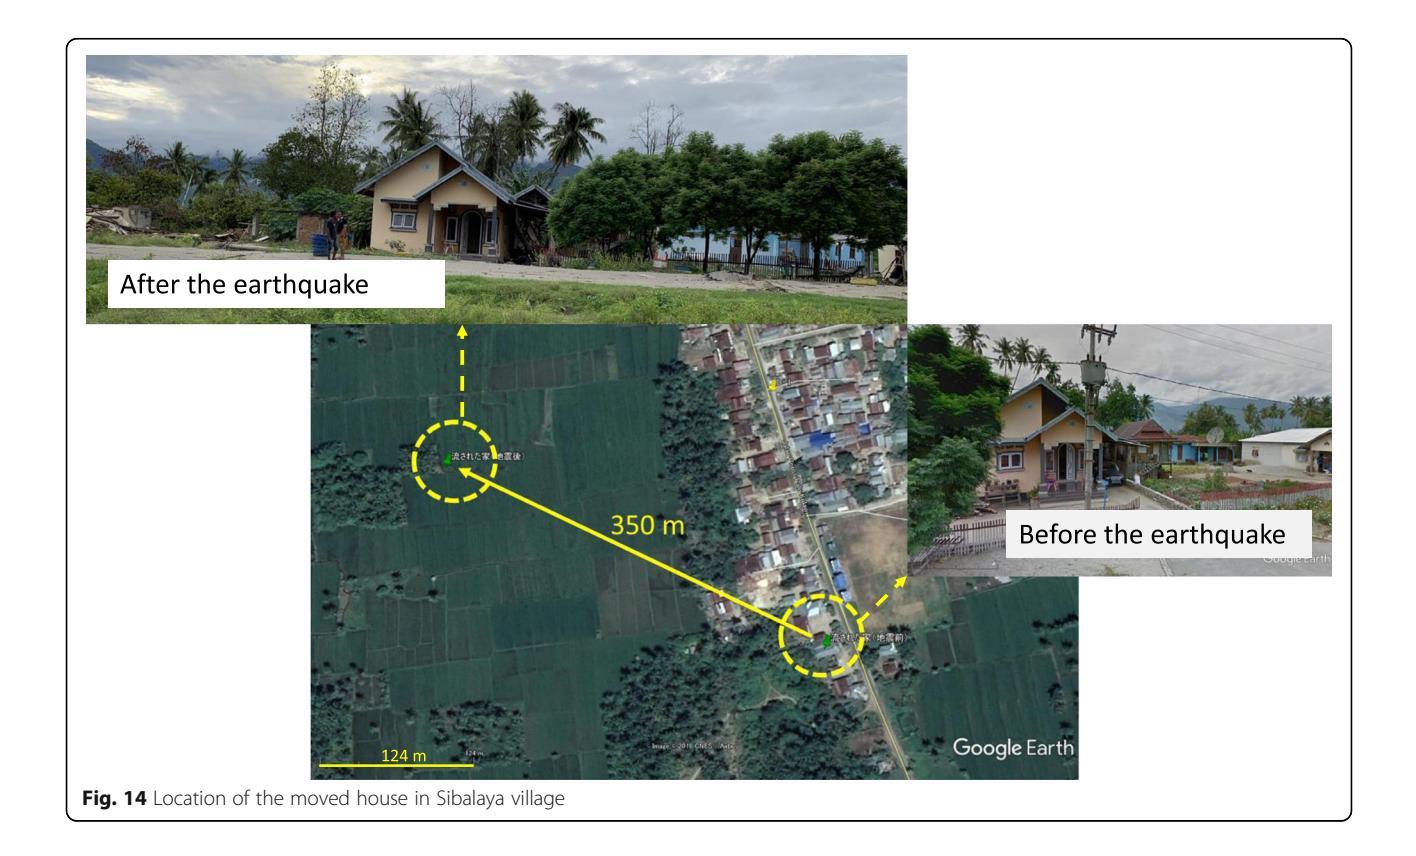
Figure 12 shows a satellite photograph by Google Earth before the earthquake and some photographs of damage in Sibalaya village. The direction of the large scale ground flow is also shown by a yellow arrow in this figure. Sibalaya village is located about 40 km south of Palu city. A satellite photograph of Sibalaya village after the earthquake could not be obtained yet. Most of this area was also used for rice field before the event. In this area, only three people were dead due to building collapse. Figure 13 shows the photograph of Sibalaya village taken by a drone after the event. The road and houses moved laterally up to about 350 m. Figure 14 shows the same house before and after the event. What made this phenomenon extraordinary is that the moving road and some houses only experienced minor damage. The mechanism of the large ground flow should be clarified in near future.
