Effects of topographic and geological features on building damage caused by 2015.4.25 Mw7.8 Gorkha earthquake in Nepal: a preliminary investigation report

Abstract

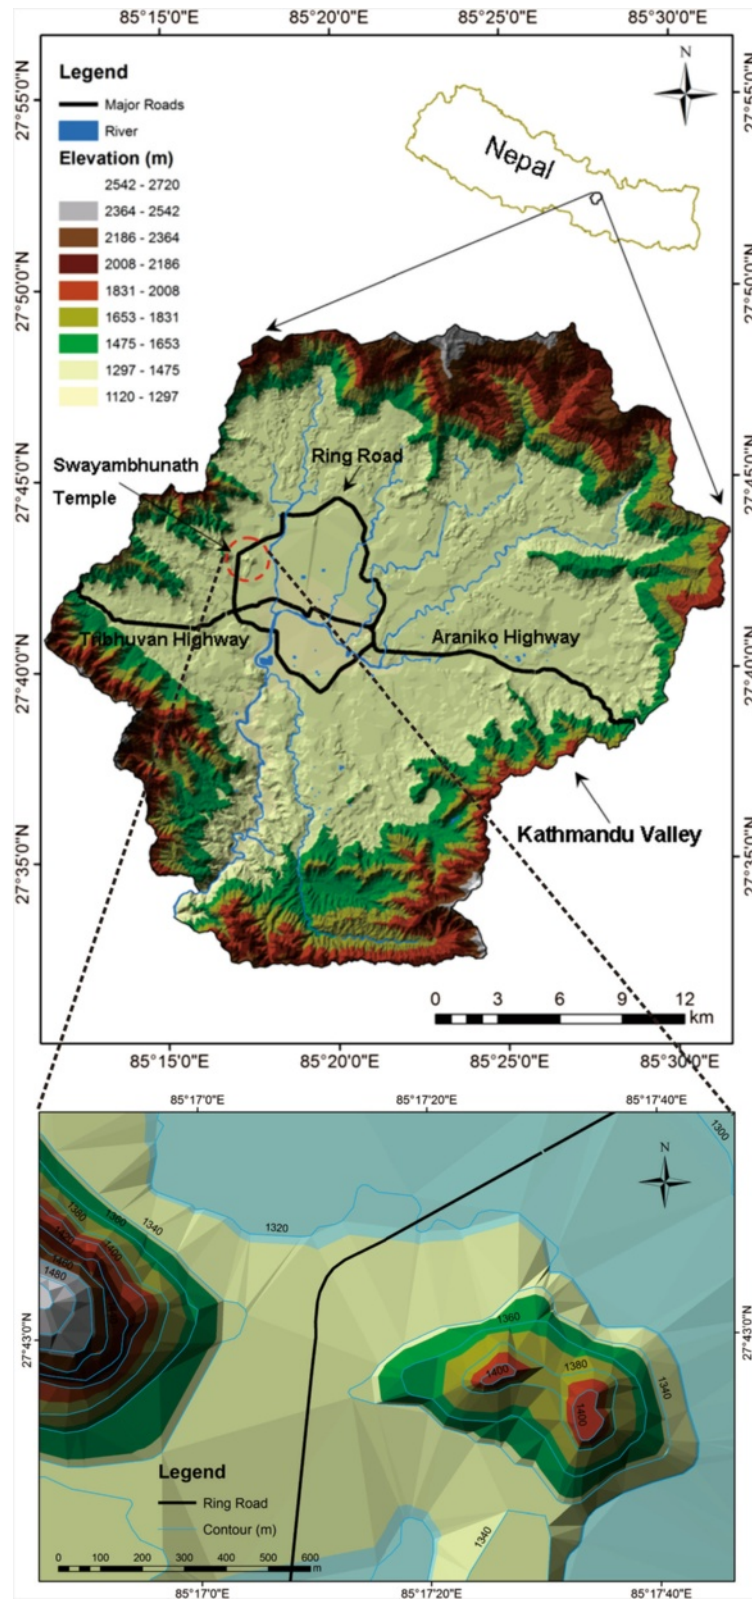
Fig. 2 The location map of the Swyambhunath World Heritage site and surrounding area

Figure 2 shows the topography of the Swyambhunath World Heritage site and its surrounding area. It is located on an isolated hill near the mountainous area in the west side of Kathmandu city. On the hill, there was a pond named Peace Pond. The local Buddhist monks in the temple told us they have felt strong shaking during the earthquake. In this investigation, we found distinctively crooked trees, known as "drunken" trees, widely distributed on the north slope of the heritage site (Fig. 3). These types of trees often indicate slope movement and probable slow-moving landslide activity, known as creep, a process which usually occurs over an extended period of time.

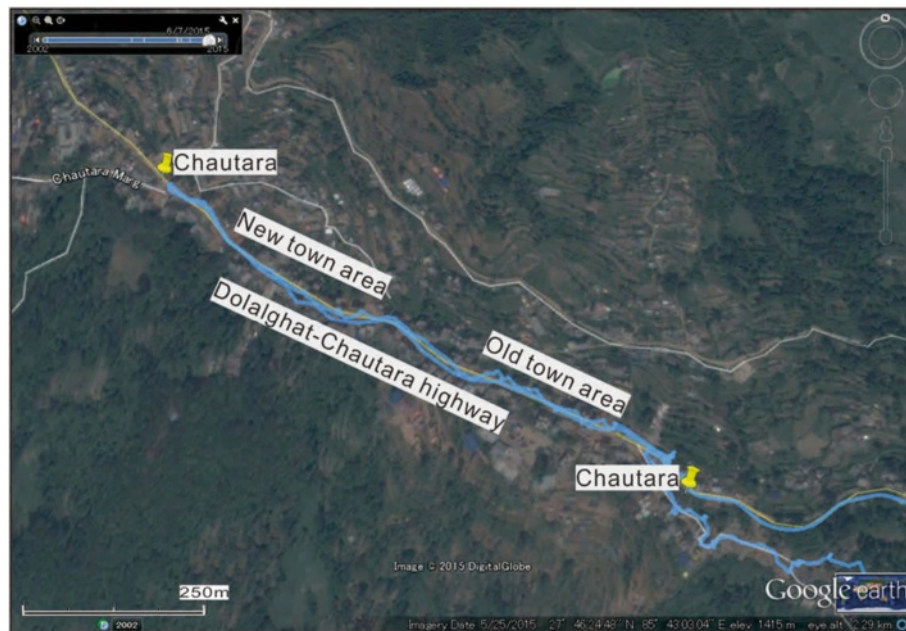
Fig. 11 Investigation route along the highway in Chautara town

the mountain ridges. Figure 11 shows the investigation route into the town, along the highway. It can be seen that the highway is located in the center of the town, and was sandwiched by the buildings along the highway. On the slopes at the two sides, step-plantation fields are widely distributed, and most of them shows evidence of landslides.

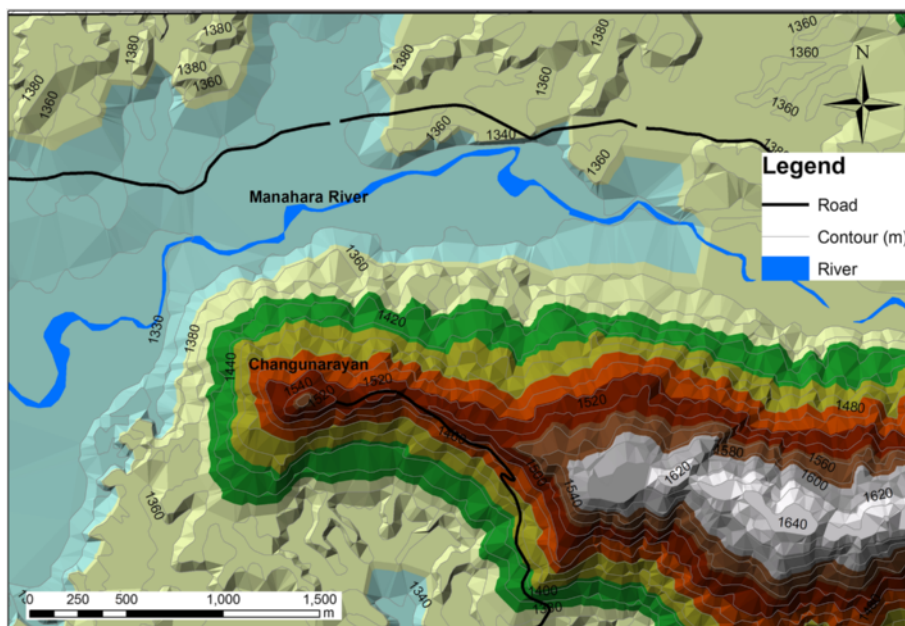
Fig. 14 Topography of Changu Narayan

The Changu Narayan temple is considered to be the oldest temple in Nepal. Figure 14 shows the topography of Changu Narayan. It is located on an isolated hill. At both sides of the hill ridge, typical topography of a landslide was confirmed.

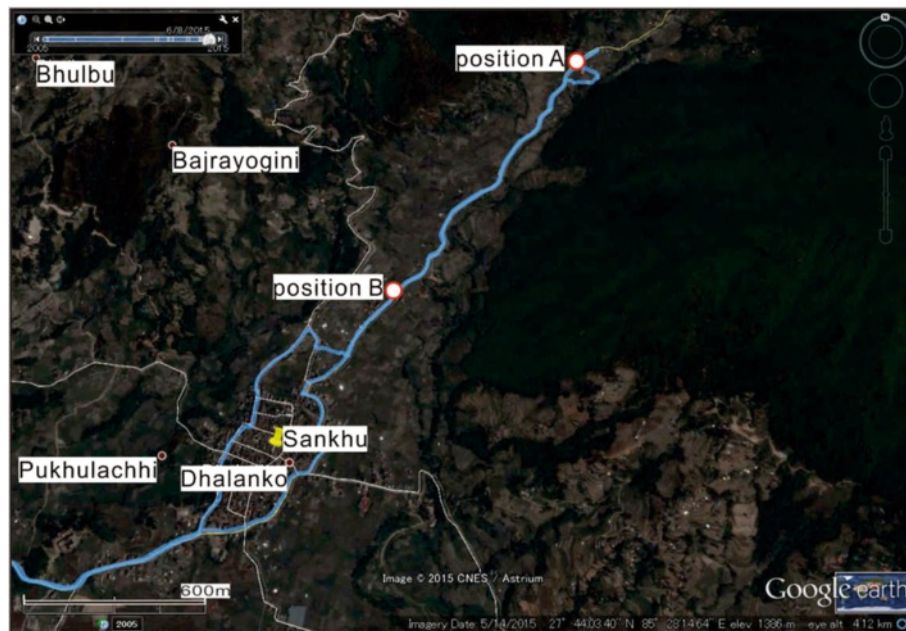
Fig. 19 Investigation route around the Sankhu area

To find the reason why the building were more heavily damaged than the surrounding villages, we observed areas around the residential section and then traveled in a northerly direction. Figure 19 shows the trace of the investigation route. It is found that this area is an alluvial fan. At Position A, we found large boulders in the shallow valley, and flowing water (Fig. 20a). On the terrace, two-floors or higher building were in good condition. At position B, there were rice paddies, surrounded by concrete buildings of two to four stories. The damage at point B was not so severe. It was observed that the most severe damage occurred at the middle-lower part of the alluvial fan. It is estimated that at that part, ground deformation has been amplified by the specified soil layer structure, and caused the concentrated collapses in the old buildings.
