Structural damage to houses and buildings induced by liquefaction in the 2016 Kumamoto Earthquake, Japan

Results: Field reconnaissance was conducted in the target area on May 27th–30th, 2016. The post-earthquake inclination angle and the tilt direction of 68 affected houses and buildings in the liquefied sites in Kumamoto City were measured by using a laser rangefinder (Leica DISTO D 510). Ground structure and condition were also determined from topographic maps, bore data and the calculated liquefaction resistance factor, F_L .

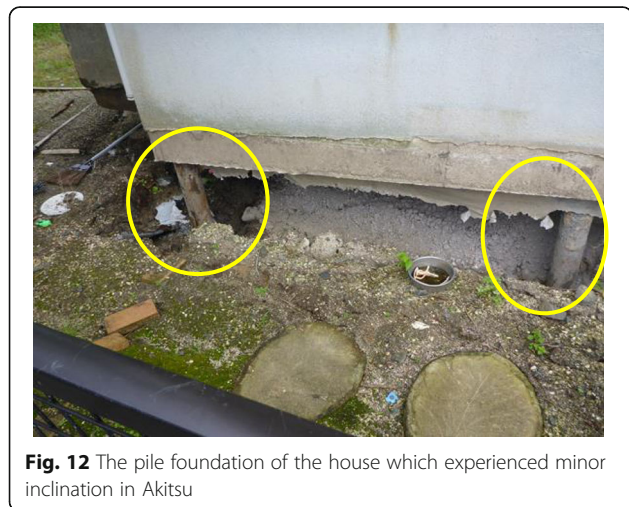
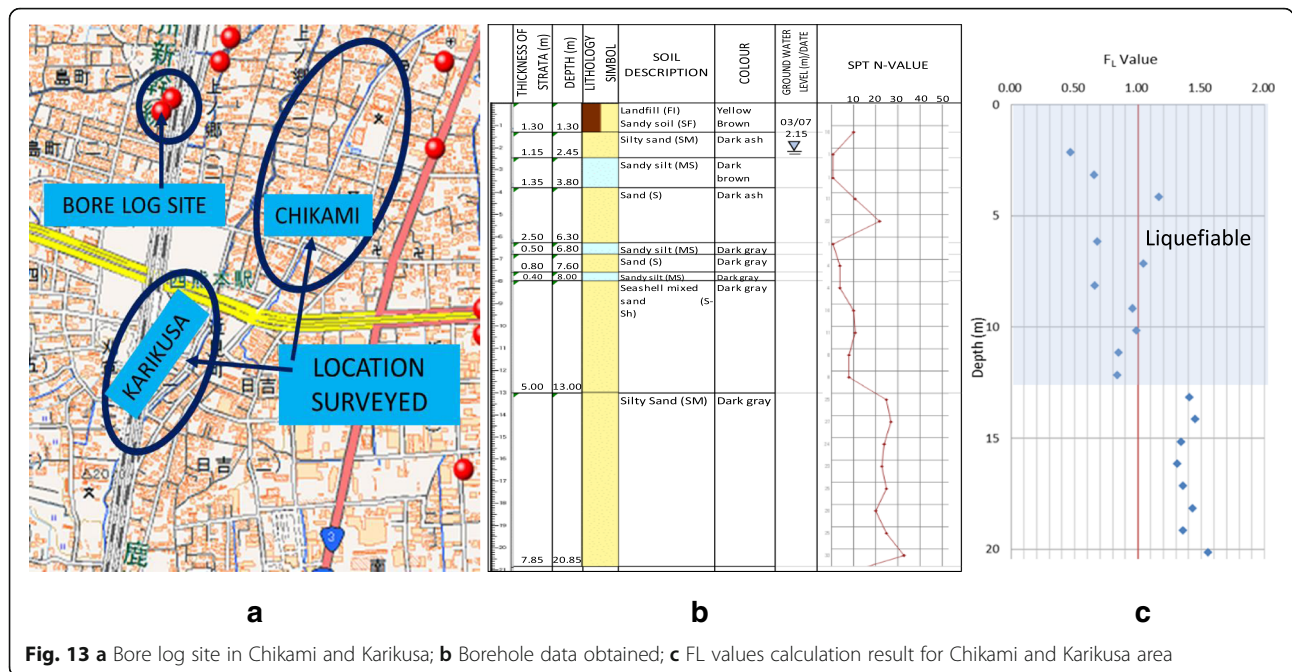
Fig. 13 a Bore log site in Chikami and Karikusa; b Borehole data obtained; c FL values calculation result for Chikami and Karikusa area

Chikami and Karikusa are located in the southern part of Kumamoto City. Figure 13a and b show the bore log site and bore data acquired in Chikami and Karikusa area, respectively. The depth of the groundwater level is as shallow as 2.15 m. The soil layers are composed of landfill from 0 to 1.5 m, sand and silt from 1.5 m to

Figure 13c gives the F_L values for Chikami and Karikusa areas. Based on calculated F_L value its potential to liquefy is moderately high to a depth of about 12.5 m below the ground surface as it is composed mostly of sand and has F_L values of less than 1, specifically near the surface. Generally, the potentially liquefiable ground surface may lead to structural damage related to differential settlement and structure tilting because sand boiling has a high potential to take place.

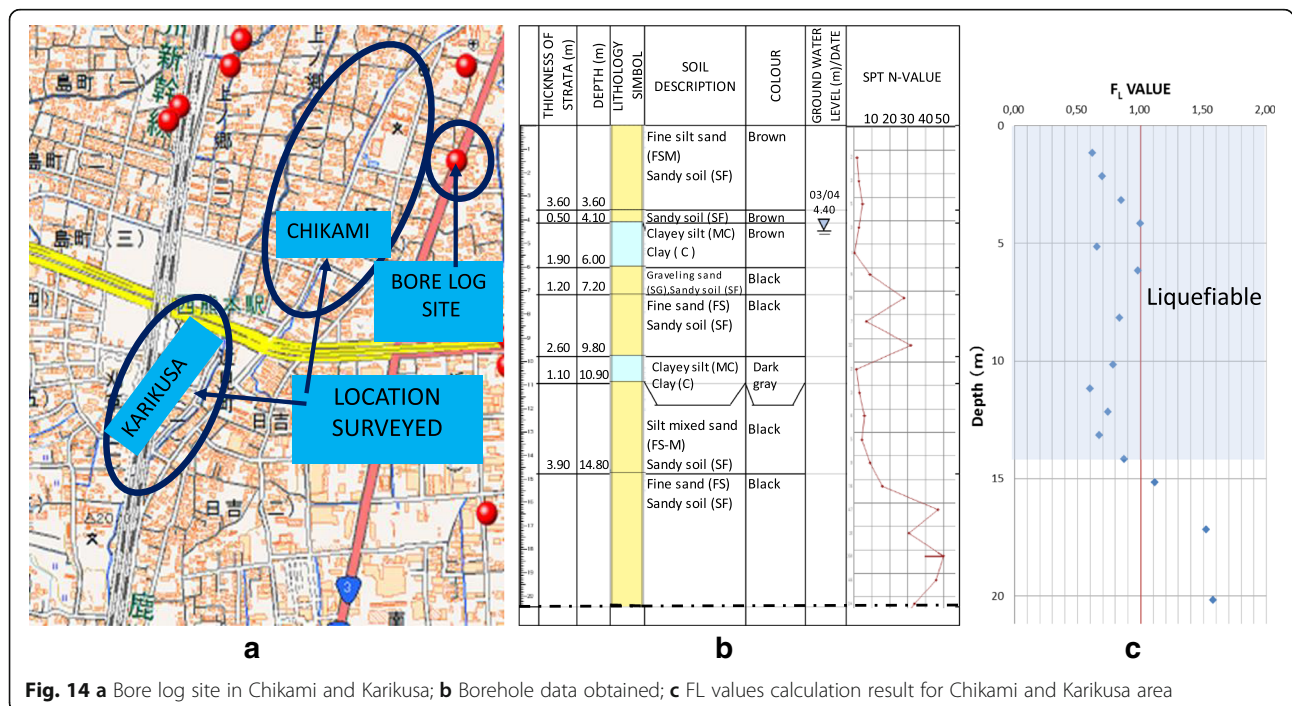
Fig. 14 a Bore log site in Chikami and Karikusa; b Borehole data obtained; c FL values calculation result for Chikami and Karikusa area

In order to ascertain ground conditions in this area, geological profiles of other two bore logs are observed in the adjacent site. The result obtained were much the same, as shown in Figs. 14 and 15.
