# RECONNAISSANCE REPORT ON THE 2000 TOTTORI-KEN SEIBU EARTHQUAKE

Damage done to civil structures by the 2000 Tottori-ken Seibu Earthquake was investigated. Field surveys were made from October 8-10 by eight members dispatched by the JSCE in cooperation with other researchers. Descriptions are given of the earthquake, seismic ground motion; the damage done to such civil structures as roads, road bridges, lifelines, dams, port facilities; slope failures; and public risk management. Although peak ground accelerations were extremely intensive, structural damage was not as severe as compared with the average damage caused by past earthquakes in Japan. Such disaster responses as search and rescue activities, emergency responses, disaster information communication, and victim supports are discussed.

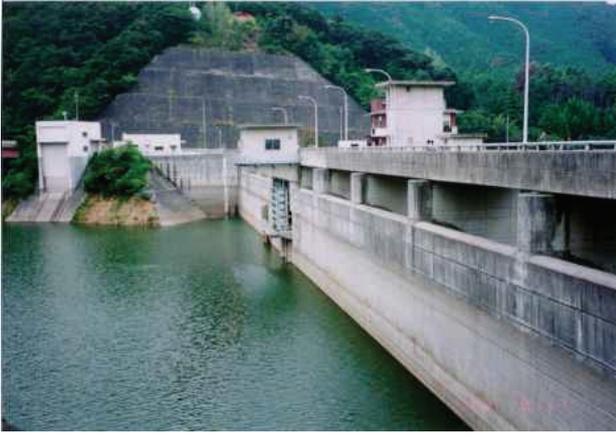
**Photo 8** Gasho Dam (viewed from the right to left bank).

This is a multipurpose dam constructed by damming up the Hosshoji River (length: 25km, catchment area: 121.7 km<sup>2</sup>) that flows from western to northern Tottori. It is a gravity style concrete dam with a height of 46.4m, crest length of 174.0m, and a body volume of 86,600m<sup>3</sup> (**Photo 8**). It is located just above the aftershock area.
