Nanoscale corrosion behavior of polycrystalline copper fine wires in dilute NaCl solution investigated by in-situ atomic force microscopy

Abstract

In this study, nanoscale corrosion behavior of copper fine wires in dilute NaCl solution is studied by atomic force microscopy and electron backscatter diffraction technique. The dissolution rate of the grains constituting the wires strongly depends on their crystallographic orientation. In pure water, the dissolution rate increases in the order of $(111) < (001) < (110)$. Addition of Cl^- dramatically increases the dissolution rate of the (111) surface to alter the order to $(110) \approx (001) \approx (111)$ at 0.1 mM. These results show that the crystallographic orientation dependence is significantly changed by a slight increase of Cl^- concentration in dilute solution.

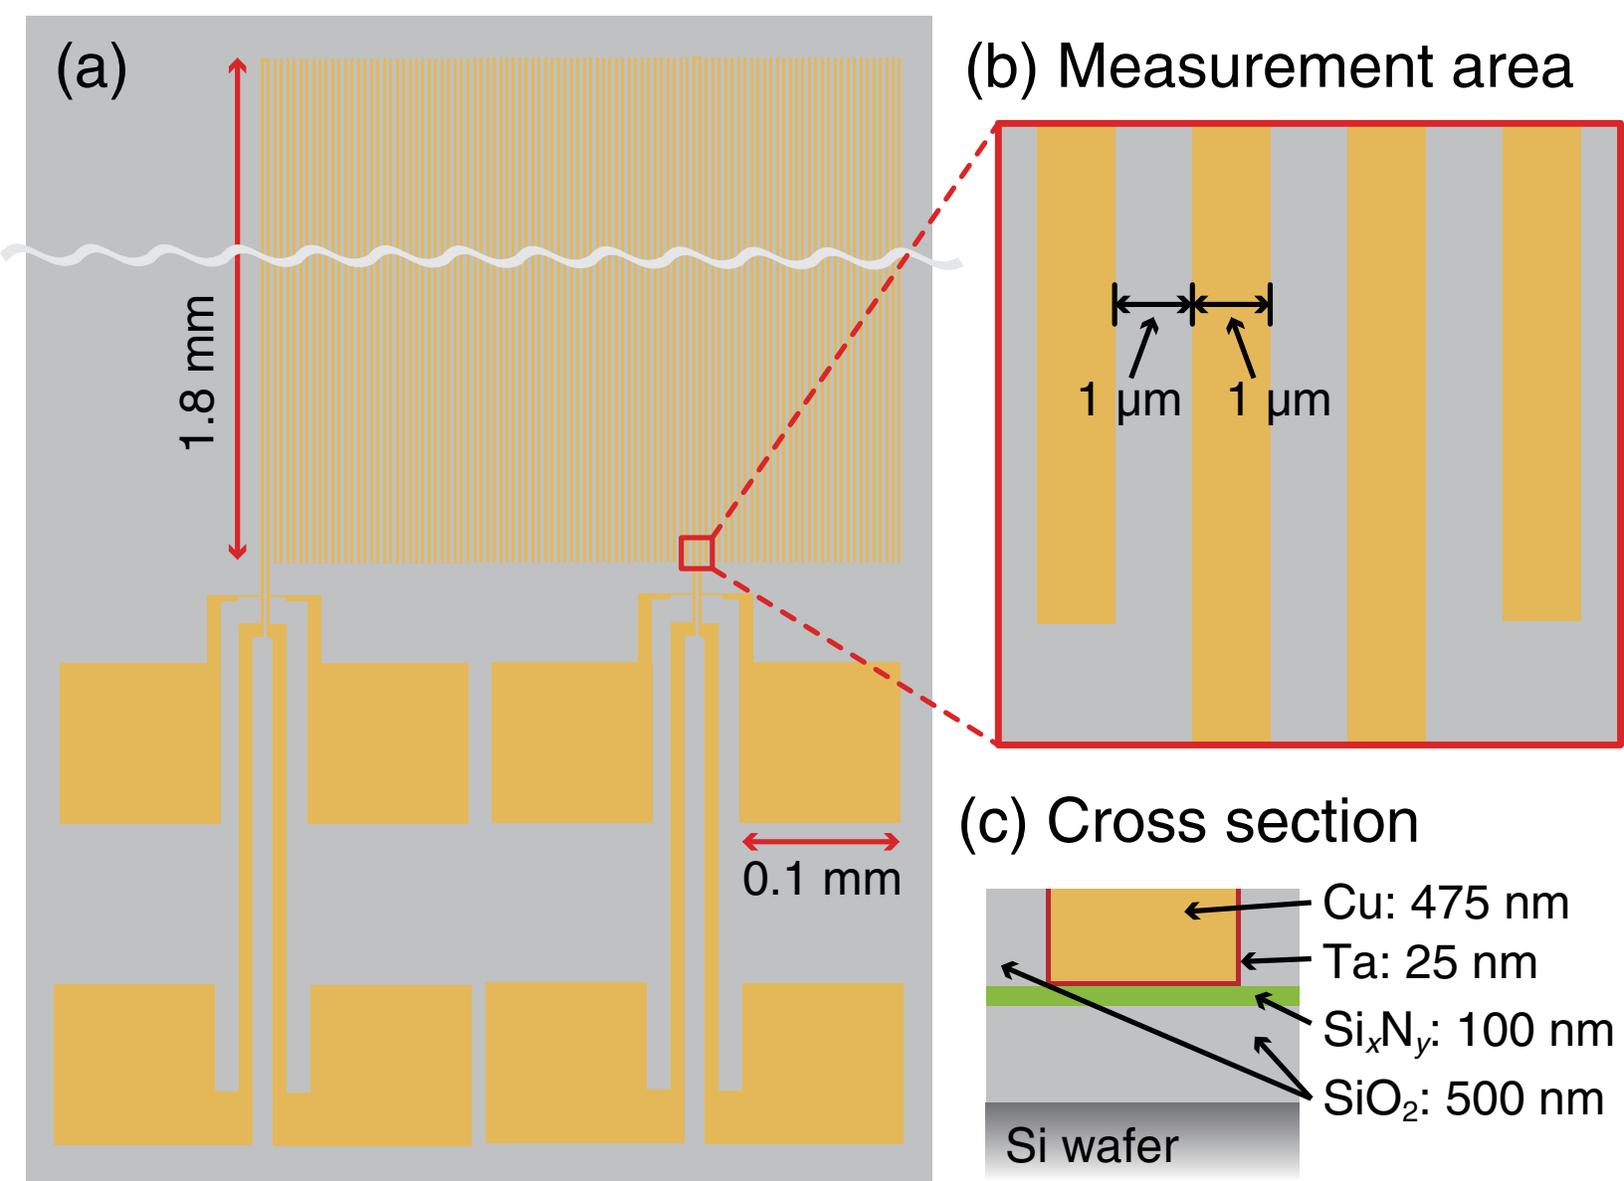
Figure1

For the AFM and EBSD measurements, patterned copper fine wires fabricated on a Si wafer (854 Cu CMPd Wafer, Advanced Materials Technology) was used. Figure 1(a) shows a large-scale view of the pattern while Figure 1(b) shows a magnified view of the area that was measured by AFM and EBSD. In this region, the line and space width is 1 μm . The two wires at the center are connected to a 0.1 mm \times 0.1 mm copper pad while the others are electrically isolated. Owing to the characteristic wiring pattern in this area, its location can be easily identified either by scanning electron microscopy (SEM) or optical microscopy. This enables to analyze the same area by AFM and EBSD.

Figure 1(c) shows a cross section of one of the wires shown in Fig. 1(b). As illustrated in this cross section, the copper wires are formed on a 25 nm Ta film

Figure 1: Schematic illustration of copper fine wires used in this study. (a) A large-scale view. (b) A magnified view of the area measured by AFM and EBSD. (c) Cross sectional view of a copper wire.

1. A patterned trench structures were formed by etching the SiO₂ layer.
2. A 25 nm Ta film was formed on the wafer surface by physical vapor deposition (PVD).
3. A thick copper film was formed on the Ta film by electroplating.
- 70 4. The wafer was annealed at 150°C for 30 min.
5. The surface was polished by CMP to make the SiO₂ thickness 500 nm, which corresponds to the copper wire thickness of 475 nm.

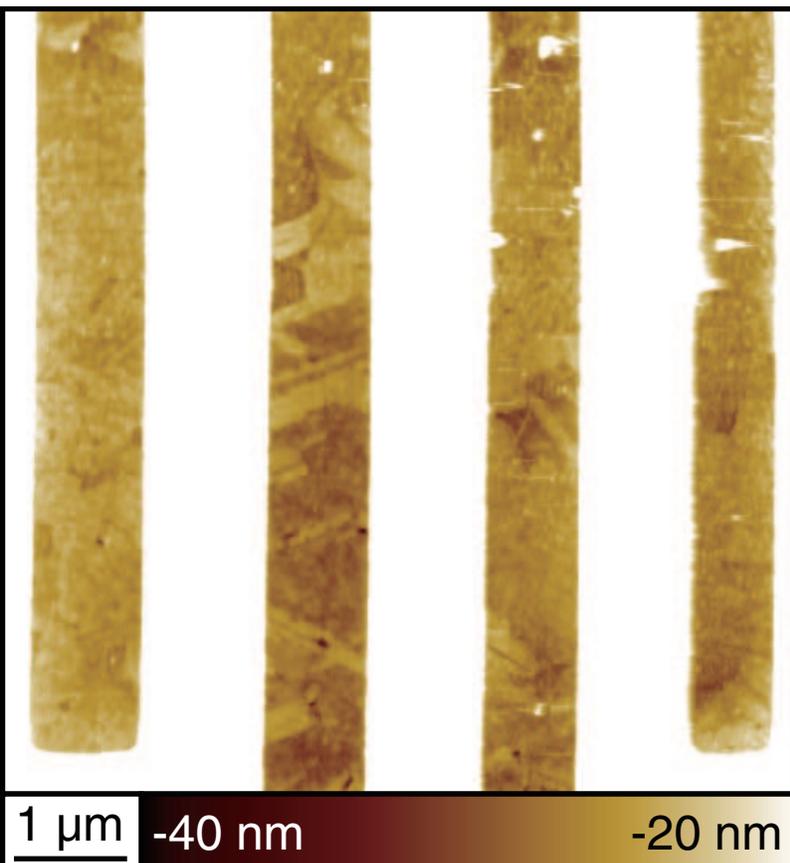
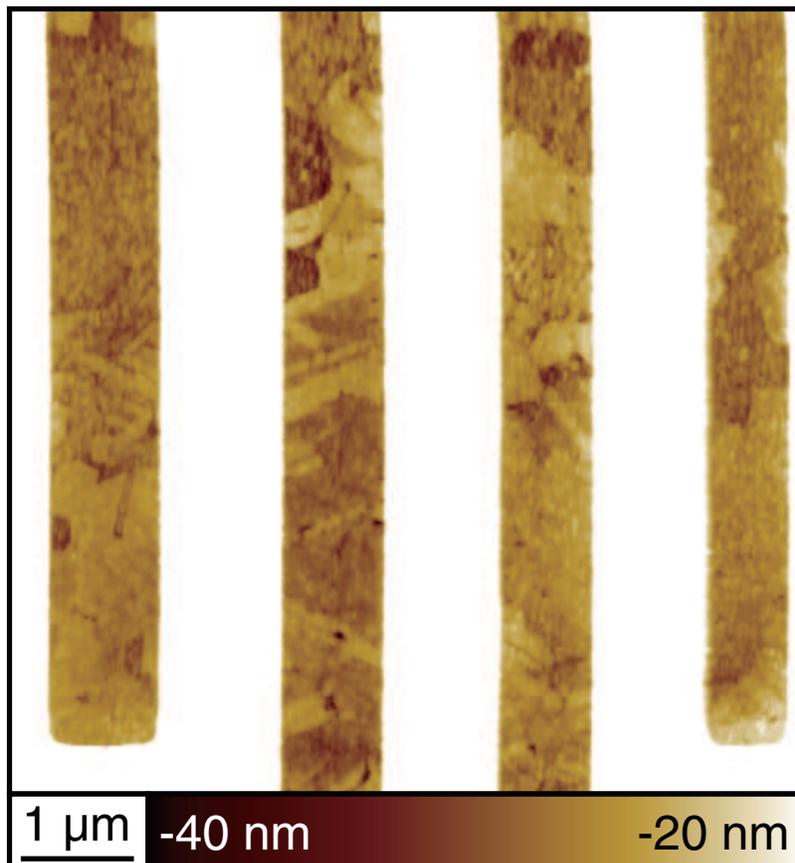
Corrosion process of copper wires in water was imaged by AFM from 39 min till 203 min since the surface was immersed in the imaging solution. Figures 2(a, b) show AFM images of copper wires in water at 39 min and 203 min, respectively. See also a video consisting of all the AFM images obtained during the corrosion process (Water.gif in supplementary online materials). The images show four copper wires as illustrated in Fig. 1(b). At 39 min, the copper surface already shows nanoscale height variations. Such initial height variations may be caused by the CMP, Ar plasma or citric acid cleaning. As the main interest of this work is on the copper corrosion processes in dilute NaCl solution, hereafter we do not discuss formation mechanism of these initial height variations but focus on the time-dependent height changes observed during the AFM imaging. The image obtained at 203 min shows a larger local height variation than the one obtained at 39 min. This result shows that the corrosion resistance is not uniform but has local variation.

Figure 2: AFM images of copper wires in water at (a) 39 min and (b) 203 min. The 0 nm in the height scale corresponds to the approximate average height of the insulating areas. (c) IPF map of the same area as imaged by AFM. (d) Height changes at the locations indicated by the arrows No. 1 in (c).

(a) 39 min

(b) 203 min

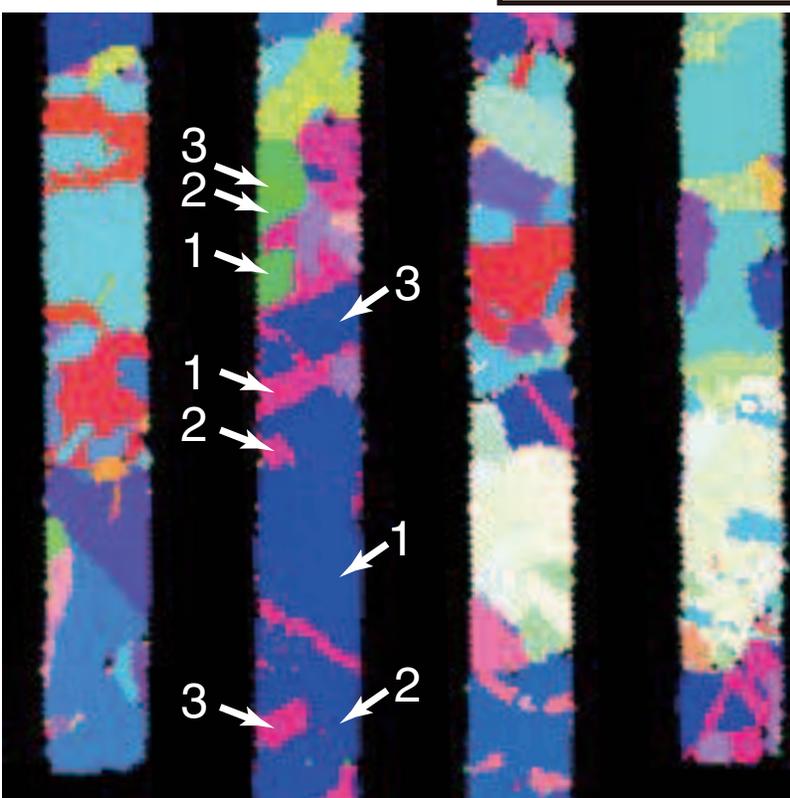
(c) IPF Map

140 Figure 2(c) shows an IPF map of the same area as imaged by AFM. Comparison between the IPF and AFM images reveals that the local areas showing different corrosion resistance approximately correspond to the grains with different crystallographic orientations. The result shows that the corrosion resistance is strongly dependent on the crystallographic orientation.

dence of copper corrosion in 0.1 M NaCl and 0.5 M Na₂SO₄ by AFM and EBSD[7]. They found that the (111) surface dissolves faster than the (001) surface when they are adjacent to each other. In this study, the (111) grains indicated by arrows 1-3 are all adjacent to the (001) grains as shown in Fig. 2(c).
 235 However, they consistently showed a lower dissolution rate than that of the (001) grains (Fig. 5 and Table 1). This disagreement suggests that such influence of neighboring grains in pure water may be weaker than that in 0.1 M NaCl solution.

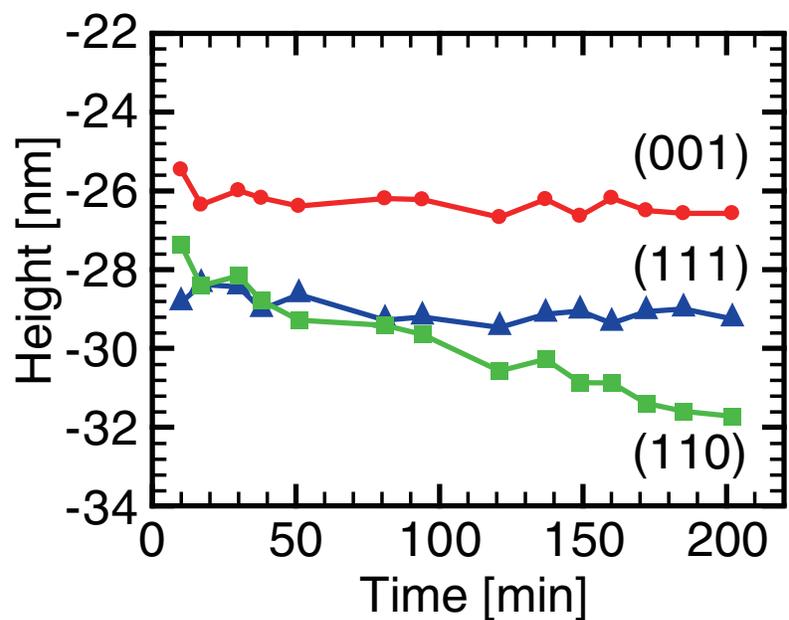
(d) Height changes at locations indicated by the arrows No. 1

145 To investigate the correlation between the crystallographic orientation and
the corrosion resistance, height changes at three locations were analyzed for
each of the (110), (001) and (111) surfaces as indicated by the arrows. Note
that all the locations were selected from the same wire to eliminate possible
influence of the difference in the macroscopic wiring pattern. Fig. 2(d) shows
150 the height changes at the locations indicated by the arrows No. 1 in Fig. 2(c).
The curves show that the height decreases almost linearly at these locations.
Thus, we calculated the average dissolution rates at positions 1-3 from the initial
and final surface heights as summarized in Table 1.

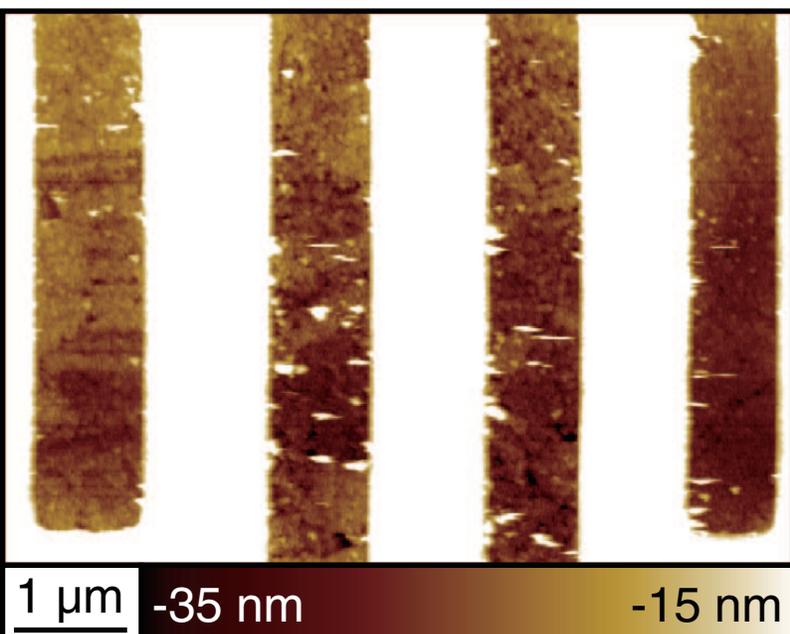
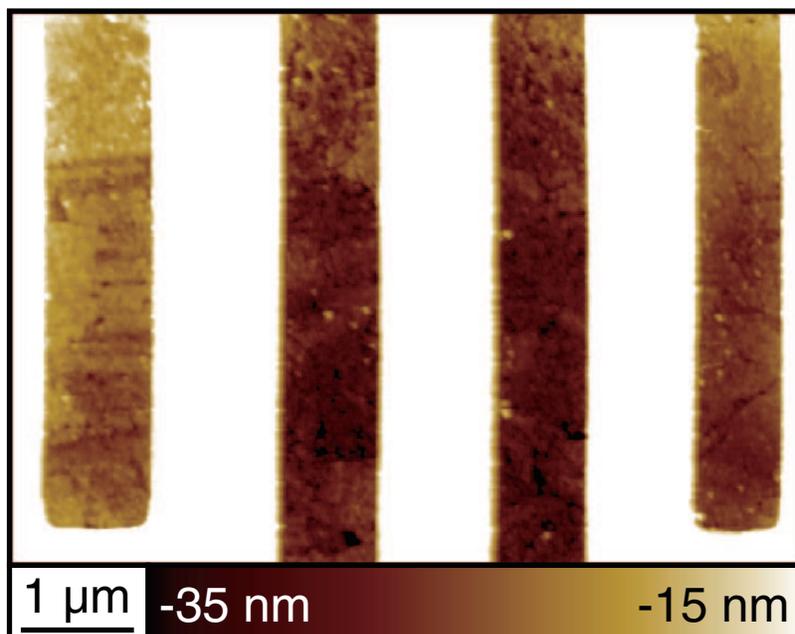
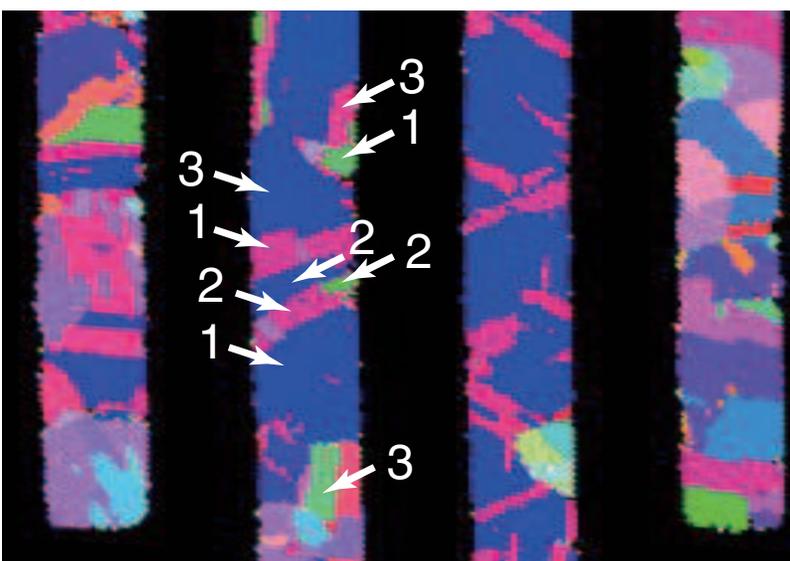
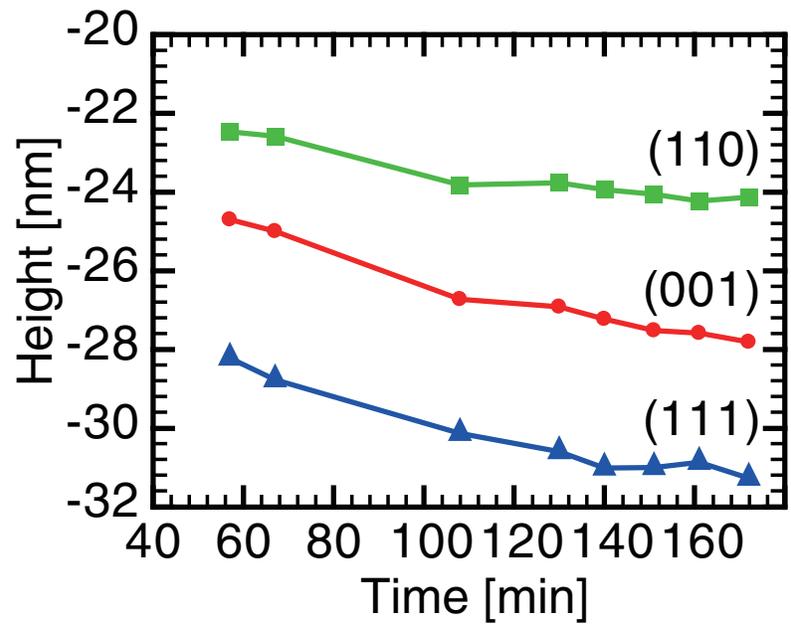
Figure 3: AFM images of copper wires in 0.01 mM NaCl solution at (a) 68 min and (b) 177 min. The 0 nm in the height scale corresponds to the approximate average height of the insulating areas. (c) IPF map of the same area as imaged by AFM. (d) Height changes at the locations indicated by the arrows No. 1 in (c).

(a) 68 min

(b) 177 min

(d) Height changes at locations indicated by the arrows No. 1

Similar analyses of the copper corrosion were performed in 0.01 mM and 0.1
155 mM NaCl solution as shown in Figures 3 and 4. See also videos consisting of
all the AFM images obtained during the corrosion processes (001mM.gif and
01mM.gif in supplementary online materials). AFM images shown in Figure
4 may appear to have a low resolution compared to the other images. This
is not due to the pixel resolution but the contaminations on the tip apex. As
160 Cl^- concentration increases, the dissolution rate increases, making it difficult
to keep the tip apex clean. However, this does not significantly influence the
accuracy of the height measurements. The average dissolution rates measured
at all the locations in different solution are summarized in Table 1 and Figure
5.

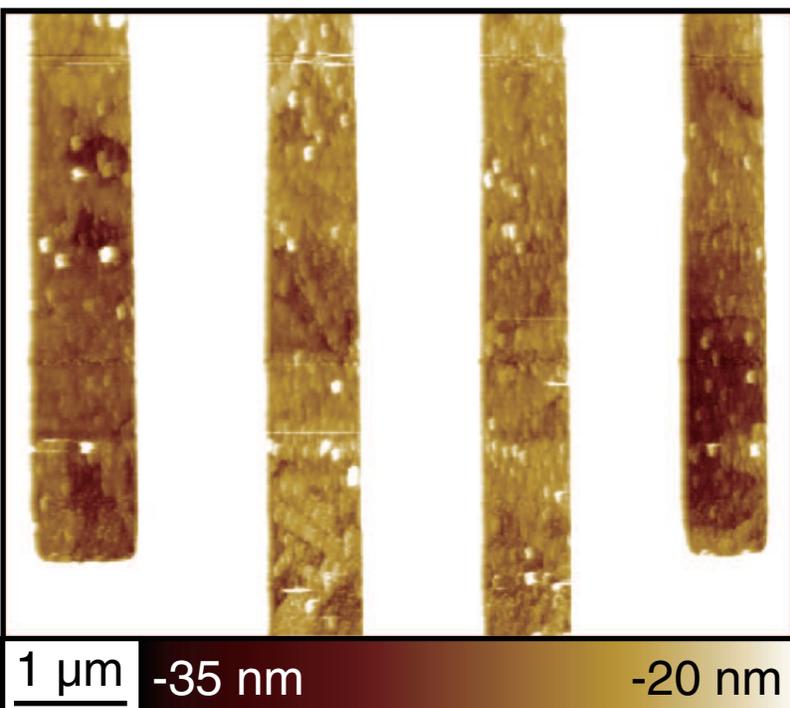
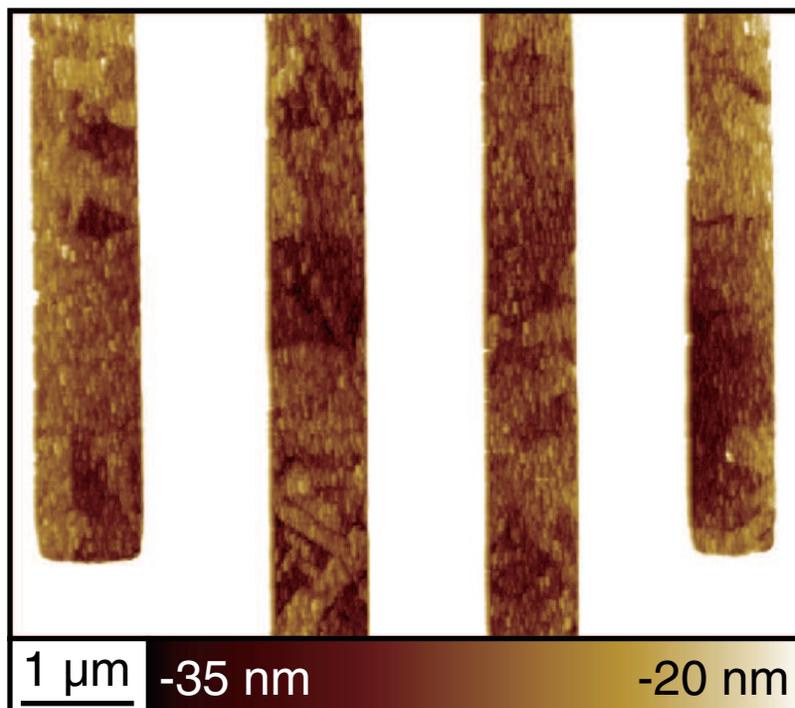
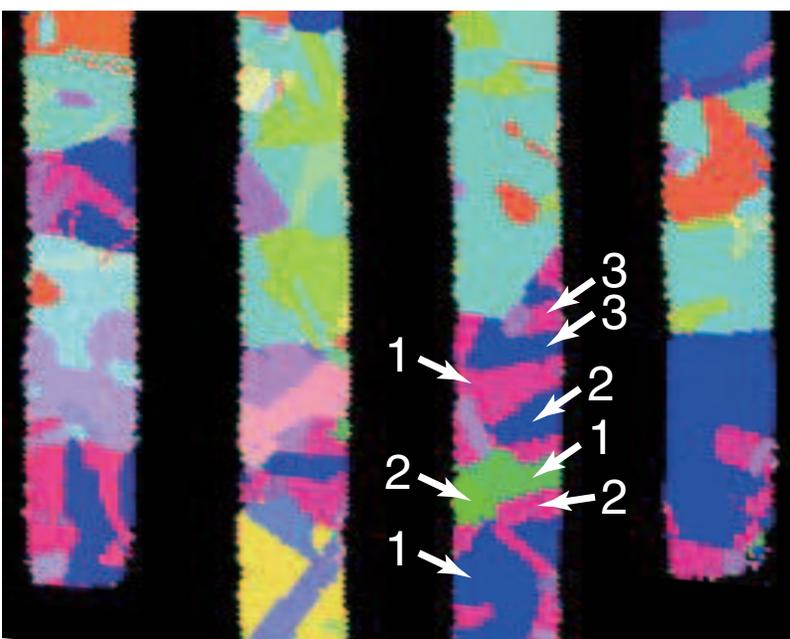
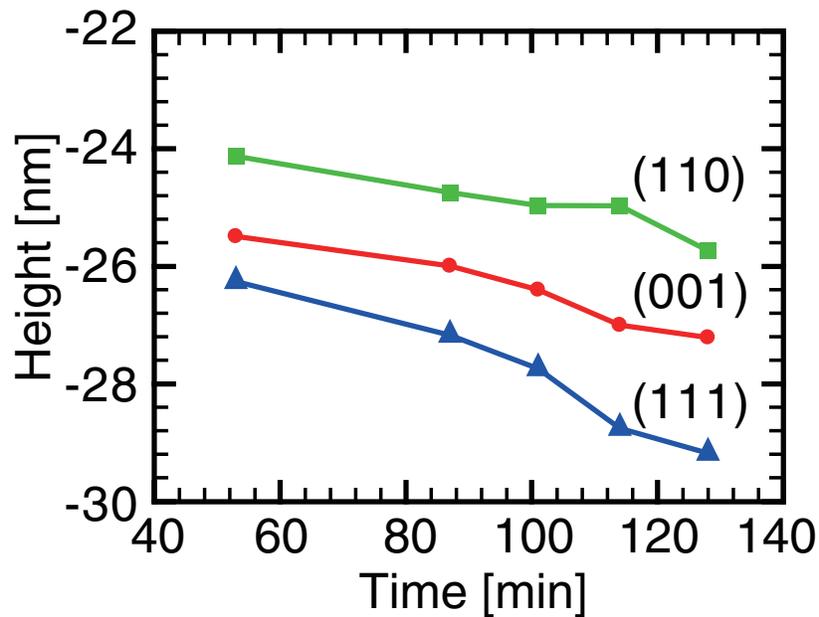
Figure 4

Figure 4: AFM images of copper wires in 0.1 mM NaCl solution at (a) 53 min and (b) 128 min. The 0 nm in the height scale corresponds to the approximate average height of the insulating areas. (c) IPF map of the same area as imaged by AFM. (d) Height changes at the locations indicated by the arrows No. 1 in (c).

(a) 53 min

(b) 128 min

(d) Height changes at locations indicated by the arrows No. 1

grains. As mentioned earlier, Lapeire et al. reported that the (111) surface dissolves faster than the (001) surface when they are adjacent to each other.[7] All the (111) grains indicated by arrows 1-3 in Fig. 4 are adjacent to the (001) grains. Thus, such an influence of the neighboring grains may result in a decrease of the reaction rate on Cu(001).
290

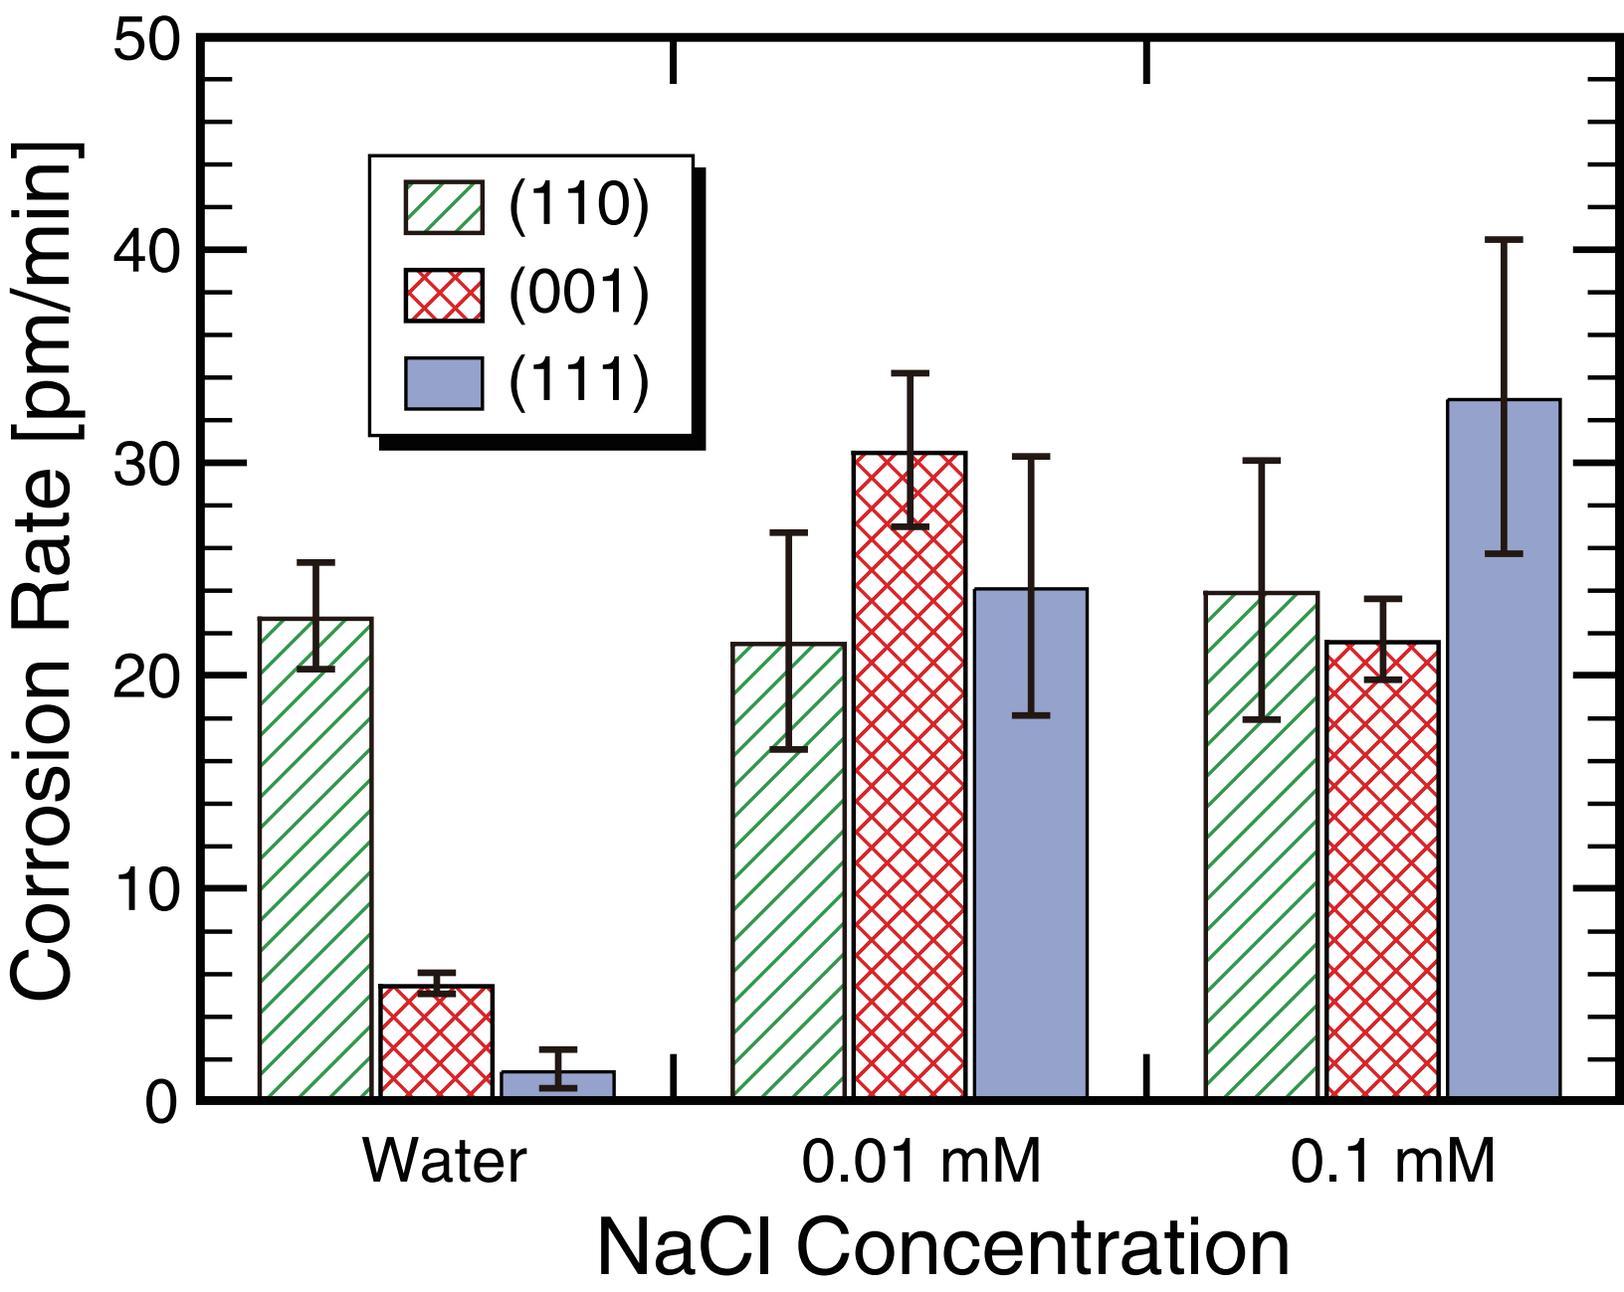
Figure5

170 In pure water, the dissolution rate increases in the order of (111), (001)
and (110). However, the addition of Cl^- into water significantly increases the
dissolution rate of the (001) and (111) surfaces while it gives little influence on
the dissolution rate of the (110) surface. Further increase of Cl^- concentration
from 0.01 mM to 0.1 mM decreases the dissolution rate of the (001) surface.
175 Although the mean value of the dissolution rate of the (001) surface increases,

the significance of the difference is not confirmed due to the large error bars. For 0.01 mM and 0.1 mM NaCl solution, the dissolution rate shows no significant difference between different crystallographic orientations.

Figure 5: Corrosion rates of the (110), (001) and (111) surfaces in water and 0.1/0.01 mM NaCl solution. The values correspond to an average of the values measured at the three locations indicated in Figures 2(c), 3(c) and 4(c). The only exception is the value for the (110) surface in 0.1 mM solution, where only the two (110) surface grains exist in the wire. The error bars correspond to a standard deviation of the measured values.

165 Due to the limited number of the grains in one wire and hence the data
points, the obtained data has a relatively large error bars (i.e. standard deviation).
To evaluate the significance of the difference in the mean values between
the data sets, two-tailed T-tests were performed with a significance level of
 $\alpha = 0.05$. Following discussions are made based on these statistical analyses.
