DOCTORAL DISSERTATION

IN-PLANE SEISMIC BEHAVIOR OF FIBER CONCRETE
FILLED MASONRY BRICK WALLS

Graduate School of Natural Science and Technology, Kanazawa
University

Major subject: Earthquake Engineering

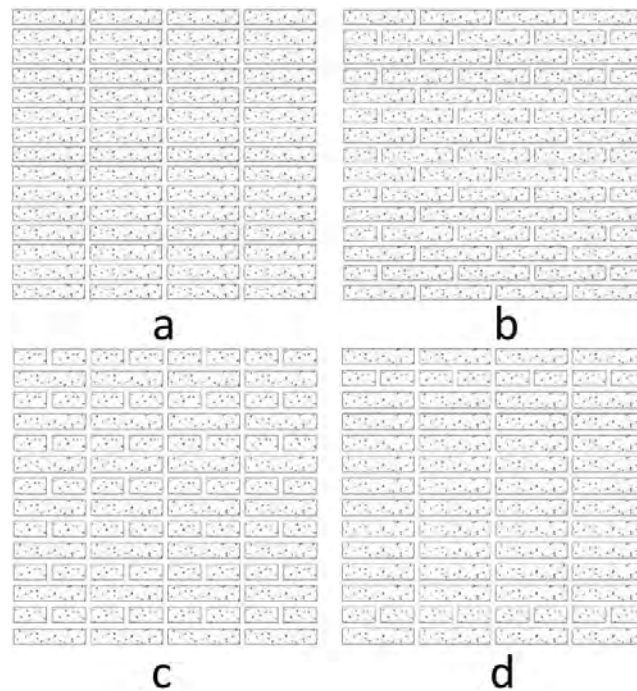
Figure 1.1 Various types of texture orders for brick masonry: (a) stack bond, (b) stretcher bond, (c) English (or cross) bond, (d) American (or common) bond.

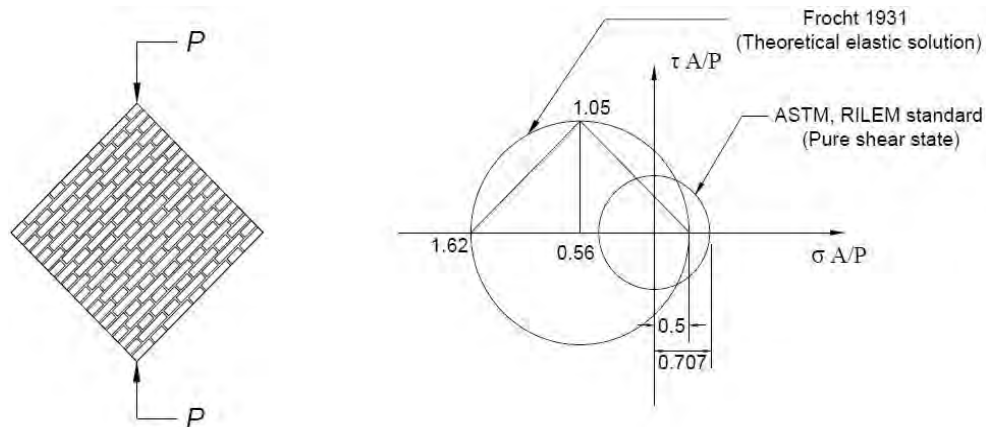
Figure 2.5 Mohr's representation of stress state at the center of masonry panel in diagonal compression test.

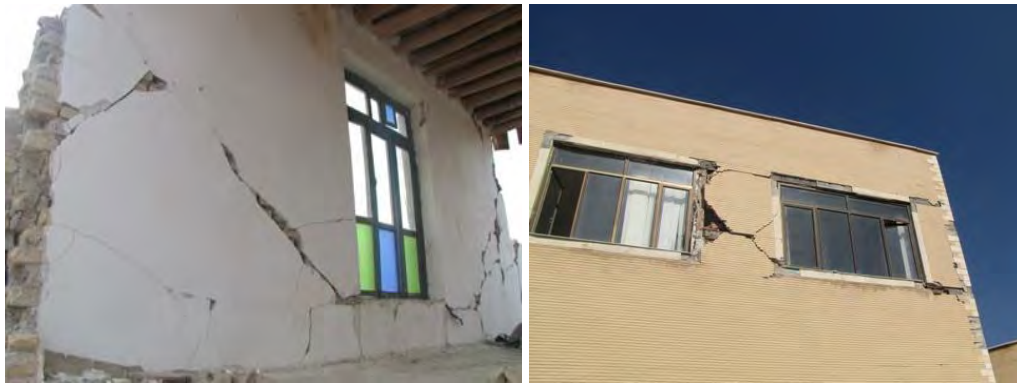
Photo 3.1 demonstrate an example of in-plane diagonal cracks in a building that was suffered from 11th of August Ahar earthquake in northwest of Iran.

Photo 3.1. Tension diagonal cracks of masonry wall [16, 17].

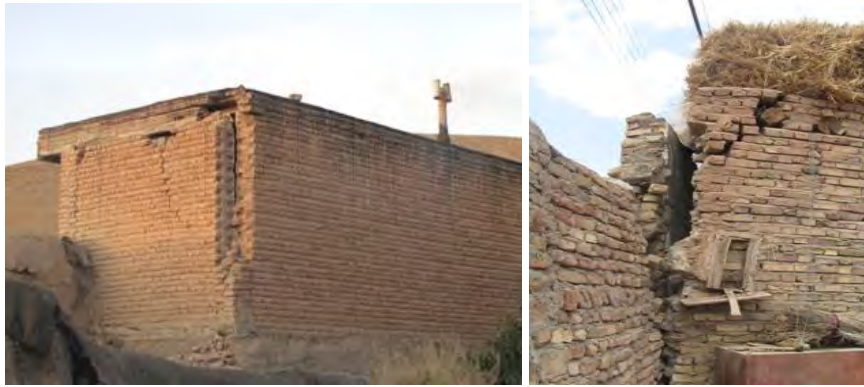
Photo 3.2. Separation of adjacent walls in masonry building.

Due to weakness in the connection corner of masonry walls this region is highly vulnerable in case of seismic loads. The most reason of this failure is due to stress concentration resulting from both lateral masonry walls. **Photo 3.2** demonstrates some examples of this type of masonry wall failure.

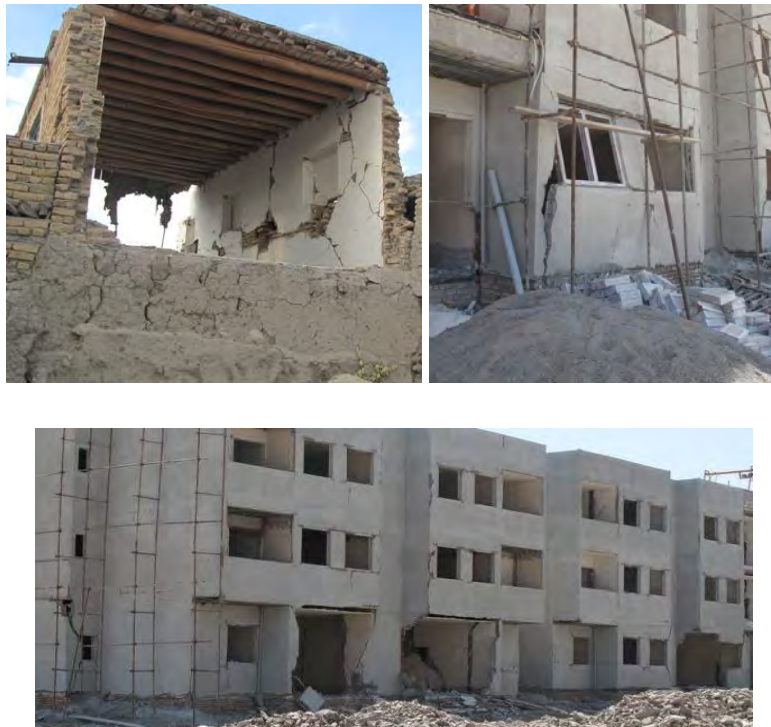
Photo 3.3 Out of plane behavior of masonry walls in case of seismic orthogonal loads.

This failure type is common when the main direction of the seismic shake is perpendicular to the masonry walls and these have insufficient transversal supports. This failure type is becomes more likely when connections between the walls fail as observed in **Photo 3.3**. If the connection between walls is weak, due for example to a poor block or brick stacking, it can easily fail. As a result each of the connecting walls becomes an independent structure, which is the worst-case scenario is only supported at the bottom. An out-of-plane failure type is extremely possible to occur under these conditions.

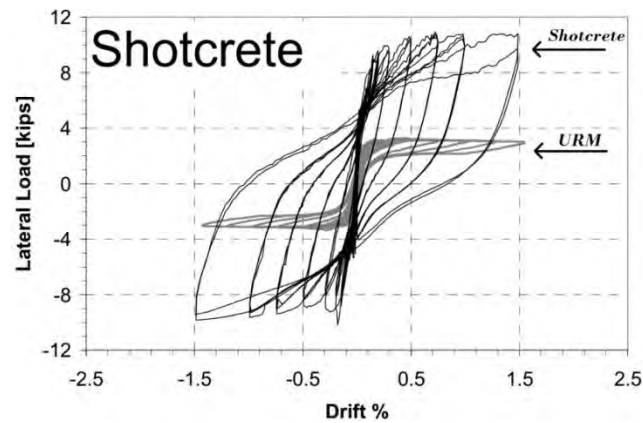
Figure 3.2 Hysteretic curves for a specimen before and after retrofitting using shotcrete (Abrams and Lynch 2001[25]).

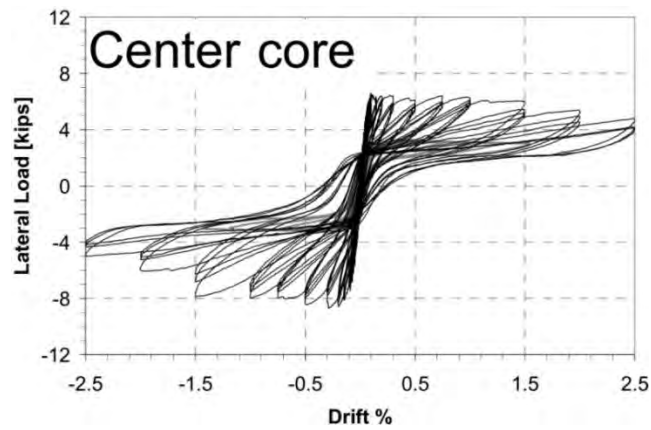
Figure 3.5 Hysteretic curves for a specimen after retrofitting using center core (Abrams and Lynch 2001[25]).

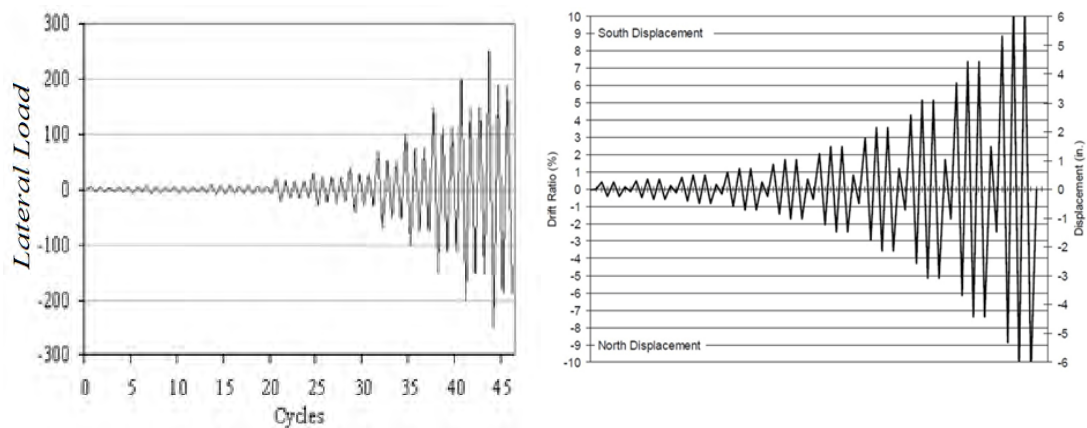
Figure 3.7 Load and displacement amplitudes in Static cyclic loading test.

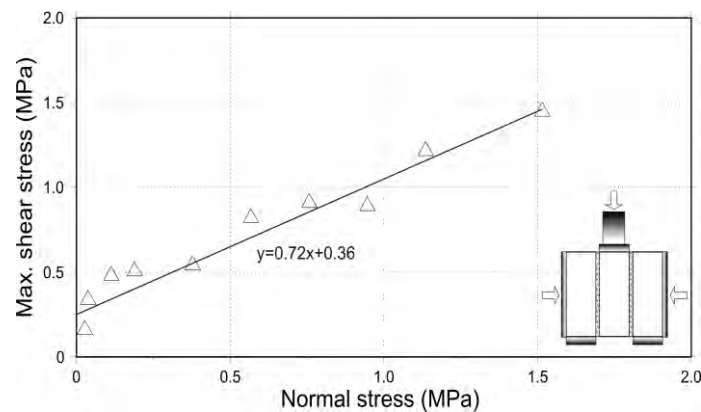
Figure 4.4 Maximum values of shear stresses in function of lateral pre-compression stress.

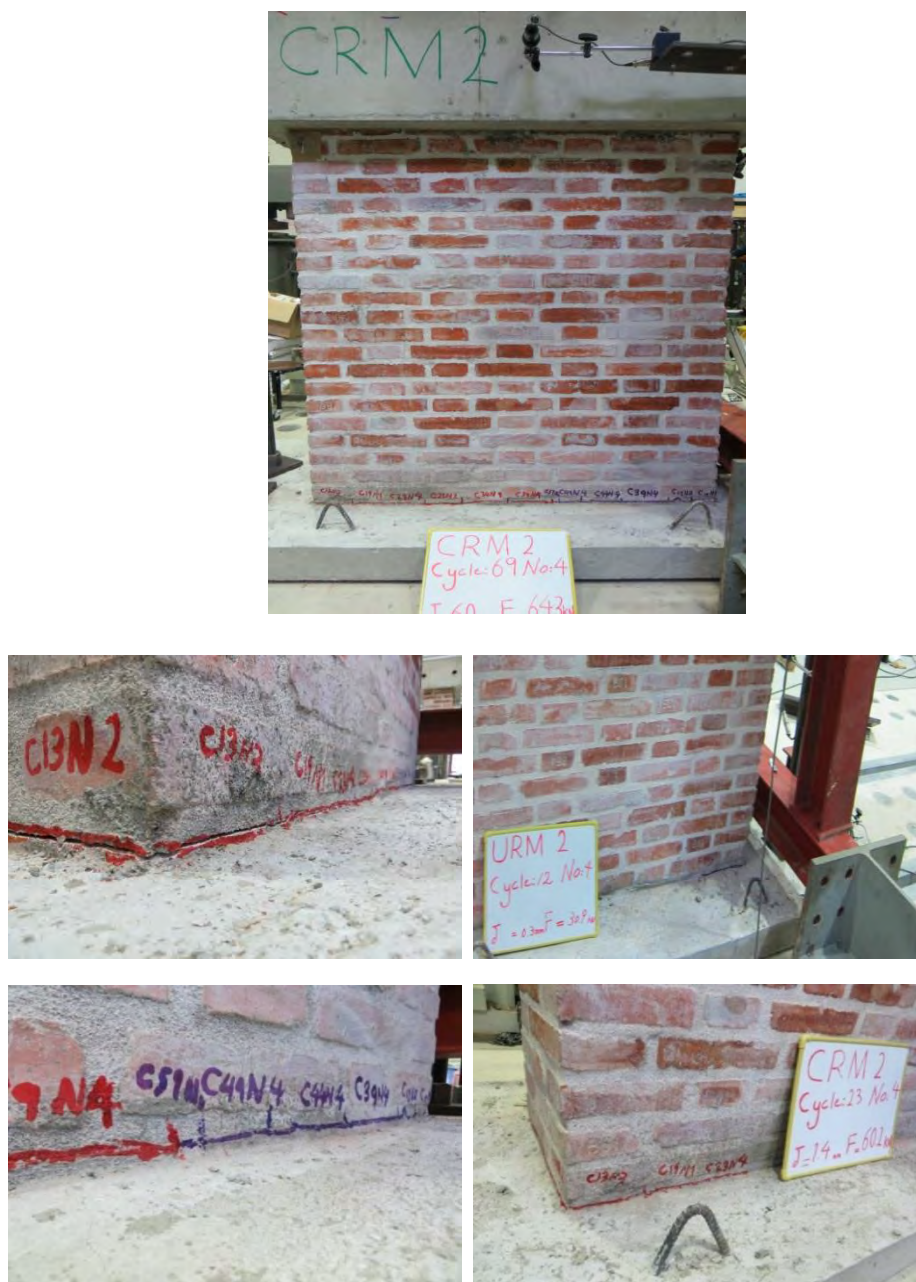
Photo 4.12. Cracking pattern and failure modes of the specimens.
